Collision with terrain involving a Robinson R44, VH-YYF

near Hughenden, Queensland, on 1 February 2015

ATSB Transport Safety Report
Aviation Occurrence Investigation
AO-2015-014
Final – 22 April 2015

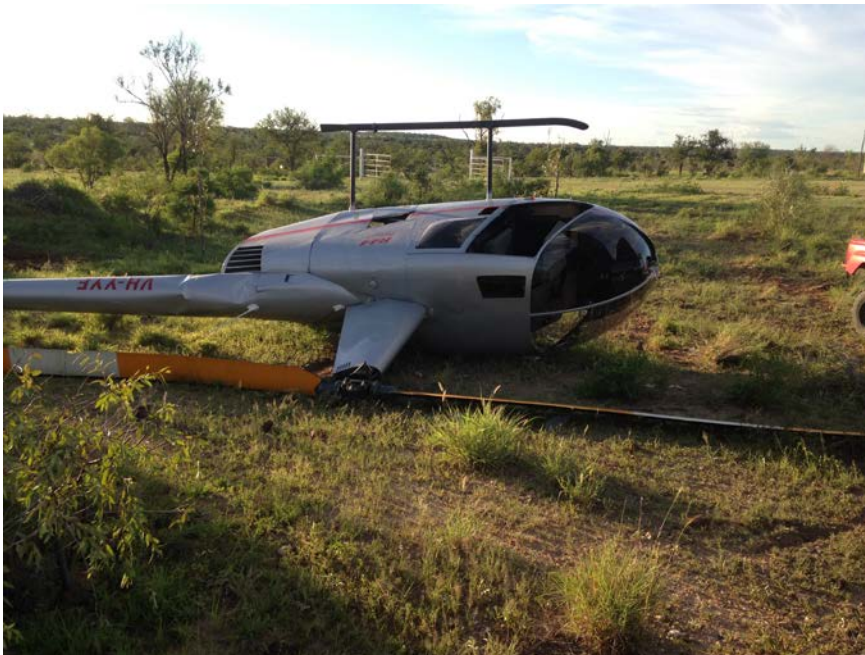
Figure 1: Damage to VH-YYF

At about 0800 Eastern Standard Time (EST), the helicopter lifted off normally. At about 20 ft above ground level, the pilot lowered the nose of the helicopter in attempt to gain forward speed and transition from hover to forward flight. The helicopter then sank quickly and the rotor rpm decayed. The pilot pulled back on the cyclic¹ control in an attempt to flare and reduce the rate of descent, prior to contacting the ground. The left skid contacted the ground first and then the helicopter spun to the right. The rear of the right skid dug into the ground and the helicopter rolled onto the right side. The pilot selected the master switch off before exiting the helicopter uninjured. The helicopter sustained substantial damage (Figure 1).
