**Departmental investigation into the  
grounding of the  
Antigua & Barbuda flag cargo vessel  
KARIN B  
while approaching  
Barry Beach Terminal, Victoria,  
on 19 October 1996**

**Report No 100**

**COMMONWEALTH DEPARTMENT OF  
TRANSPORT AND REGIONAL  
DEVELOPMENT**

Published: May 1997

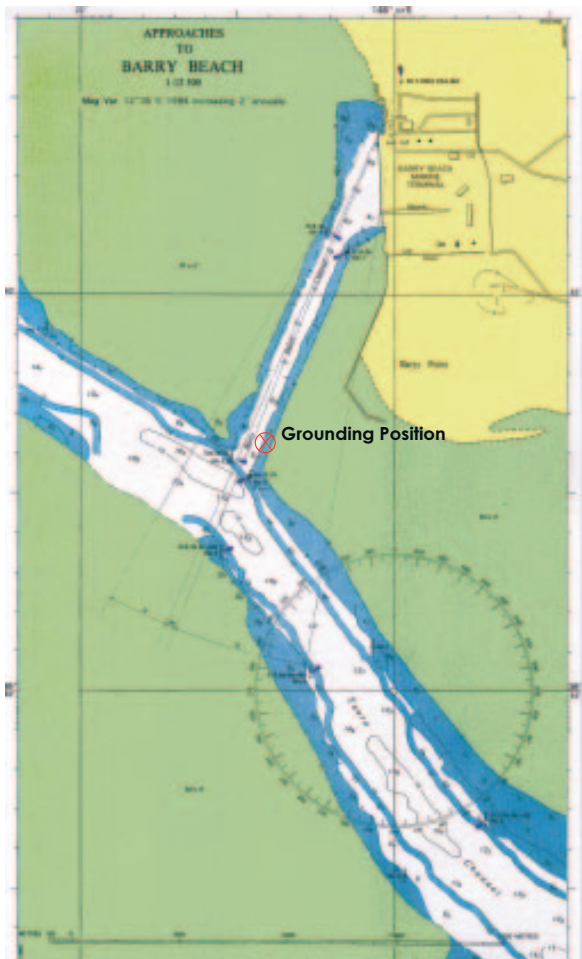
**Portion of chart Aus 182 showing the grounding position**

As Karin B was passing between no.2 and 9 buoys, the Master received the instruction “steady”, immediately after which there was a sudden shift in the wind to the west and a tremendous increase in the strength to an estimated 35 knots. The Adviser gave orders for full speed and a series of helm orders, initially to keep the stern clear of no.9 buoy and then to try to keep the vessel in the channel. However, at 0750, even with the bow thruster on full power, Karin B was set on the starboard hand bank, about one cable inwards from no.9 buoy, six cables from the berth, and immediately listed about 10° to port.

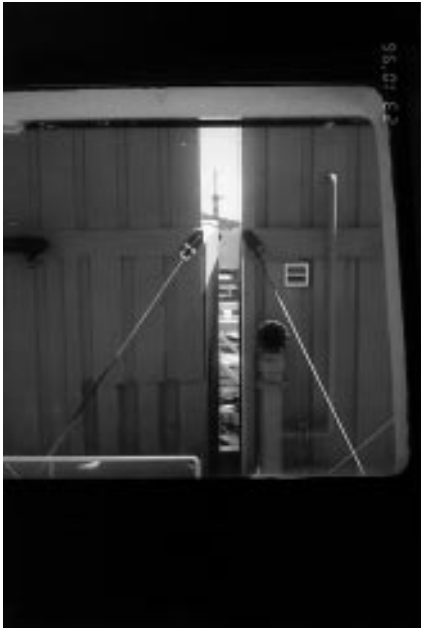
**View from control position**

Although he introduced himself as the pilot, the Adviser went on to inform the Master that he was on board purely in an advisory capacity, to assist him during the entry. Introductions completed, the Adviser was surprised to find the vessel did not have the local charts and that there was practically no visibility forward from the wheelhouse, because of the deck cargo.

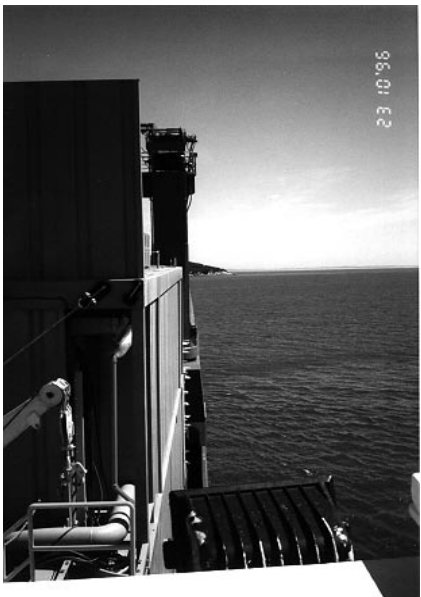
**View from starboard bridge wing**

Due to the lack of forward visibility from the wheelhouse, the Adviser took up station on the starboard bridgeway, calling out course
