**Departmental investigation  
into the collision between  
the Singapore bulk carrier  
MAERSK TAPAH  
and the Australian fishing vessel  
NIMBUS  
south of Low Isles, Great Barrier Reef  
on 26 November 1996**

**Report 103**

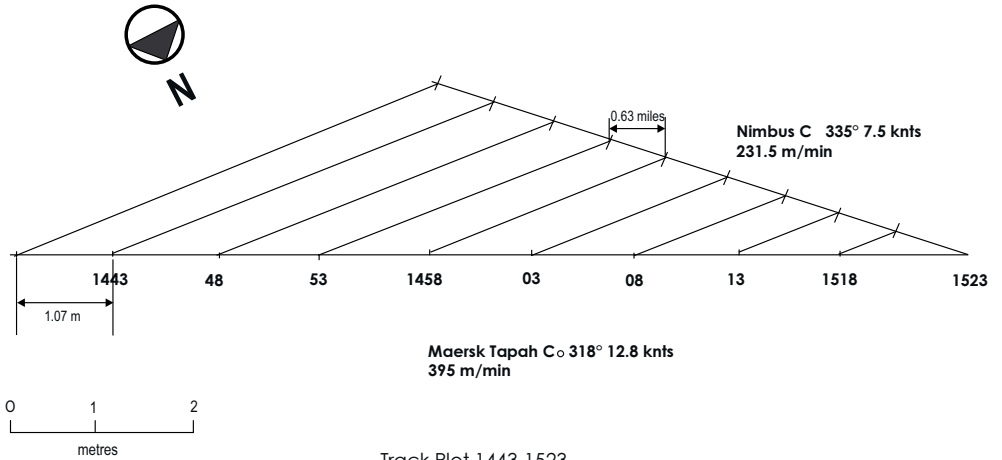
Track Plot 1443-1523

The officers of the watch on board Maersk Tapah fixed the ship’s position at regular intervals and maintained a record of positions and courses in the log book. The vessel also had a course recorder which had been turned on and synchronised before sailing from Gladstone.

From this data the Inspector is satisfied that Maersk Tapah was on a course of  $318^{\circ}$  at a speed of, or slightly in excess of, 12.8 knots. The course recorder shows that, other than a deviation at 1404 over a period of about 6 minutes, the vessel maintained a course of about  $318^{\circ}$  from the alteration off Little Fitzroy Island at 1250 to the alteration near Low Isles at about 1543, 20 minutes after the collision.

The conclusion therefore is that both vessels maintained a constant course and speed and were on converging tracks.

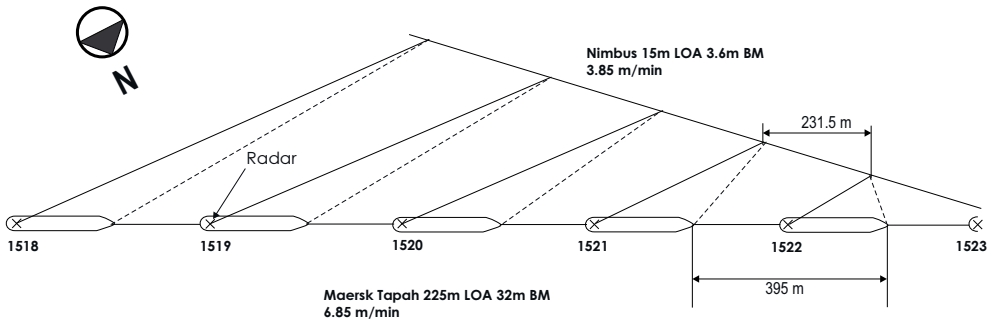
SITUATION 1518 - 1523

Before the collision the Second Mate queried the Pilot in respect of the passing distance from Nimbus. The Pilot assessed the other vessel’s course as being nearly parallel to that of Maersk Tapah. In fact the two vessels were on a collision, or near collision, course converging at an angle of  $17^{\circ}$  and closing at the rate of about 70 m per minute.

One minute before the collision Nimbus would have been level with the break of the forecastle and about 70 m from the ship. Within 30 seconds, Nimbus would have been at mid-length and about 35 m from Maersk Tapah's side and this is consistent with the Pilot's own observation. This would have brought Nimbus very close to Maersk Tapah's stern. If collision did not result from a direct converging of the vessels' tracks, it is probable that interaction occurred, the pressure wave at the stern of the bulk carrier causing the fishing vessel's bow to turn to starboard, drawing the fishing vessel against Maersk Tapah's stern, resulting in damage to the fishing vessel's stem area. This would be consistent with the observations of the Maersk Tapah's crew, gathered at the stern of the bulk carrier.

Although the Pilot maintained that he used the centre line gyro repeater to monitor the bearing of the fishing vessel to assess the overtaking situation, the evidence is that the vessels were converging and the Pilot did not appreciate the degree to which this was occurring.
