**Departmental investigation
into the collision between
the Australian fishing vessel
ESTER J
and a bulk carrier
in Bass Strait at about 0215
Eastern Australian Summer Time
on 26 November 1996**

Report 104

Published: July 1997
ISBN 0 642 19989 2

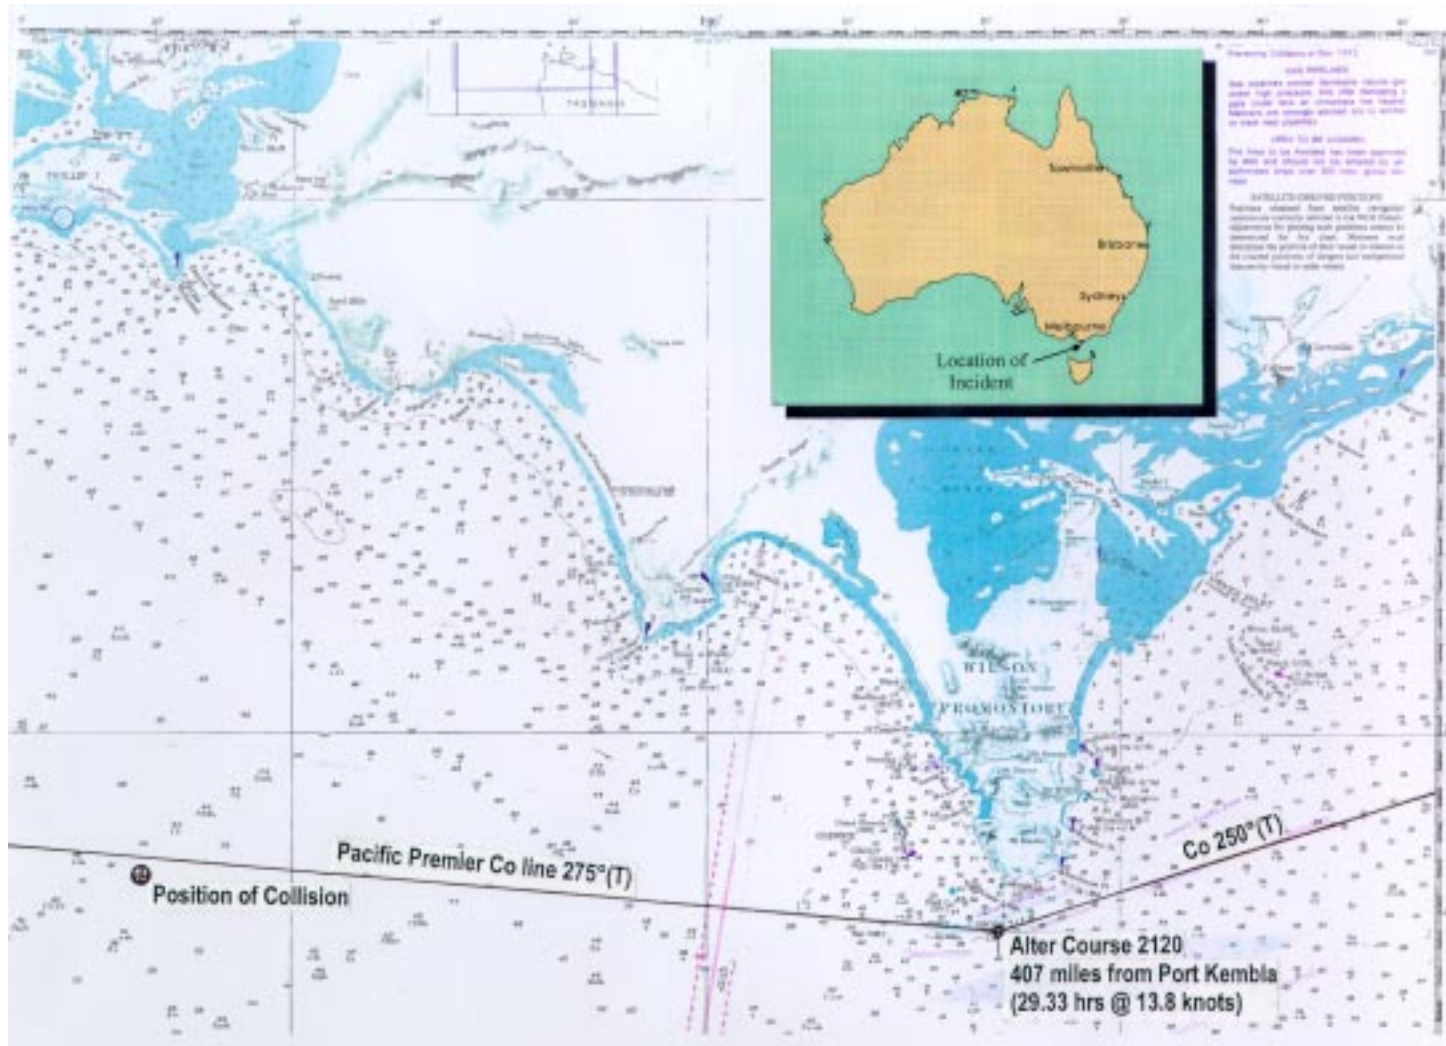
Portion of chart Aus 445A&B showing location of incident

The collision position was recorded as Ester J's anchor position, 39° 7.88' South 145° 19.25' East, 30 miles from the Victorian coast line in international waters.

The anchorage position was directly on the track of vessels bound from the eastern seaboard to South Australia, the west coast or for overseas ports in the Indian or Atlantic Oceans. Although not heavily trafficked, the track is in regular use.

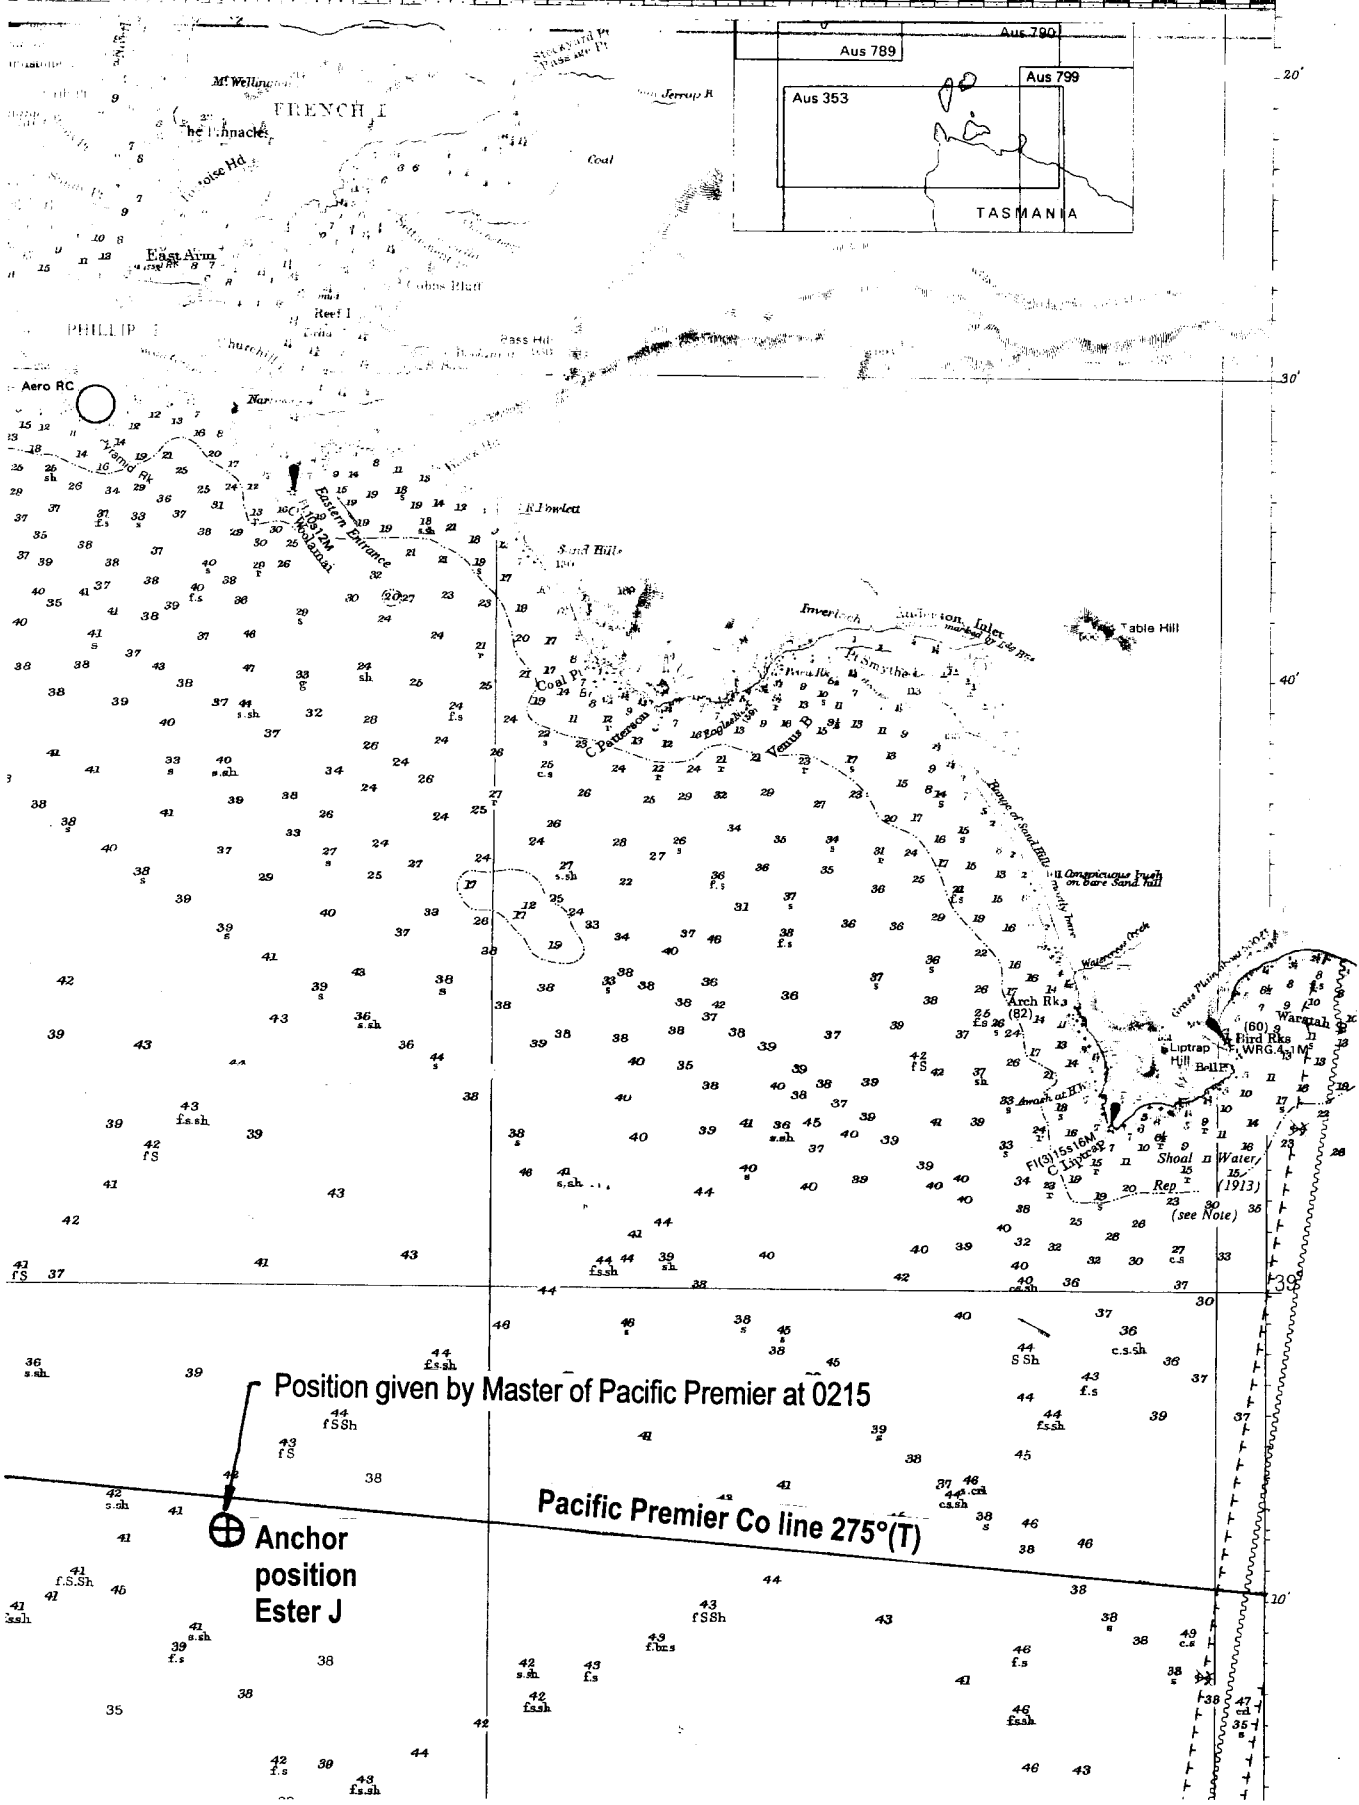
Portion of chart AUS 445A showing situation 0215 26 November 1996

The position of Pacific Premier at 0215 on 26 November, was stated by the Master to be 39° 08' South 145° 20' East. This is consistent with the vessel having sailed 455 miles in the 33.75 hours from dropping the pilot at Port Kembla at a speed of about 13.5 knots. The fishing vessel's position by GPS was 39° 7.88' South 145° 19.25' East. The two positions were less than one mile from each other.
