**Departmental investigation into the
collision between
the Turkish bulk carrier
GUMBET
and the fishing vessel
MOONSHOT
off Pakhoi Bank, Queensland
on 13 December 1996**

Report 106

**Navigation Act 1912
Navigation (Marine Casualty) Regulations
investigation into the
collision between
the Turkish bulk carrier
GUMBET
and the fishing vessel
MOONSHOT
off Pakhoi Bank, Queensland
on 13 December 1996**

Published: July 1997

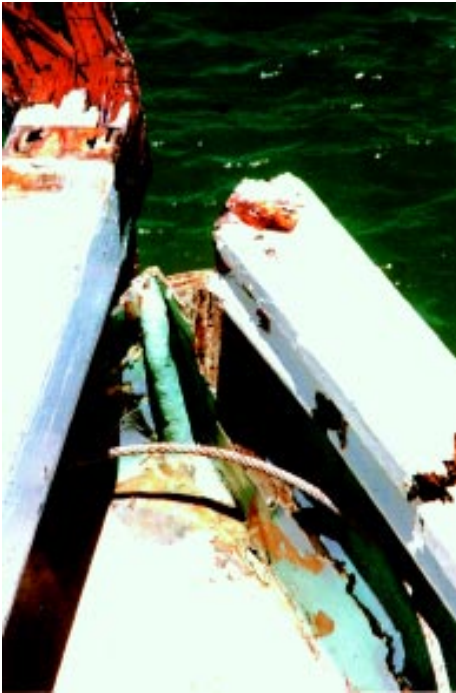
Moonshot received damage to the stem and starboard bow, also to the starboard fishing boom. After ascertaining that the vessel was not taking water, the crew retrieved the fishing gear, then returned to Townsville for Moonshot to undergo repairs.

Damage to Moonshot's Bow

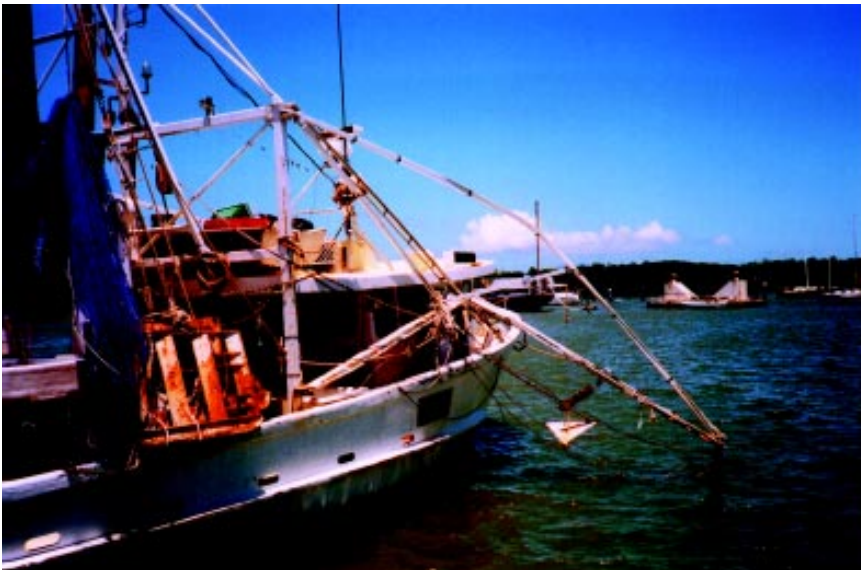
Damage to Moonshot's Starboard Outrigger

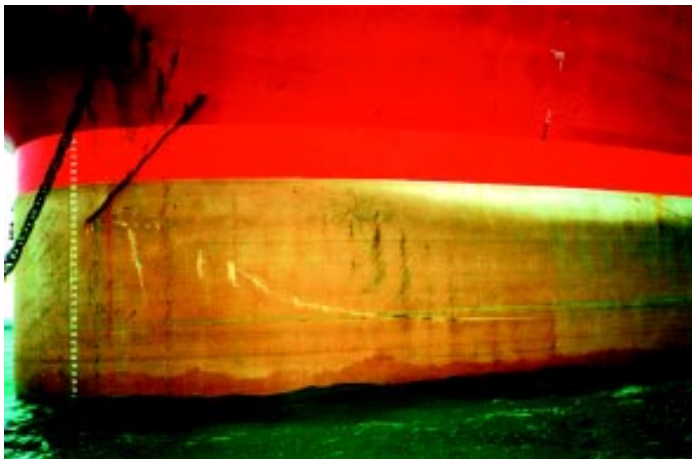
Gumbet anchored off the port of Geelong at 1600 on 18 December 1996. An inspection of the vessel revealed white contact marks on the port bow, beneath the hawse pipe and extending aft, between the light and load water lines.

Contact marks on
Gumbet's Port Bow,
Geelong
18 December 1996

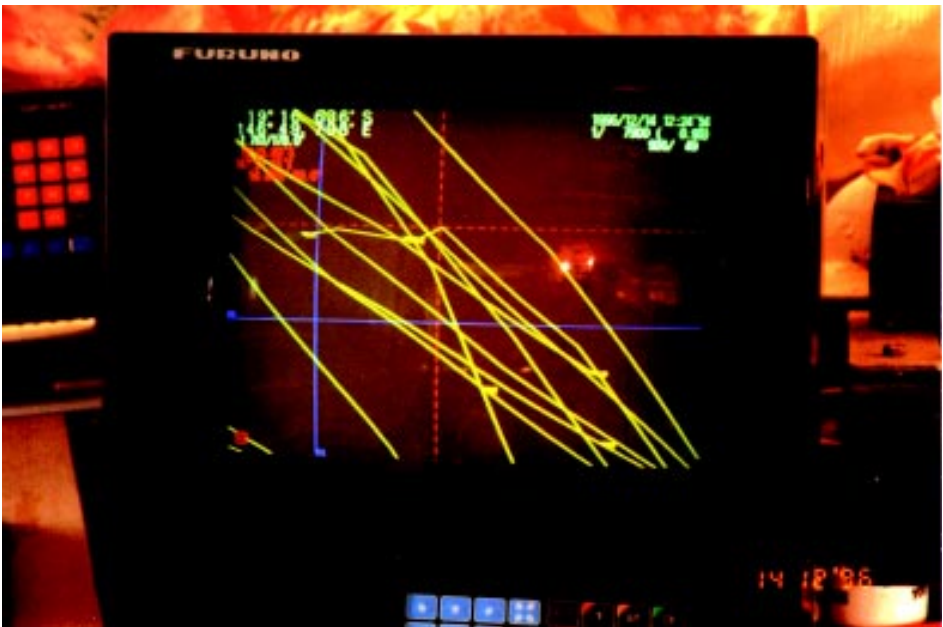
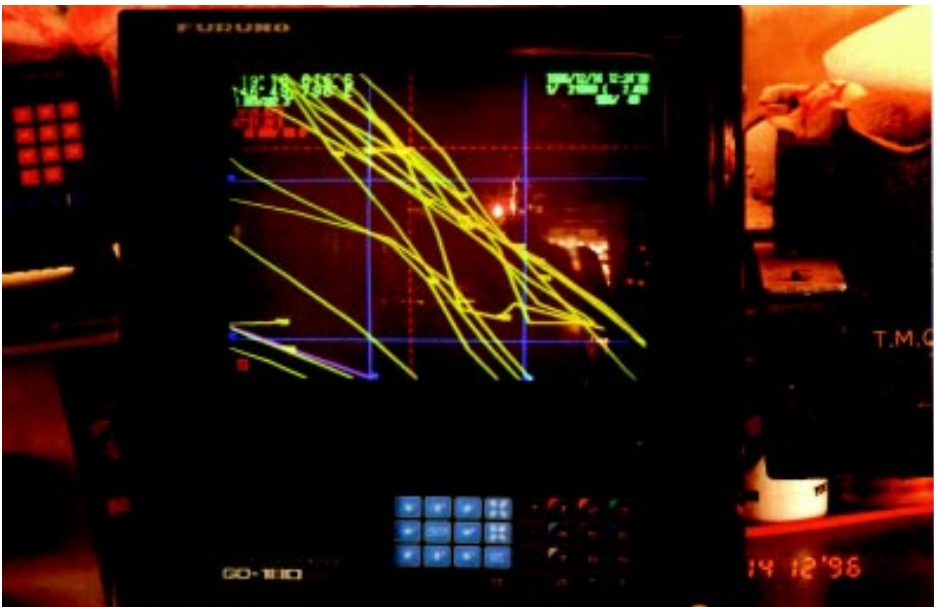
Moonshot's Navigation Plotter

Although Moonshot's real-time position from the GPS was constantly displayed on the navigational plotter, the position was only stored in the computer memory at 10-minute intervals. Thus, when recalling the information, Moonshot's track appears as a series of straight lines joining the recorded positions. As alterations of course can occur at any time during a 10-minute period, the actual track is virtually impossible to determine. As the plotting period is from the time the plotting is activated, the plotting times can be as much as five minutes out of phase with the clock.

From the plotter, after making the turn to starboard, and from position $19^{\circ} 26.9' S : 147^{\circ} 52' E$, the vessel made good a track of 341° True for a distance of 0.474 miles, providing a speed of 2.84 knots. The plot then moves in a direction of 325° for a distance of 0.493 miles, providing a speed of 2.96 knots, then in a direction of 312° for a

distance of 0.371 miles, providing a speed of 2.23 knots, to position $19^{\circ} 25.8'S : 147^{\circ} 51.26'E$. When interviewed, the Skipper stated that that was the position of the collision, although the position he provided to MRCC, from the GPS, was 0.07 miles (130 m) to the west of that position. The navigation plotter shows that during the next 10-minute interval Moonshot moved 0.046 miles (84.5 m) in the direction 242° . Then, after coming to a stop, Moonshot drifted for a considerable time, as indicated by a “knot” of position traces.

The reduced distance during the third 10-minute period would indicate the collision occurred towards the end of this period, which in turn indicates the plotting times were close to, if not in fact at, 0330, 0340, 0350 and 0400.

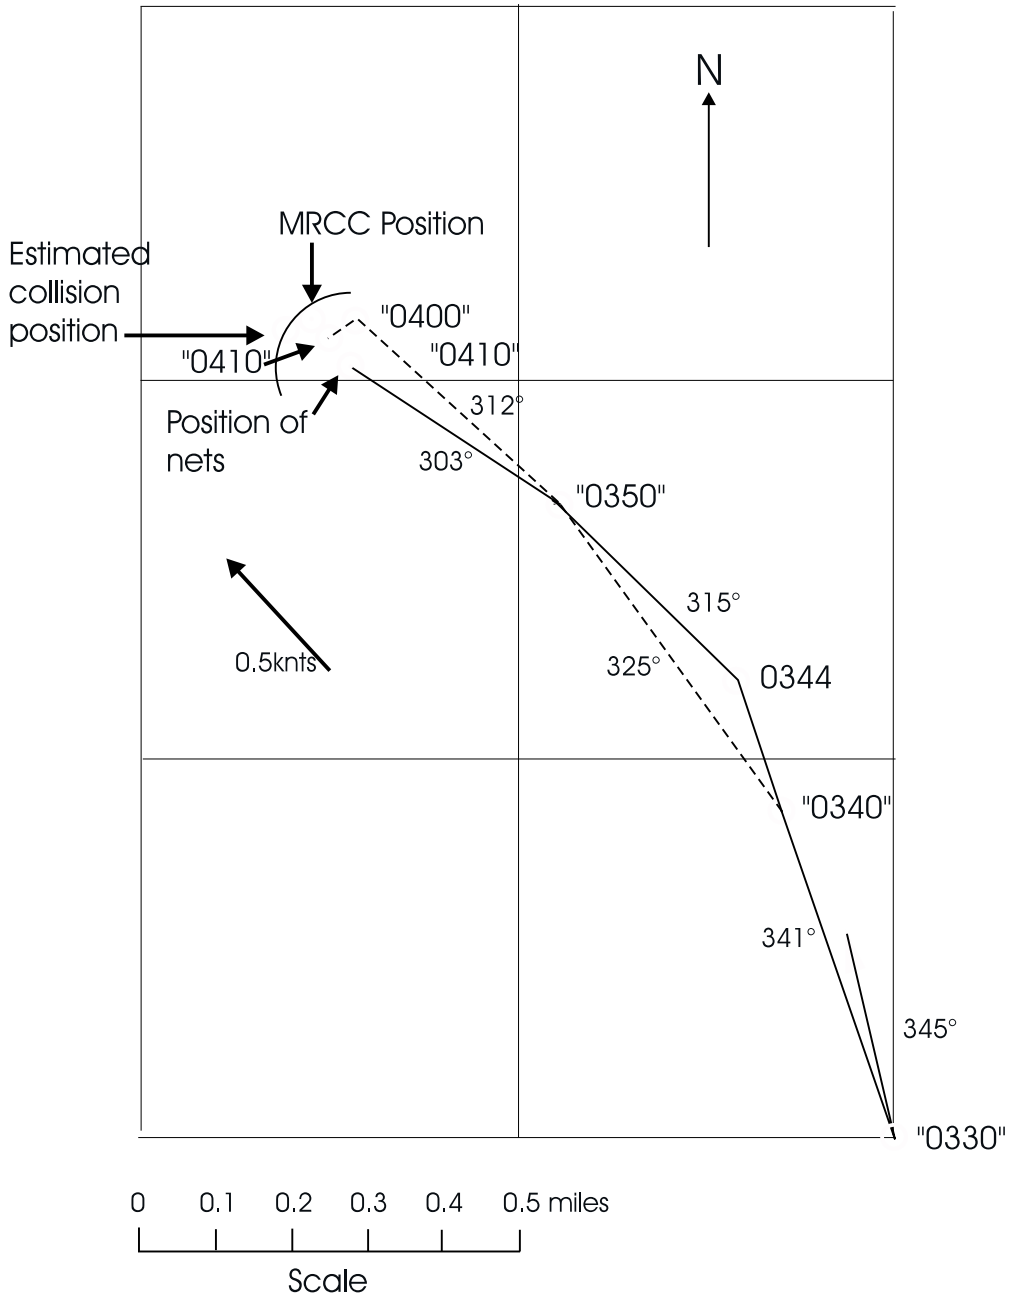
Analysis of Moonshot's Movements

Moonshot was spun about to port by the force of the impact, so as to parallel Gumbet, therefore it would be expected that any movement of Moonshot, as a result of the collision, would be towards the south and east. The trawl nets, towed about 0.09 miles (160 m) astern of the fishing vessel, would come to rest on the sea bed at the time of, or very shortly after, the collision and eventually Moonshot would come to lie down wind and down tide of the nets, as if at anchor. The approximate position of the nets can be estimated from the position where Moonshot came to rest and from that, the approximate position of the collision. It is estimated that the nets were in a position 110 m at 187° from the “0400” plotter position.

alteration of around 10° is considered reasonable in the case of a fishing vessel. The track made good from the “0350” position to the estimated net position is 303° , providing a substantial change in direction, in excess of 40° , from the north-north-westerly course.

Gumbet reportedly crossed ahead of Moonshot before the owner altered the “few” degrees to port, therefore the indications are, he made an earlier alteration of course to port. As the previous, more northerly track line was 315° , it is possible the owner had brought Moonshot to a similar course, at about 0344.

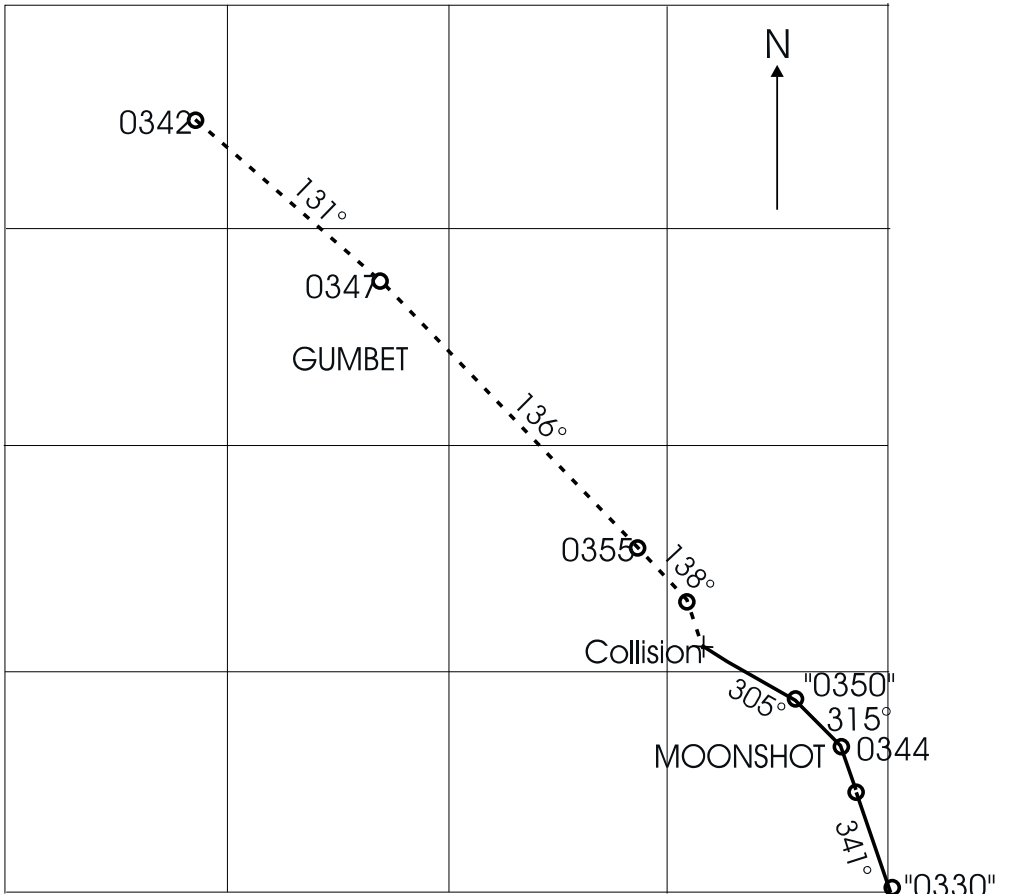
Reconstruction

At 0342, Gumbet and Moonshot would have been about 4.1 miles apart, which indicates a discrepancy of about half a mile between the positions provided by the GPS instruments aboard the two vessels. From this point onwards, it is difficult to reconcile the accounts of the owner of Moonshot and the Second Mate of Gumbet, and the indications are that both the owner of Moonshot and the Gumbet’s Second Mate wrongly recalled the angles on the bow of the other vessel.

The Second Mate's evidence was that at 0342, Gumbet was heading 128° and Moonshot was 3° on the starboard bow. However, if when the two vessels were 2.8 miles apart (at 0347) the Second Mate had altered 5° to starboard, given their courses and speeds, Gumbet would not have crossed ahead of Moonshot, but would have passed about a quarter of a mile to the south of the fishing vessel.

It is considered probable that at 0342, Gumbet was on a heading of 131°, making good a speed of 12.5 knots, with Moonshot bearing 135° at 4.15 miles. At that time, Moonshot was making good a track of 341° at a speed of 2.84 knots. Had both vessels maintained course and speed, Moonshot would have passed ahead of Gumbet at 0355, at a distance of nine cables (1668 m), the nearest approach occurring at around 0358½ at a distance of about 0.8 cables (148 m). The alteration of course by Moonshot to around 315° at about 0344 and the 5° alteration of course to starboard by Gumbet (to 136°) at 0347 created a converging situation, which was maintained by the subsequent course alterations by both vessels.
