**Departmental investigation into the
marine aspects of a helicopter crash
during marine pilot transfer operations
from the Maltese flag cargo vessel
CAPE ARNHEM
off Gladstone on 25 February 1997**

Report No. 109

Published: December 1997
ISBN 0 642 19997 3

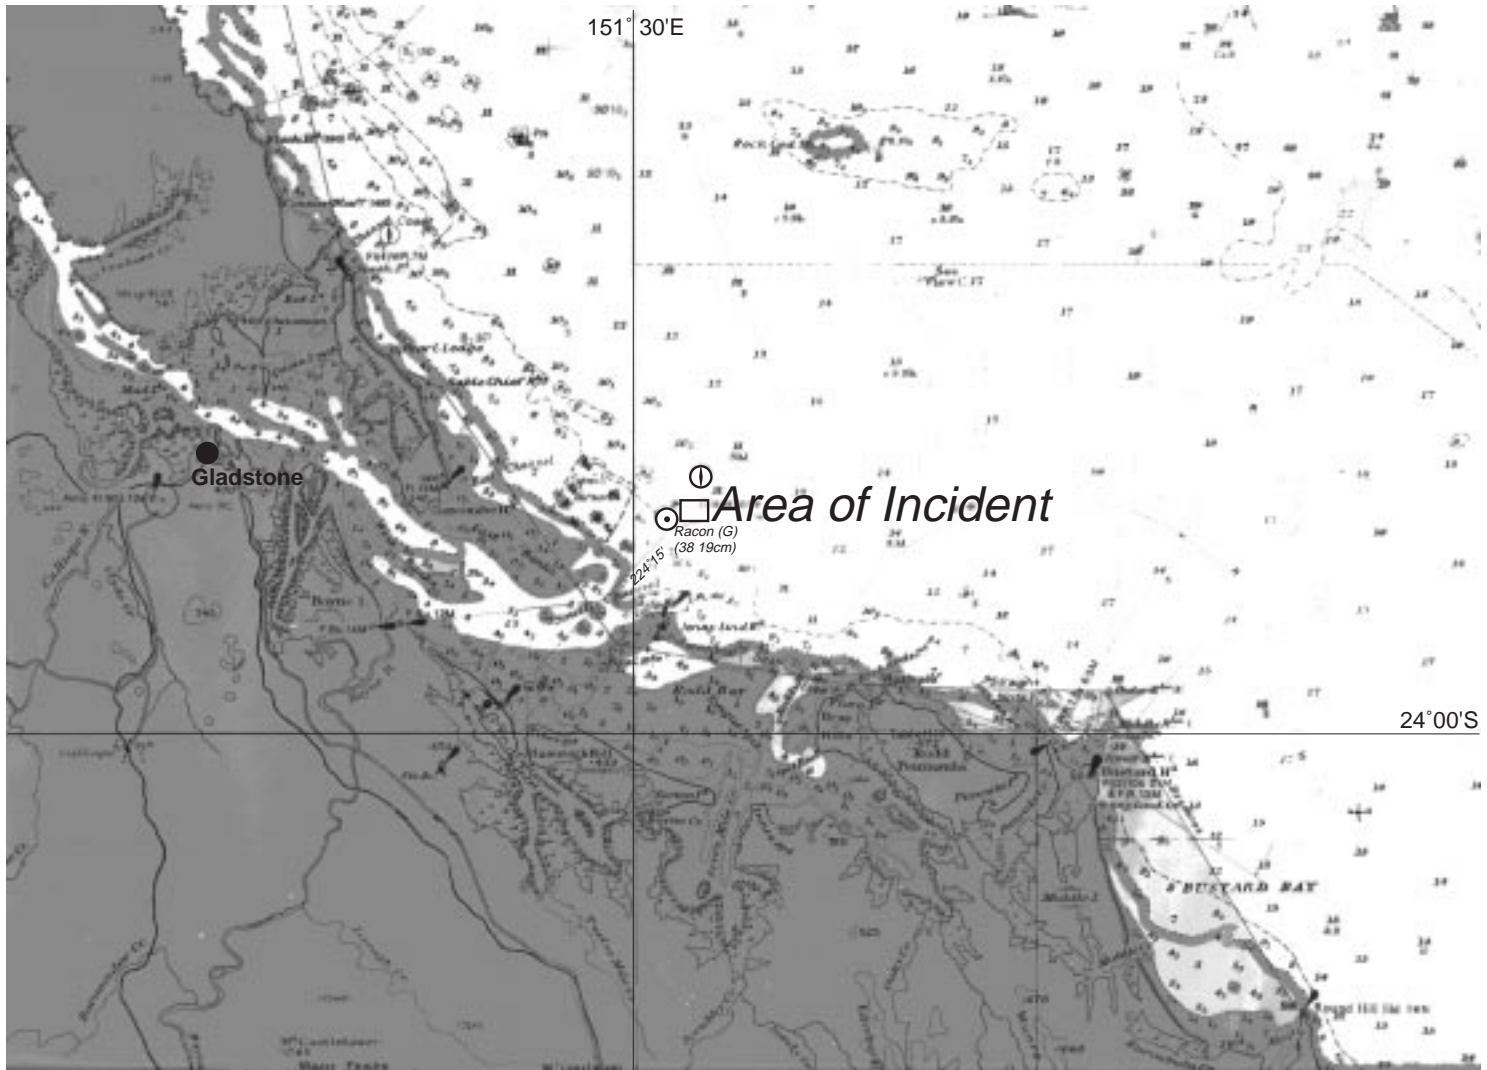
Portion of chart Aus 366 showing location of incident

The helicopter was heard before it was seen by those on the bridge and it landed, on schedule, very shortly afterwards. It approached from the starboard side and landed on the starboard side of No.2 hatch, just forward of mid length, as the vessel cleared Nos. 1 and 2 buoys.

After a brief pause, and as the vessel was coming up to the Fairway Buoy, the helicopter lifted off the hatch at 0112, hovered for a few seconds, then tilted nose down and started to move across the hatch towards the port side. Those watching from the deck and from the bridge stated the helicopter then accelerated, rose and banked to the left as it did so. Suddenly there was a loud bang and those watching realised the helicopter main rotor blades had struck the cargo hook, or block, of No.2 crane. The helicopter started to pivot in an anticlockwise direction and the tail rotor also struck the hook, after which the helicopter rolled to its right and, upside down, plunged into the sea, about 15 m to 20 m from the ship’s side.

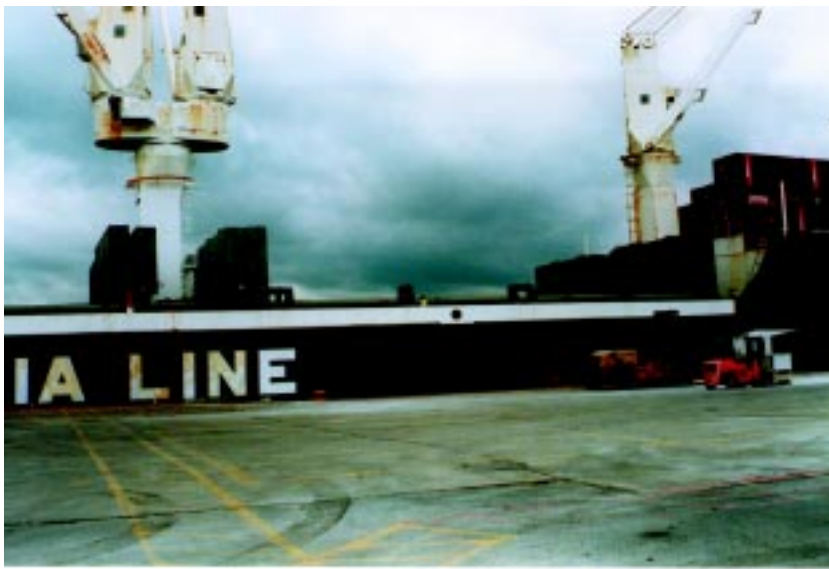
Cape Arnham No.2 hatch

The Master of *Cape Arnhem* was persuaded, against his own judgement, to agree to a helicopter operation. However, No.2 hatch was clear of obstructions and the distance between the crane housings, at the forward and after ends of the hatch, was 25 m, well in excess of the 16 m clear space required by the

No.2 hatch was sheltered by containers stowed on No.1 hatch. The air conditions experienced by the helicopter while hovering above the hatch, before moving off, were likely to be considerably different to the air conditions at the ship’s side. In such circumstances, a windsock, or pennant, could have been of benefit to the helicopter pilot. A windsock needs to be flown from a point visible to the helicopter pilot at all times and in this instance, a pennant flown from the suspended crane hook would have provided visual indication of the relative wind to the helicopter pilot both during approach and take off, it would have also drawn the helicopter pilot’s attention to the suspended hook.

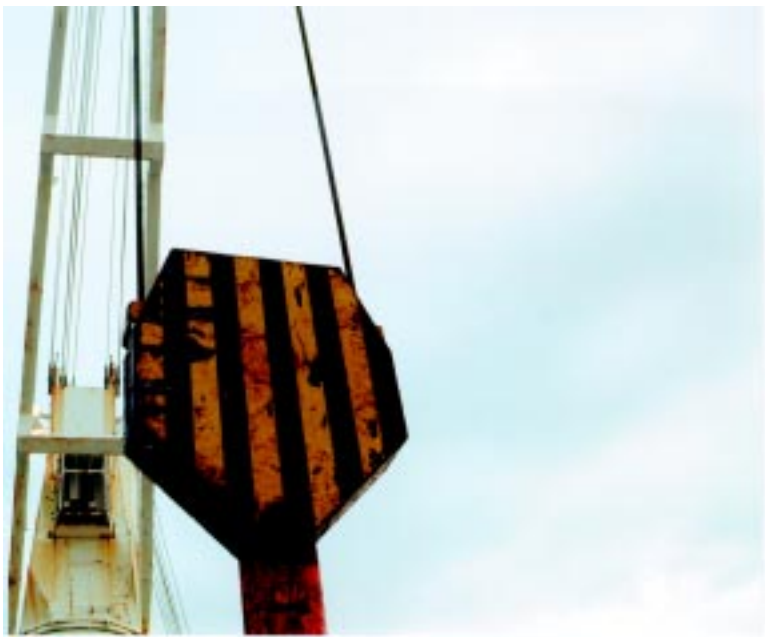
The helicopter lifted off the hatch, hovered briefly, tilted and started to move forward, across the hatch, towards the port side. It then started to climb, accelerated and, according to those watching and to their concern, it banked to the left. There was then a loud bang as the main rotor blades struck the hook block of the topped No.2 crane. The helicopter started to rotate, the tail rotor also striking the hook block. The helicopter then flipped upside down and fell to the sea, about 20 m from the ship’s side.

Cape Arnhem No.2 crane block showing rotor blade contact

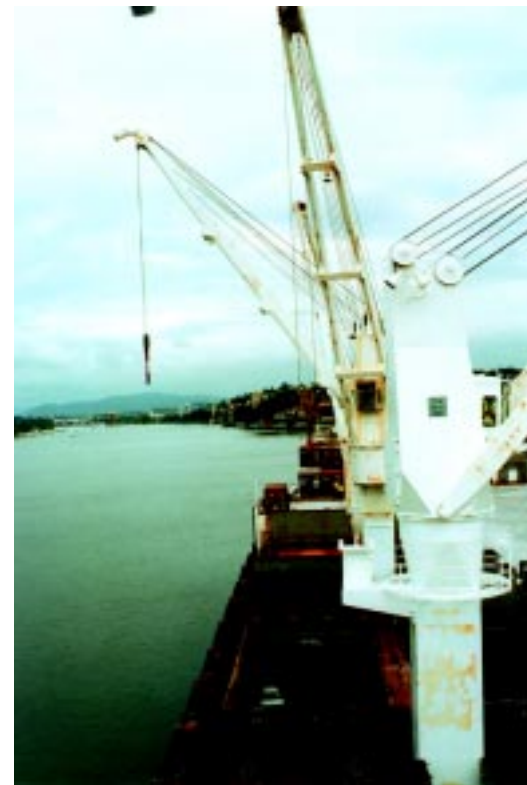
clear to the port side, in preparation for the helicopter landing on No.2 hatch. The floodlights were up to full luminescence and the crane topped and swung to port to the maximum amounts by 0055, ten minutes before the scheduled arrival time of the helicopter. The crane hook and block were also raised to the “cut-out” point, and hung suspended outboard of the ship’s side, about 18 m from the head of the jib and about 15 m above the level of the hatch lid. The Bosun and seaman who had topped the crane took up station at the forward end of No.2 hatch, under the break of the forecastle, on the starboard side, to await the arrival of the helicopter.

Cape Arnhem No.2 crane swung outboard viewed from the bridge
