**Departmental investigation into the  
momentary grounding of the  
Cypriot flagged bulk carrier  
AIKATERINI L  
while entering Geraldton, WA  
on 13 March 1997**

**Report No. 111**

**Navigation Act 1912**  
**Navigation (Marine Casualty) Regulations**  
**investigation into the momentary grounding**  
**of the Cypriot flagged bulk carrier**  
**AIKATERINI L**  
**while entering Geraldton, WA**  
**on 13 March 1997**  
**No. 111**

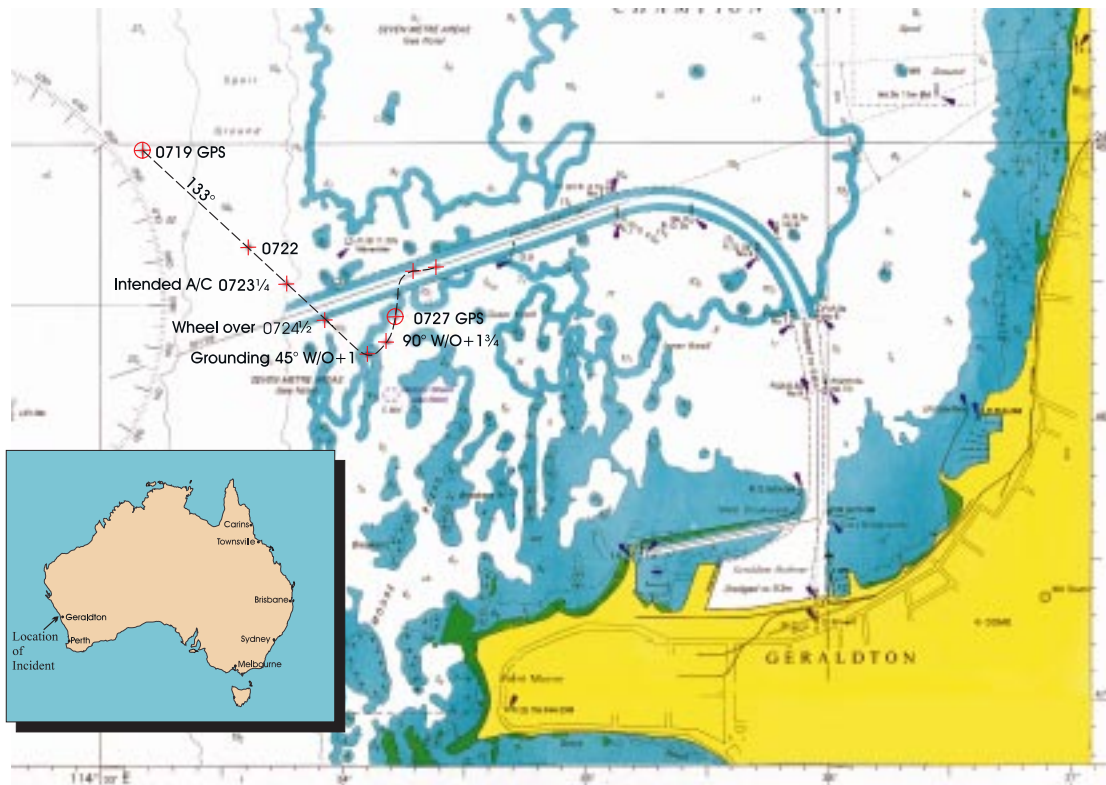
Portion of chart Aus 81 (1983 edition) showing reconstruction track of Akaterini L

It is apparent that Aikaterini L most probably made contact with the northern point of a rock ridge that lies 270 m to the south of the entrance channel and 480 m east-south-east of the Pimple Buoy.

The vessel's probable track was reconstructed from the two positions plotted on the chart, the vessel's manoeuvring diagram and the recorded time of grounding, 0725. Based on this reconstruction, Aikaterini L would have been at the alter course position, with the Pimple Buoy four points on the port bow, at 0722<sup>3</sup>/<sub>4</sub> and the wheel would have been put hard to port at 0724, when the vessel was on the southern boundary of the entrance channel.

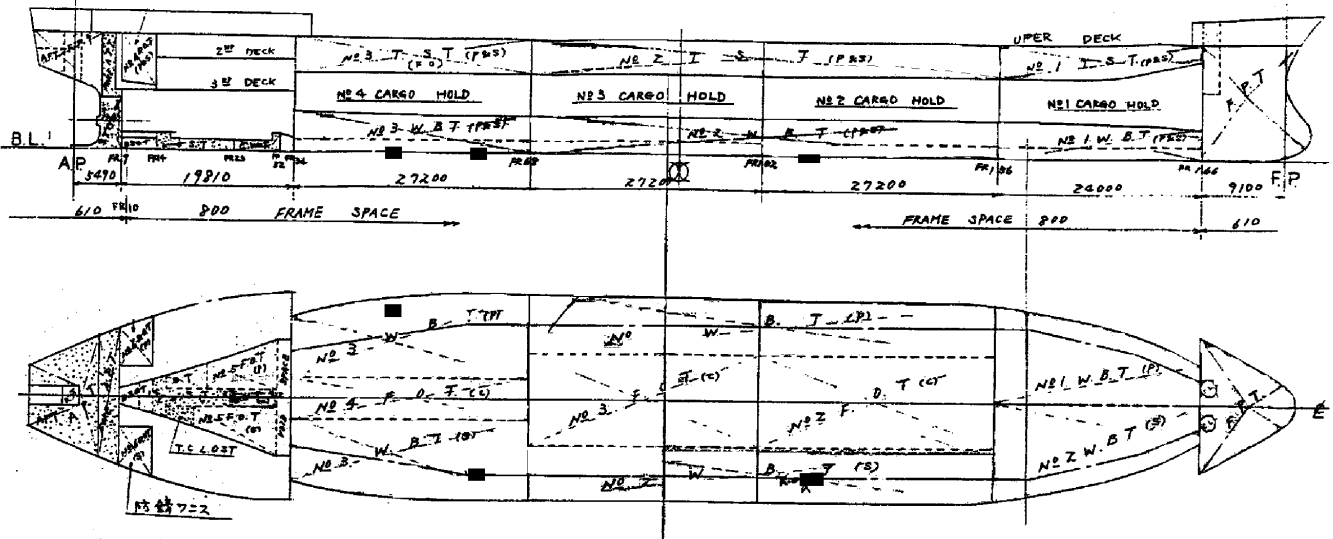
An underwater survey of the hull, conducted by Franmarine Underwater Services Pty. Ltd., confirmed the cracks in Nos. 3 port and 3 starboard double bottom tanks and also found a small crack plus a large, 2.7 m gash in no. 2 starboard double bottom tank. After temporary repairs had been carried out, Aikaterini L was permitted to sail in ballast on 19 March, in order to proceed to Singapore for permanent repairs.

■ Location of Hull Penetrations

General arrangement of Akaterini L showing location of bottom plate damage
