**Departmental investigation into the  
damage sustained by the Australian tanker  
OSCO STAR  
during tropical cyclone Justin  
9 March 1997**

**Report 113**

Navigation Act 1912  
Navigation (Marine Casualty) Regulations  
investigation into the damage sustained by the Australian tanker  
**OSCO STAR**  
during tropical cyclone Justin  
9 March 1997

Published: March 1998  
ISBN 0 642 19999 X

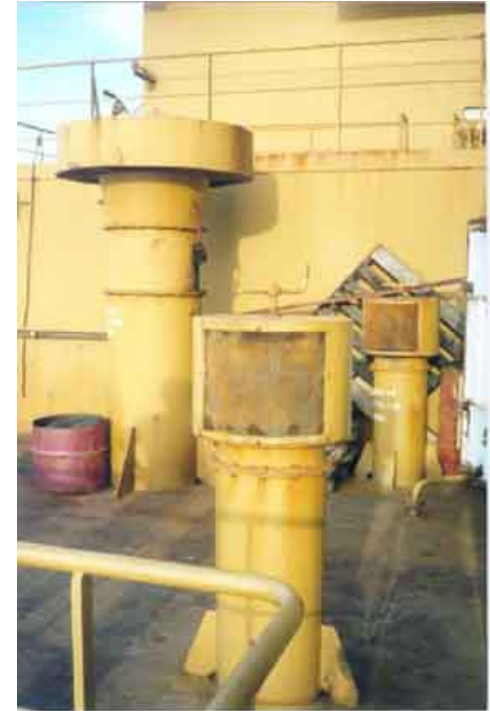
**Ventilators on top of emergency generator room**

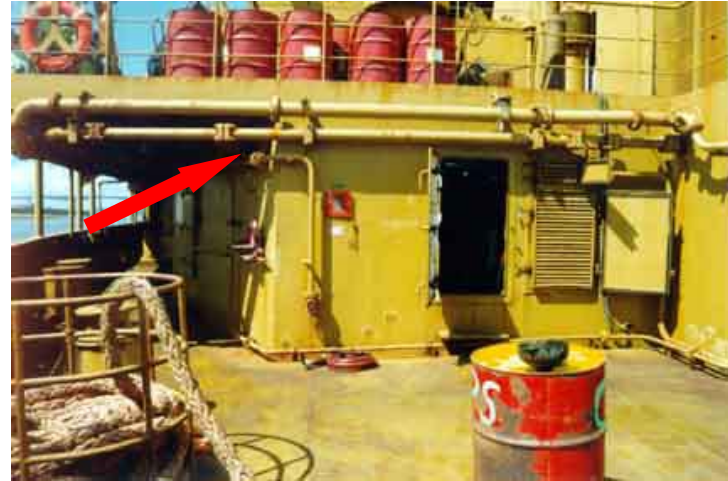
#### **Poop deck**

Connecting this louvred opening to the fan which cools the generator, there is a canvas shroud about 300 mm long. At its underside, the canvas appeared to have been slit with a knife at some time, presumably to allow any water which entered the louvres to drain away instead of sitting in the canvas and being picked up by the fan when the engine ran. The area around this slit was caked with salt, indicating that, at some time either in the past or during the cyclone, water had entered the louvres. It was stated that the flap for the louvres had been closed, however, it could not be ascertained that it had been closed securely and there appears to be some doubt about it still being closed at the time that access was finally gained to the emergency generator room after breakfast on 9 March.

Poop deck of Osco Star with the open door to emergency generator room. Engine cooling-air to right of doorway. Small vent flap with broken lug is shown arrowed.

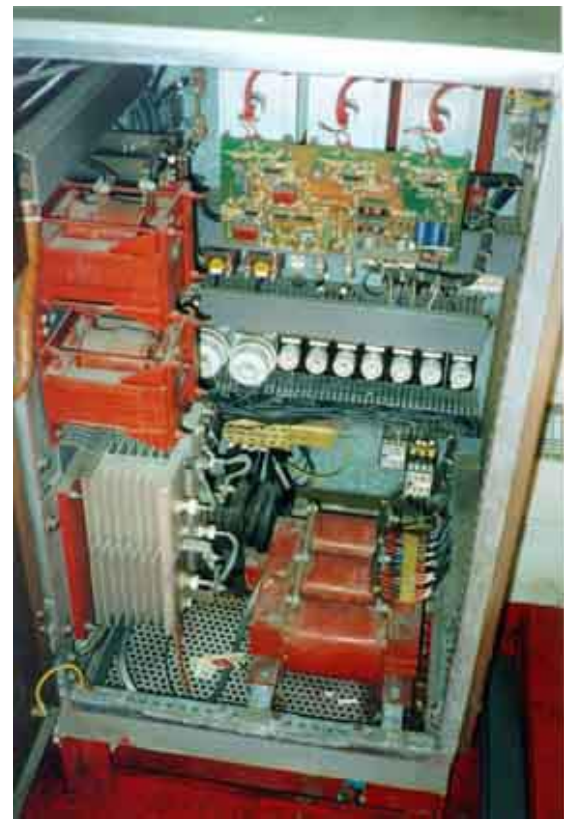
**Interior of SCR60 cabinet**

Interior of SCR60 cabinet in emergency room contains transformer/rectifier units for 24 volt DC supplies and charger for emergency batteries. White circular fuses can be seen, centre, two amp fuses on left.

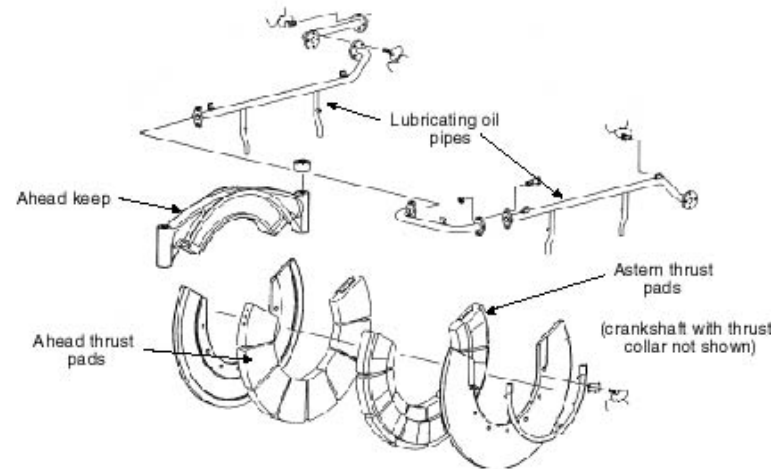
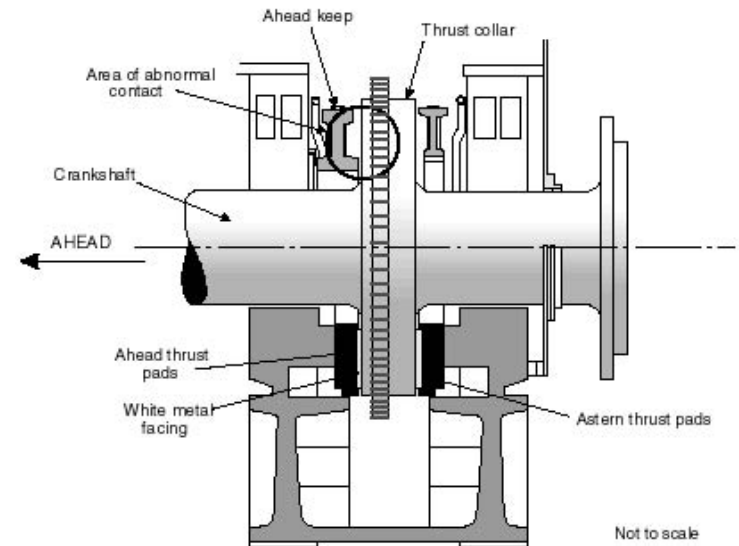
**Oscostar - thrust bearing block**

The predominant feature of the mechanical damage to the main engine was the severe damage to, and dislodgement

of, the ahead thrust bearing pads and their keep.
