**Departmental investigation into  
an injury aboard the tug  
WAMBIRI  
at Fremantle WA  
on 13 April 1997**

**Report No. 114**

**Australia**  
Department of Workplace Relations  
and Small Business

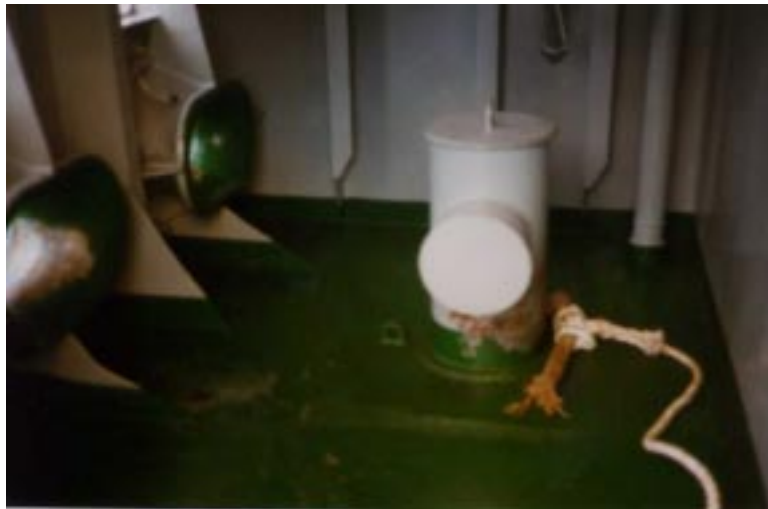
**Photograph of bollard, piece of grommet and messenger**

The tail had parted where it passed around the bollard and a short length of the protective sheath, with the messenger attached to it, remained by the bollard. The 6.5 cm circumference messenger was attached to the tail by means of a soft eye splice, the eye being passed around the rope of the tail twice, so that there were four parts fitting firmly around the tail. Because it fitted firmly, the messenger could not be moved easily around the eye of the tail and so would be left trapped between the eye and the bollard. The possibility was explored that it might create an irregularity in the strain within the eye, as it was in that area that the towrope failed. However, expert opinion provided to the Unit is that whereas this might be the case with cable, or multiplate “square” laid ropes, it was not so with Marlow ‘Superline’ ropes.

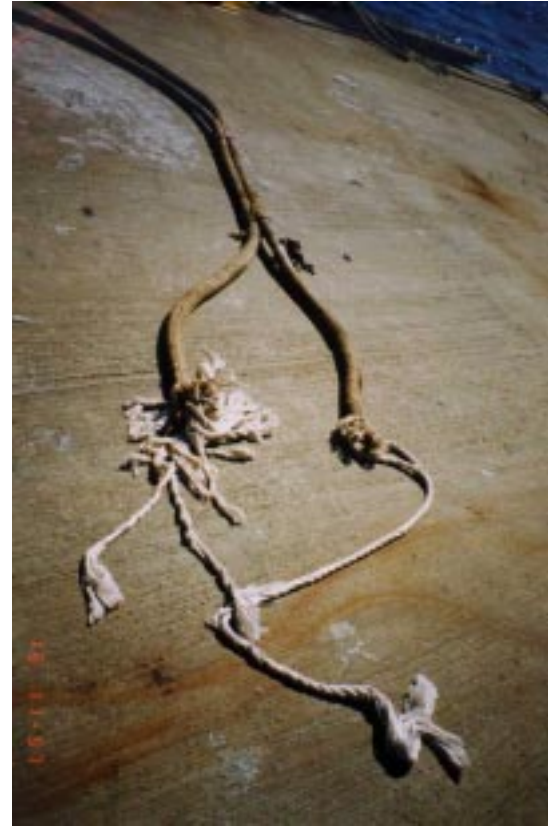
**Failed grommet**

The broken tail, which had been cut into two pieces by the crew of *Wambiri*, was examined and tested by Universal Testing Services (Australia) Pty Ltd (UTS), at Henderson, Western Australia. The tail was found to be in a malleable state with no visual signs of localised stiffening and, apart from the ends at the break, there was no significant damage to the body of the rope. The rope was considered to be in good condition and UTS concluded that the tail had apparently been subjected to some form of occurrence during its operational use which had impacted on its performance.

The longer length of the tail was tested to destruction by UTS and failed under a load of 35.53 tonnes, 59% of the certified minimum breaking strength. However, the test was considered inconclusive as the length of rope available for testing (3.5 m between the formed end splices, needed to set it up on the test rig) was less than half the standard length used for test purposes.

- Low level of alertness, and possible acute fatigue, of the Tugmaster, caused by the recent shift change.
- The misinterpretation of the signals made by the crew on the poop of *Salome*.
- The act of placing the uni-lever in the neutral position, to slow the tug down, expecting the towrope to pull clear, before the eye was seen to be clear of the Panama lead on the vessel, which resulted in:
- The rapid stopping of *Wambiri* before the towrope had been removed from the bollard on *Salome* and a consequent shock loading of the towrope.
- Possible unidentifiable damage to the eye of the towrope, sustained on some earlier occasion, which resulted in the towrope being less resilient to shock loading.
