**Departmental investigation into the
contact with a submerged obstruction
by the Panamanian woodchip carrier
TAIO FRONTIER
while entering
the River Tamar, Tasmania
on 6 May 1997**

Report No. 117

Australia
Department of Workplace Relations
and Small Business

Published: February 1998

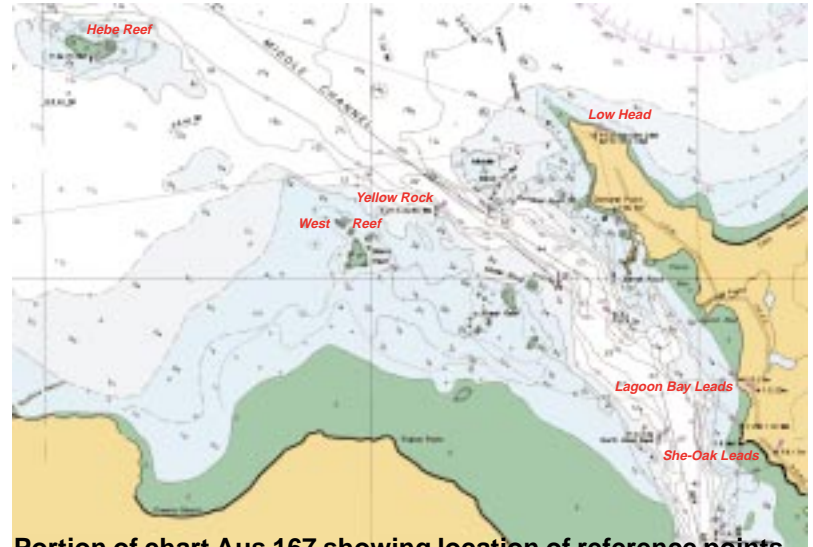
Portion of chart Aus 167 showing location of reference points

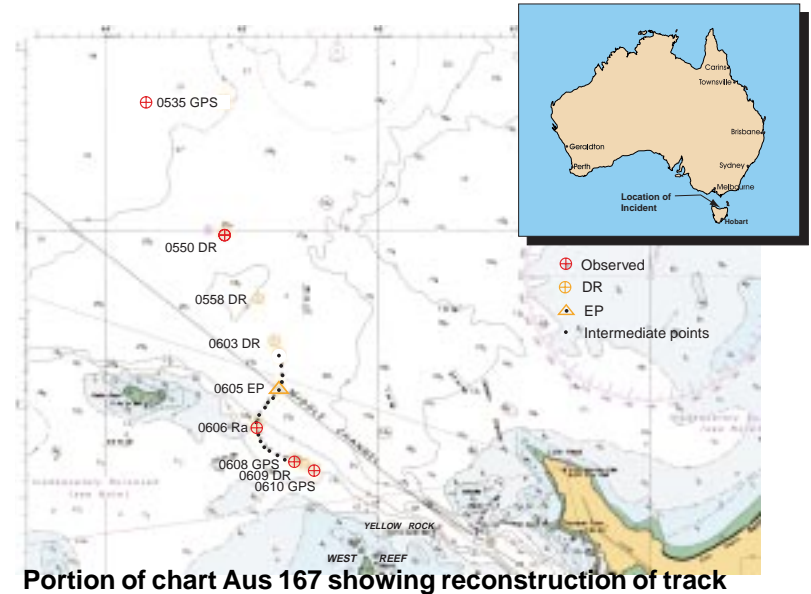
Consideration was given to the possibility of the positions plotted from the GPS being in error and that *Taio Frontier* made contact with the 6.1 m sounding depicted on the chart at the extreme of the south-eastern tip of Hebe Reef. That 6.1 m sounding is towards the end of a ridge which runs in an east-south-easterly direction with depths over it of between 5.9 and 6.7 metres. Had *Taio Frontier* passed over the ridge a more prolonged contact would have been likely. However, the vessel could not have made contact with that particular area on the heading

it was on at the time, as while making the turn it would have run hard aground, on a southerly heading, about 2¼ cables east-north-east of Hebe Reef beacon.
