**Departmental investigation
into the grounding of the Egyptian
bulk carrier
THEBES
in the western approaches
to Torres Strait on 11 June 1997**

Report No. 119

Published: April 1998

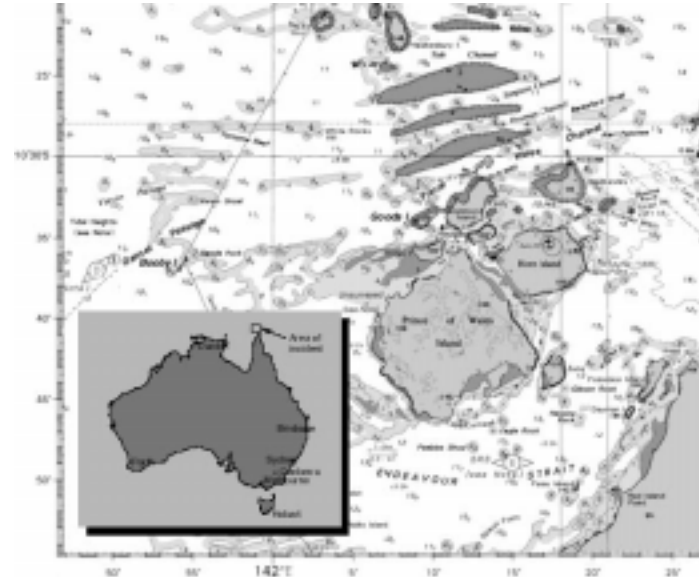
Portion of chart Aus 296 showing location of incident

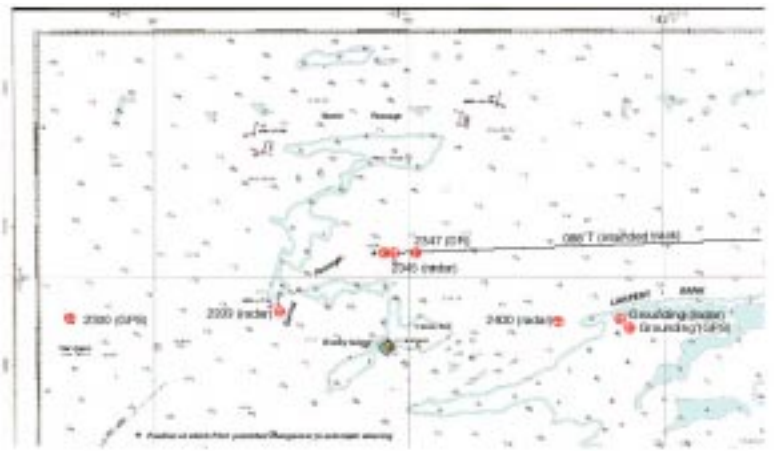
Portion of chart Aus 296 showing positions and grounding of Thebes

The track made good between the 2345 and 2400 positions was 112.3°, indicating that, even allowing for the south-south-westerly flowing ebb tide, *Thebes* had deviated from the correct course very soon after the change over from manual steering was made. This was supported by the radar observations at the REEFCENTRE.

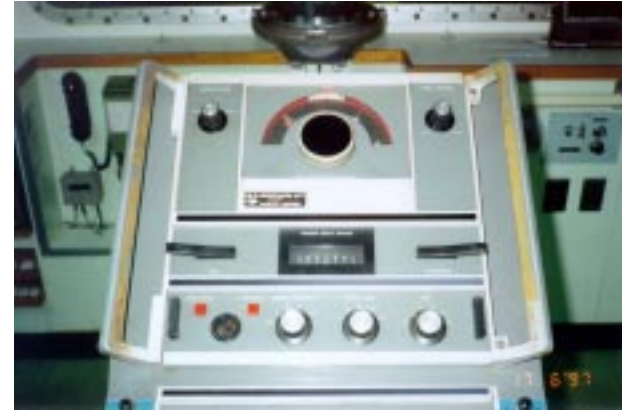
Thebes wheelhouse

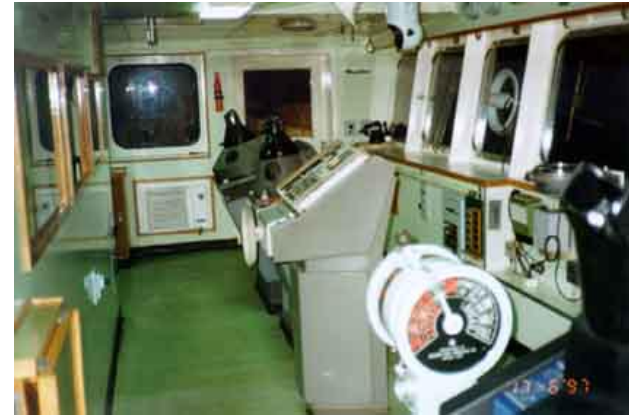
Thebes steering console
Steering mode change over switch

The steering mode selector switch is located in the top left hand portion of the control panel of the console, which is angled at about 50° from the vertical. The three control positions for the switch are above the switch, away from the operator. The switch is operated by turning a raised, flanged knob, a cut in the flange indicating the switch position and aligning with an illuminated strip for night time operation/indication.

Even for a tall person standing at the steering position, the body of the knob hides the position indicator cut in the flange, thus the positioning of the switch is not readily discernible, particularly at night.

- The design of the steering console is such that the setting of the selector switch is not readily discernible, particularly to someone of medium or small stature and at night cannot be readily seen at all.
