Departmental investigation
into the grounding of the Indian flag bulk carrier
DAKSHINESHWAR
off Wednesday Island, in the Torres Strait
on 12 July 1997

Report No. 120

Australia
Department of Workplace Relations
and Small Business

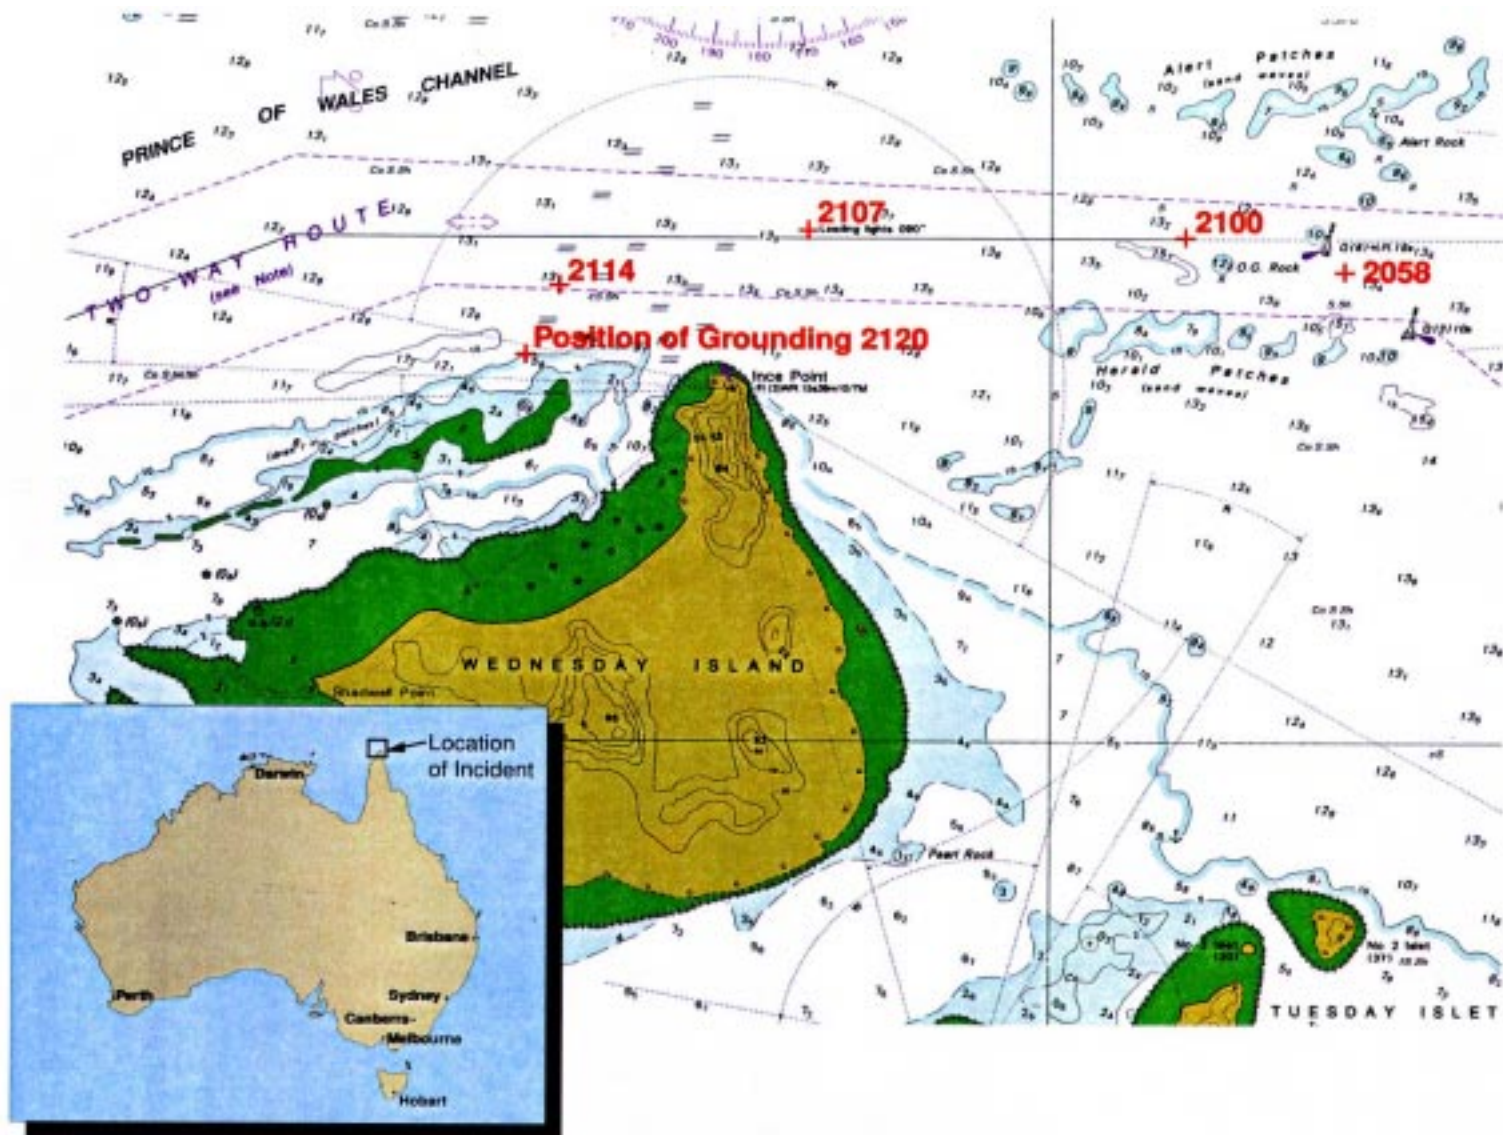
Portion of chart Aus 283 showing location of the vessel at times leading to the grounding

The course recorder, advanced 3 minutes 20 seconds, shows the vessel steadying on a course of 273° at 2100, which would correspond with the ship coming onto the leading lights after passing between Alert Patches buoy and Herald Patches buoy. The vessel was then steering between 270° and 273° for a period of 11 minutes 20 seconds, before the ship's head started to swing to port.

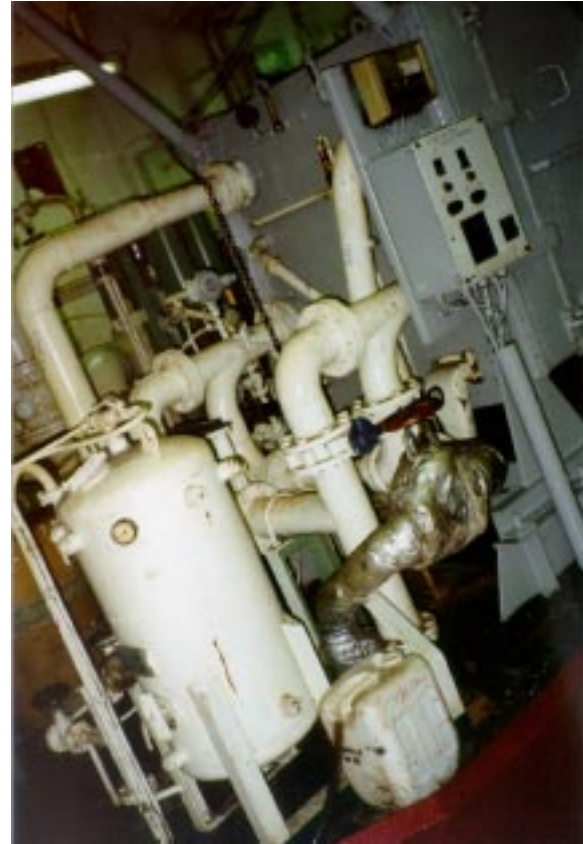
Fresh water generator

Shutting down the fresh water generator, the operation carried out by the 5th engineer, transfers the cooling load from the fresh water generator to the jacket water plate cooler and causes an “upset” to the cooling system temperature which has to be counteracted by the controller as described above. The magnitude of the “upset”, or swing in temperature, depends on the speed with which the valves on the fresh water generator are manipulated during the change-over.

The most dramatic effect on jacket water temperature would be caused by shutting down the fresh-water generator. In the opinion of the Inspector, there is a distinct possibility that the fresh water generator was shut down considerably later than stated in evidence, a view reinforced by the confusion that existed amongst the engineers about the timing of events. If it had been shut down later, there would have been concern to shut it down relatively quickly, as the ship's speed might have been reduced to manoeuvring speed at any time after "Stand-by". If shut down too quickly, the consequences for the main engine JCW temperature would have been as actually occurred.

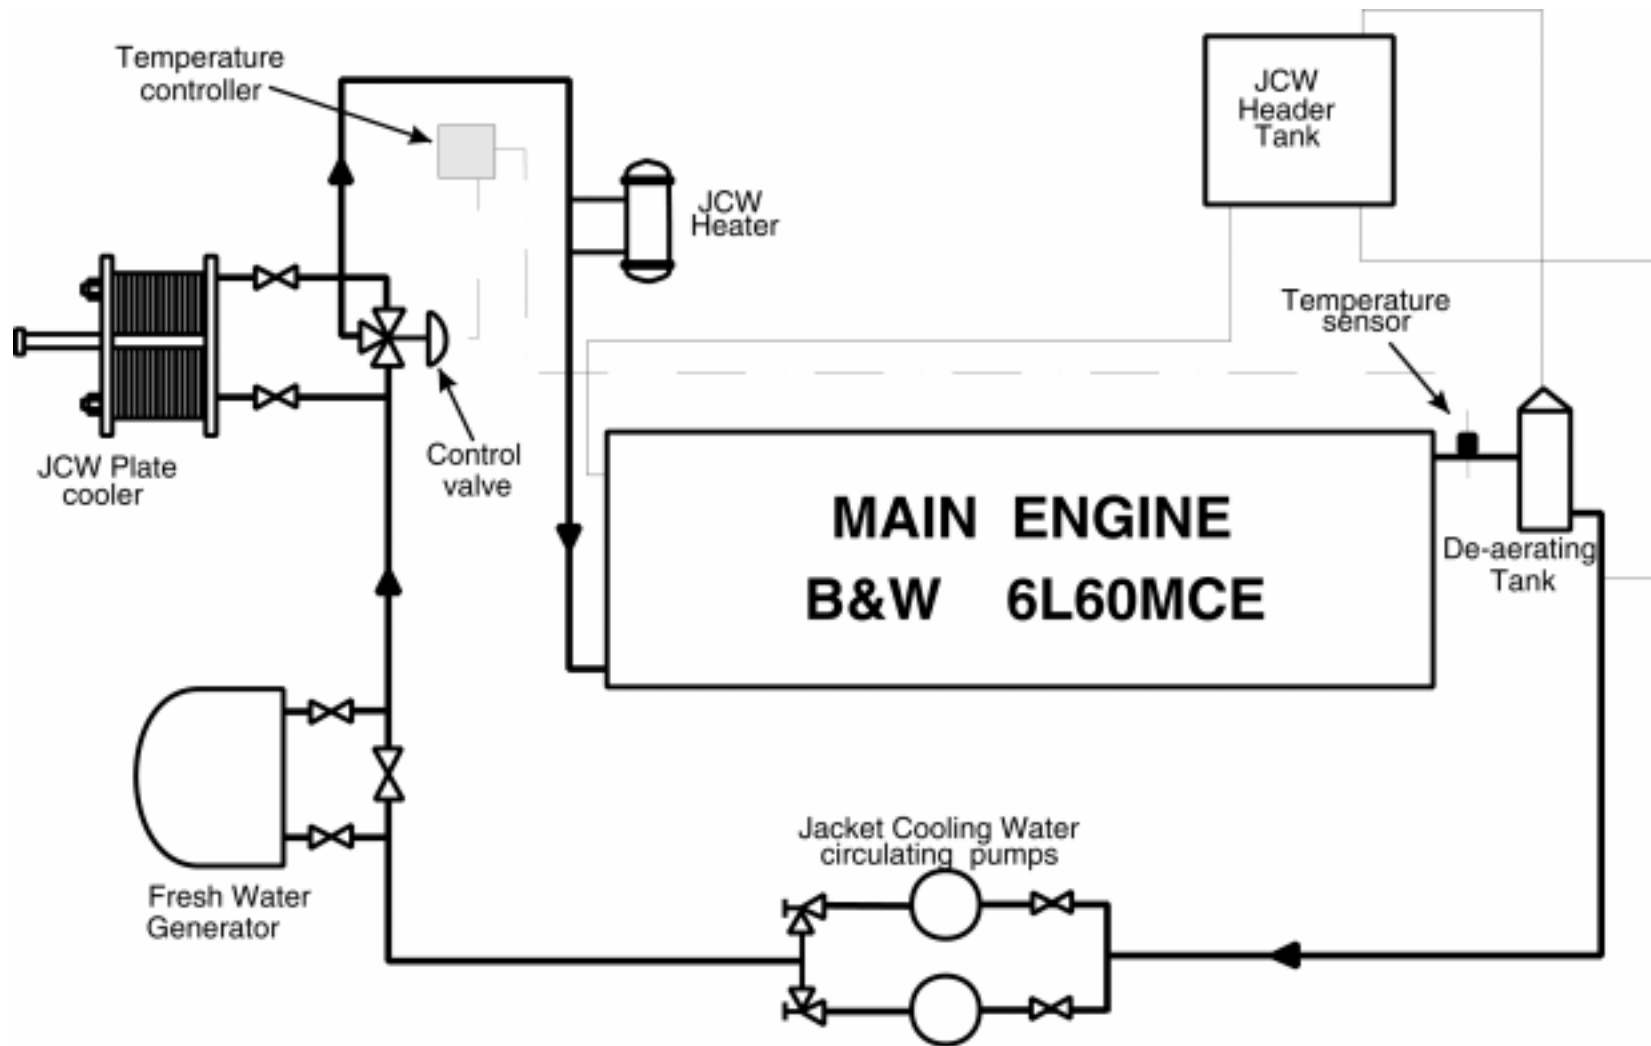
The main engine is cooled by circulating fresh water through the cylinder jackets by means of two JCW pumps. From the pumps, the cooling water is usually (when the ship is on passage) passed through the ship's fresh water generator, or evaporator, where much of the heat contained in the cooling water is given up to the generation of distilled water in the unit. The fresh water generator is an Alfa Laval "D" type. From the fresh water generator, the water then passes through the JCW cooler, where remaining excess heat is exchanged in a seawater-cooled plate type heat-exchanger.

The temperature controller on the jacket cooling water system is a Nakakita type NST M 732 which controls a Nakakita Seisakusho pneumatic actuator on the bypass valve of the jacket cooler. The cooler is an Alfa Laval "Plate Pack" plate cooler. The controller senses the temperature of the JCW at the point where it leaves the main engine and the system is designed to maintain a constant temperature at the inlet to the fresh water generator in order to ensure its stable operation. This is unlike the older, conventional system, where it was designed to maintain a constant temperature of the cooling water at the inlet to the main engine.

M.V. Dakshineswar - Schematic diagram of main engine jacket water cooling and temperature control system

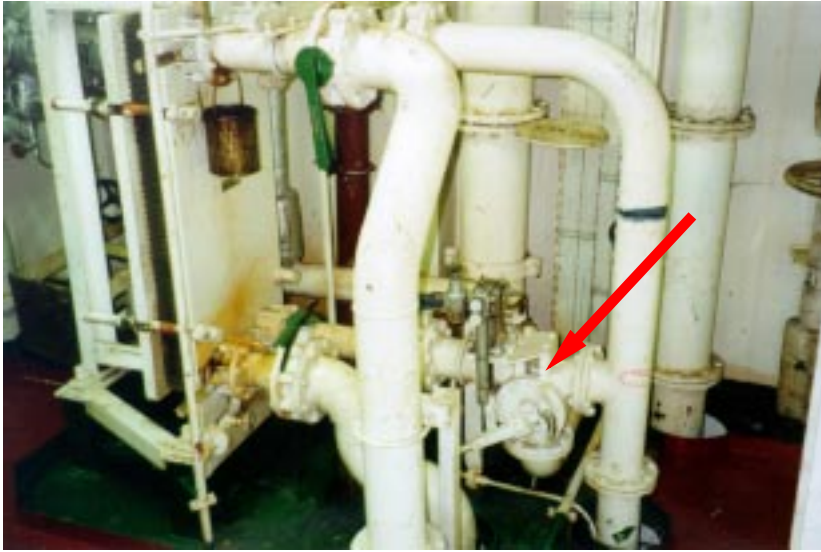
Main engine jacket water cooler

After the vessel was refloated and moved through the Prince of Wales channel on 16 July, observation of the action of the jacket water cooler showed that it was behaving . There was no sign of hunting and it maintained the actual temperature of the cooling water to that of the set point when load changes occurred.

However, the set point for the system temperature had been set at between 73° and 75°C, much lower than the 80-82°C required in the Chief Engineer's Standing Orders and normally maintained when on passage.

Main engine jacket cooling water cooler (plate type) showing 3- way by-pass valve (arrowed) and its pneumatic actuator.

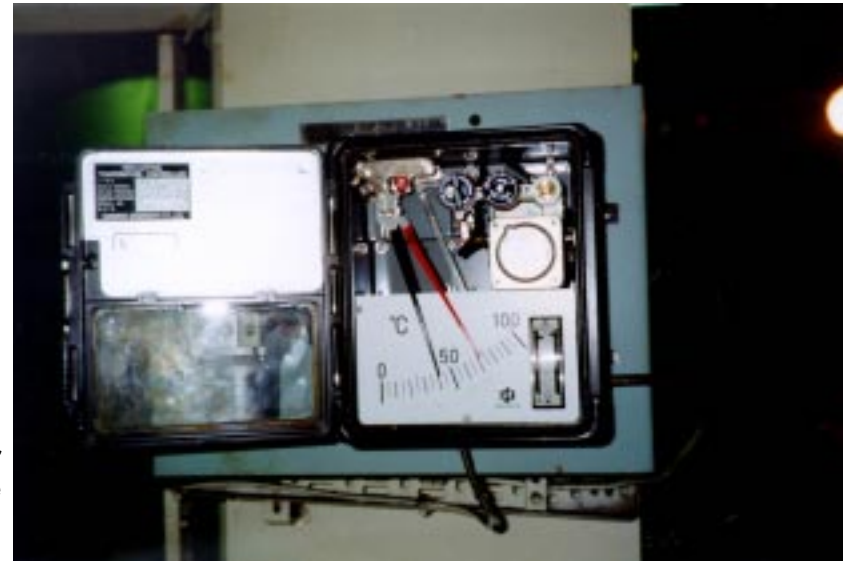
Jacket water temperature controller

Opening the front panel of the controller and manually moving the set-point control will, however, change the output signal from the controller, albeit in an uncontrolled manner, as the controller will then change the pneumatic output signal to try to adjust to the new desired temperature value. The change in actual output signal, however, will depend on two factors, which are a) the speed with which the set point or “desired value” is moved and b) the magnitude of the difference between the new desired value and the existing setting.

The faster the set point is changed, or the greater the difference between the new desired value and the existing setting, the more the controller will respond and the more unstable will be its initial response. If the input change is large, the system will go into an initial “hunt” and the bypass valve will move rapidly from one extreme position to the other. This will cause a drastic change in the cooling water temperature until the controller regains stable control of the temperature. If the temperature swing is sufficiently large, it would activate the “jacket water temperature - high” alarm and, if the temperature is slightly higher, may trip the emergency shut-down for the engine. The ‘high jacket water temperature’ was set to alarm at 85°C, 3° to 4° C above the normal running temperature at sea. The “engine trip”, on high cooling water temperature, was set at 90°C.

Nakakita Seissakusho main engine jacket cooling water temperature controller, with cover opened showing 'set point' indication (red pointer) and actual water temperature (black pointer)
