Incidents at sea

Departmental investigation the
accommodation fire on board
the Taiwanese bulk carrier
MING MERCY
off Port Kembla, NSW
on
7 August 1997

COMMONWEALTH DEPARTMENT OF
**TRANSPORT AND
REGIONAL SERVICES**

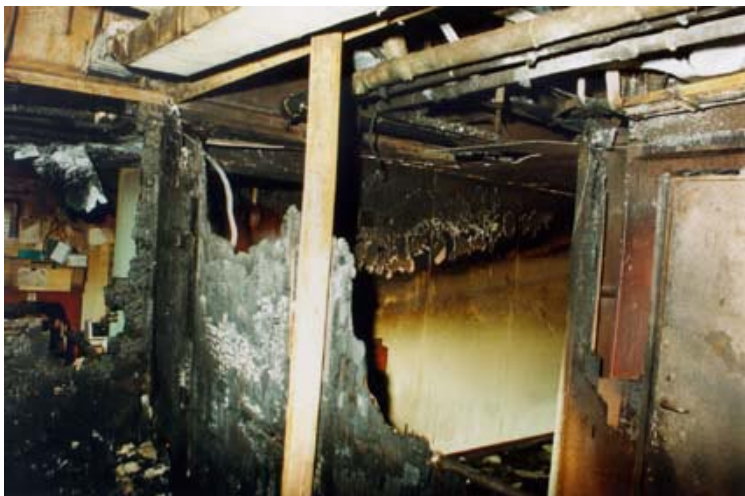
From 1st Engineer's cabin looking starboard and into alleyway

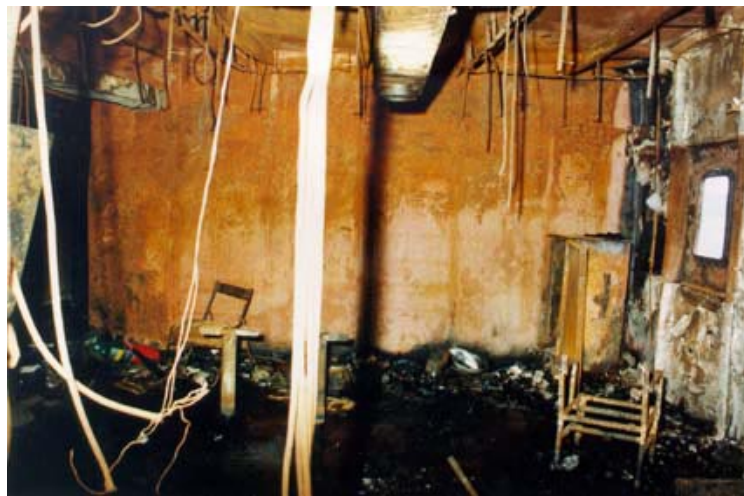
Showing portside of 1st Engineer's day room.

The area in which the fire damage was most complete was in the 1st Engineer's day room. No lagging remained on the overhead ducts or piping and no discernable remains of the timber furnishings were left. The charcoal was fine and consisted of very small pieces, indicating almost complete combustion of all the furnishings in the space. The timber framed and plywood lined bulkhead between the day room and the alleyway had been burned away down to the level of the deck. Most of the heat damage to the exterior paintwork on the front of the superstructure was located outside the 1st Engineer's day room.

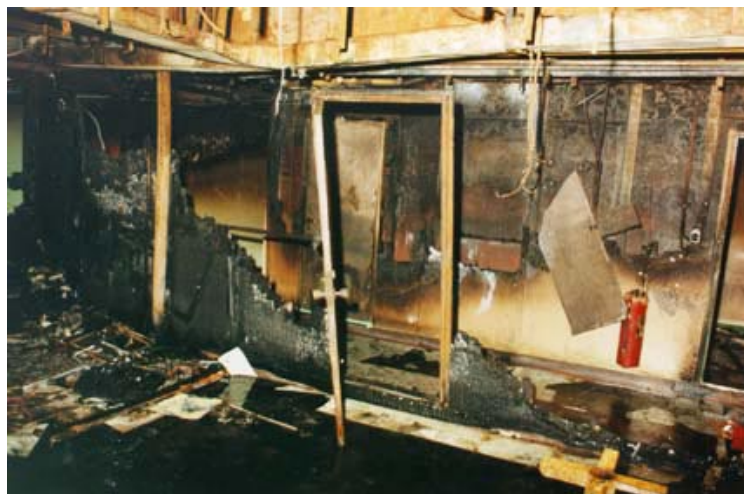
Doorway and remains of bulkhead between 1st Engineer's cabin and cross-alleyway

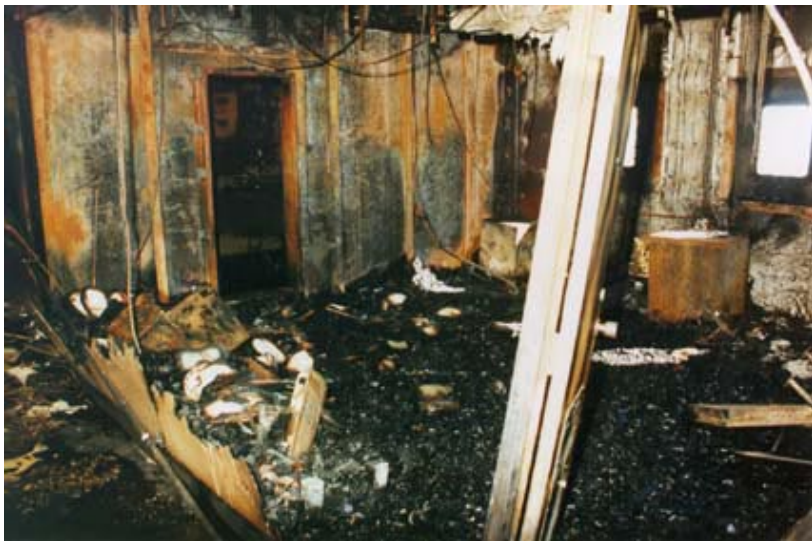
The interior of the Master's day room was severely fire-damaged, with linings and contents completely destroyed on the port side and damage decreasing towards the starboard side. The pantry, on the port side, and the night cabin, on the starboard side, had both suffered severe fire damage to their contents and bulkhead linings.

Interior of Master's cabin looking forward with pantry on left

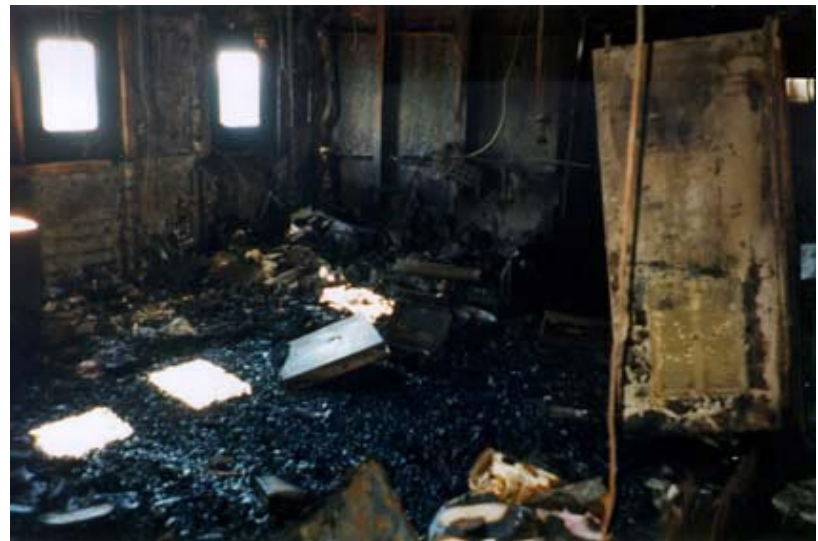
Master's cabin looking forward and to starboard

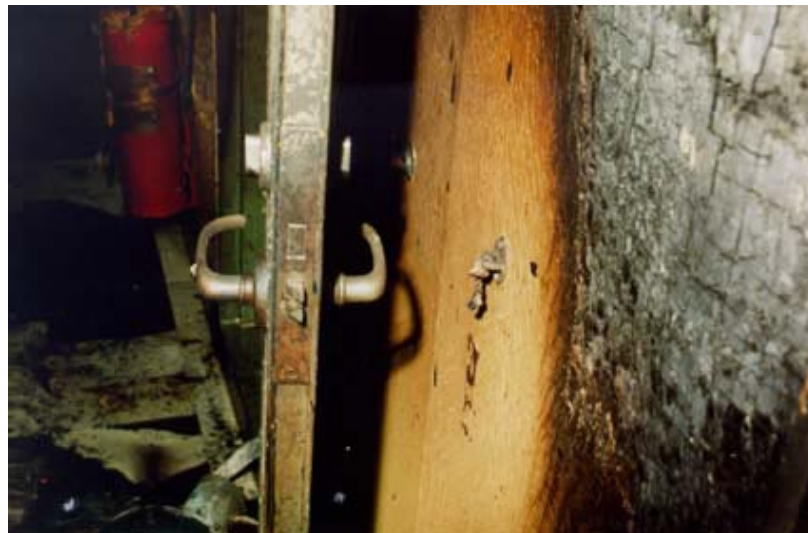
The door from the stairwell landing to the alleyway was reported as having been open during the fire and remains of a piece of nylon rope were found connected to a hook eye on the bulkhead. It is apparent that this had been used to secure the door in the open position.

Door to stairwell at lower bridge deck showing remains of rope used to secure door in open position

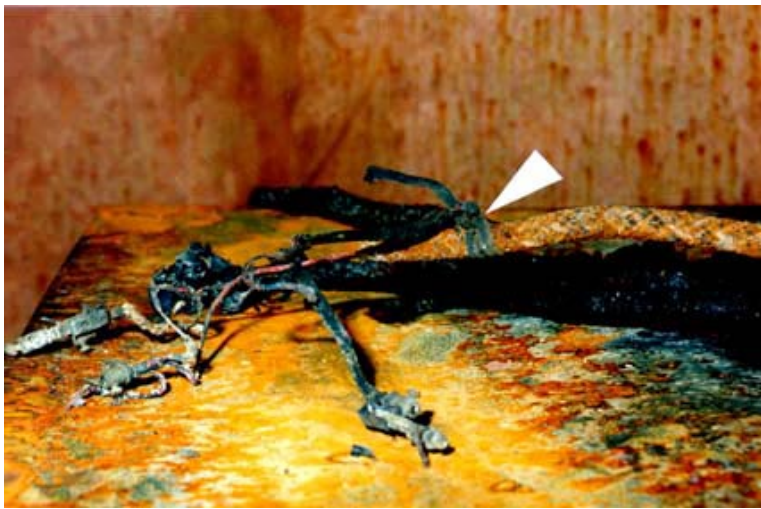
Earth strap tied with a knot to flexible conduit(arrowed)

An earth strap, from the socket for the earth pin, was tied with a “granny” knot to the outer metal flexible sheath of the fixed wiring on the bulkhead. Also attached to this earth strap was another piece of cable which was broken and of unknown purpose. The remains of another wire gave every indication of having directly connected the active and neutral sockets, while at each active and neutral connector, a further piece of wire led off to a broken end.

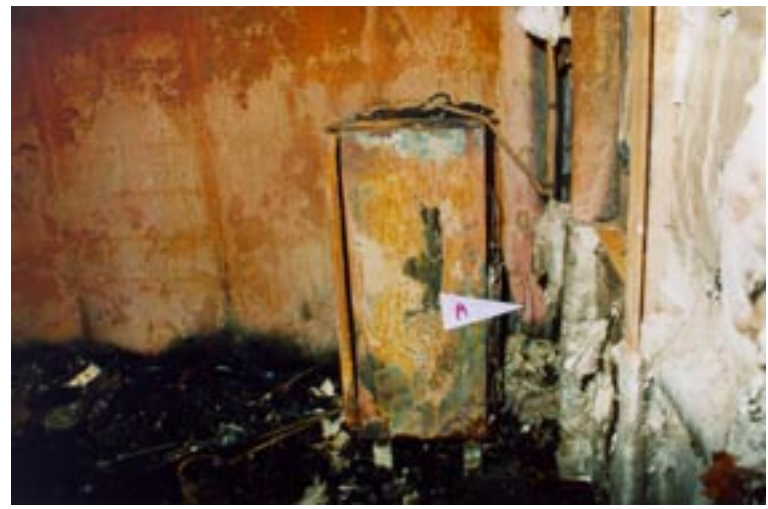
The refrigerator was connected to a three-pin power socket on the forward bulkhead. Excess electrical cable was wound around the condenser, at the back of the fridge, and held in place with short, twisted, lengths of wire. No evidence, however, of unusual electrical activity, such as arc beading was evident in the remains of the cable or pins on the plug.

Refrigerator in corner of 1st Engineer's day room. remains of power outlet arrowed

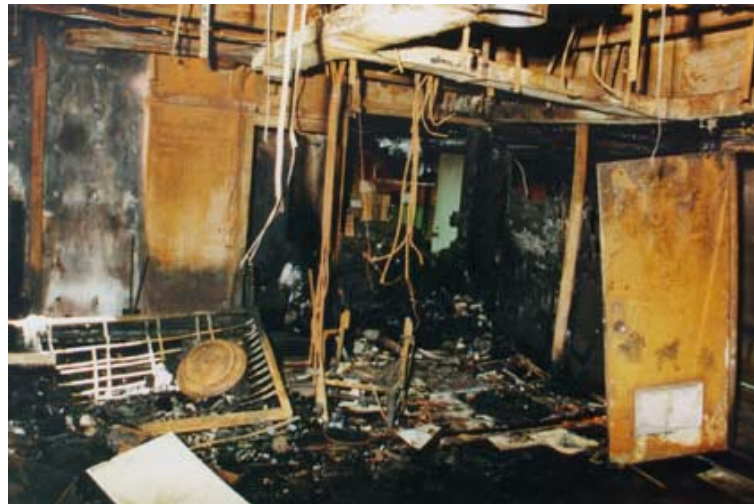
Within the 1st Engineer's accommodation, the fire damage was much more severe in the day room than in the night cabin. The timber bulkhead between the two was destroyed and the side of the bunk adjacent to the bulkhead had collapsed to the deck. The starboard side of the bunk remained intact and other damage on the starboard side of the night cabin was less severe. Burning patterns on the remains of the bulkhead adjacent to the alleyway indicated that the fire had travelled from the day room into the night cabin.

Interior of 1st Engineer's cabin, from day room into bedroom, remains of bed bottom left

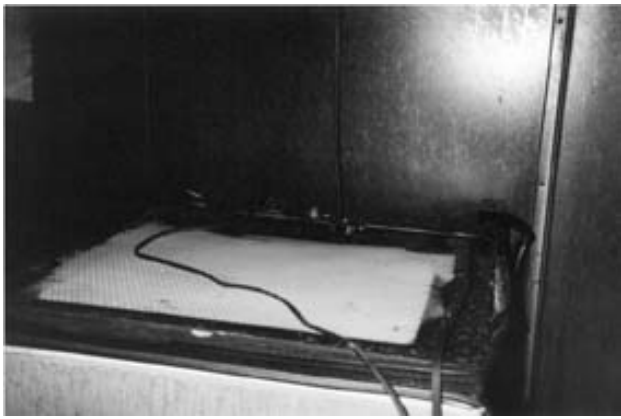
Photo 1

Photo 1. Steel appliances, such as this refrigerator, had no earth connection and were connected by two-core, unsheathed, cable to the power supply which in some instances was from the lighting circuits.

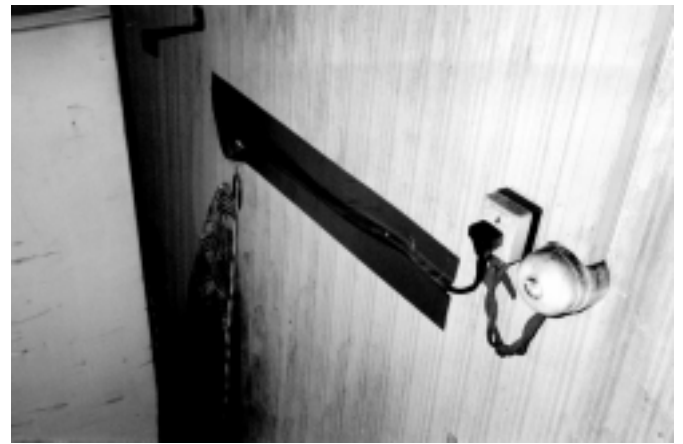
Photo 3

Photograph 3, taken in a relatively undamaged cabin, shows the installation of an extension or additional, power socket. The physical evidence found, in the form of the wiring above, would indicate that a similar arrangement existed behind the refrigerator in the 1st Engineer’s dayroom. If, however, the “air pot” kettle had been plugged into one of the two power outlets, it could not have been the same type as others, described above, as there was an earth pin still in the socket and the others have no earth connection.

Typical examples of sub-standard wiring extensions in accommodation

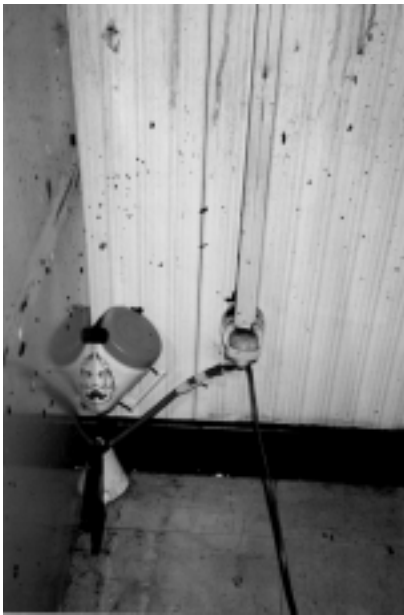
Photo 5

Typical examples of sub-standard wiring extensions in accommodation
