**Departmental  
investigation into  
switchboard fire aboard  
the Australian flag bulk  
cement carrier Goliath at  
Devonport, Tasmania on  
23 August 1997**

investigation into the switchboard fire aboard the Australian flag  
bulk cement carrier GOLIATH at Devenport Tasmania on 23 August 1997

Published: May 1997

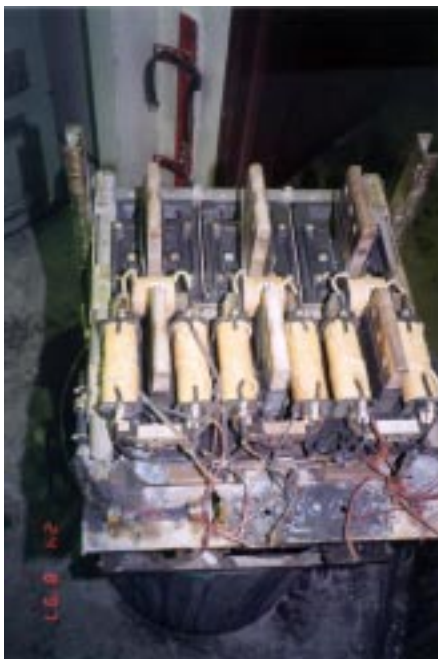
**Fire damage No.2 ACB back C.T.'s on outgoing lines**

Subsequent examination of the circuit breaker indicated, among other things, serious overheating of the copper leads to the soft start contactors and the overcurrent coil.

*"The breaker is extensively damaged with the internal insulating parts having been completely consumed by fire. Damage to accessories mounted on the breaker and the wiring to them is extensive. The circuit breaker carriage has been damaged by the fire.*

*The main current carrying path of the circuit breaker is intact, but the centre pole shows signs of overheating. The plug-in contacts of the main circuit are in good condition (except for damage due to the fire).*

*From the above observations, the source of the problem would be the overheating of the centre pole causing the insulating parts to ignite. The cause of the thermal failure of the centre pole is unknown.”*

Following the fire, Lloyd's Register of Shipping stipulated that the circuit breaker should be replaced by a complete new unit.

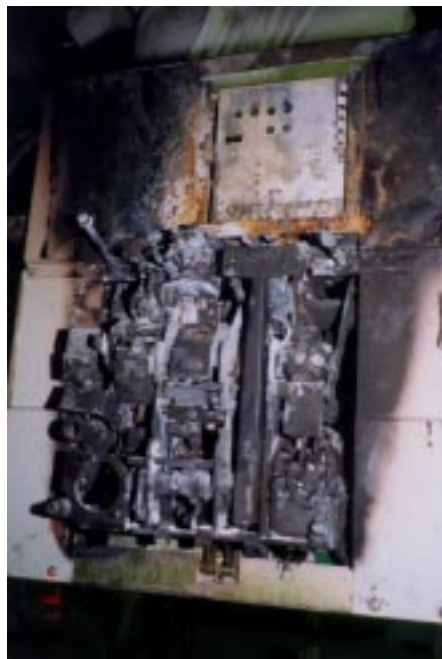
**Fire Damage No.2 ACB view**

The fire destroyed the circuit breaker and its associated control equipment. Heat damage had affected the adjacent cubicles either side of No.2 cubicle. These cubicles contained the circuit breaker for No.1 generator and the generator synchronising panel. Neither No.1 generator, nor No.2 generator, could be connected and the synchronising panel was inoperative. The remainder of the main switchboard had suffered some smoke damage. See photographs pages ....

1. The fire in the main switchboard was caused by an internal fault in the air circuit breaker for No.2 generator.
2. Damage to the circuit breaker was such that, on subsequent examination, it was not possible to determine exactly what had caused the fault, although overheating of the centre pole in the main current carrying path was probably the triggering factor.

A considerable amount of PVC insulation on electrical cables was burned during the fire. When this occurs, highly corrosive hydrogen chloride is formed which must be promptly removed before severe corrosion affects components. Due to the extensive smoke damage, this operation would have necessitated the removal, disassembling, cleaning and testing of all the large circuit breakers in addition to any necessary repair work. As a result of both financial and risk management considerations, the owners and ship managers together decided to replace all of the ship's air circuit breakers with AT15 and AT25 models manufactured by Terasaki in Japan.

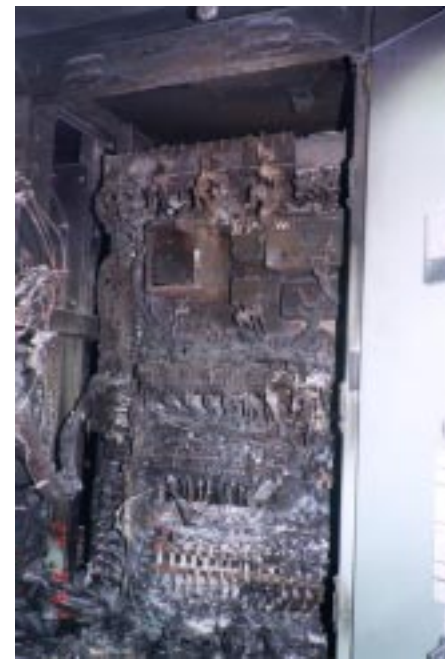
**Fire damage No.2 D/G upper level**

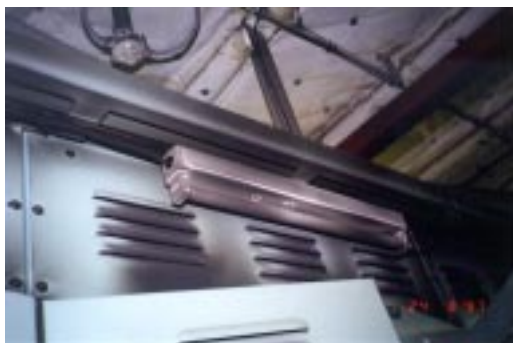
**Heat detector above synchronising panel**

A heat detector, part of the automatic fire detection system, was situated above the main switchboard, within one metre horizontally of the cubicle. It seems that the cubicle had limited the heat radiation by the fire and, although covered in soot, the detector had not operated during the incident. This detector was later tested and found to be operational.

4. A heat detector, located above, and very close to, the cubicle containing the No.2 generator circuit breaker proved ineffective at giving an early alarm as heat was contained largely within the cubicle and the main problem was the generation of large quantities of smoke from the insulation of cables.

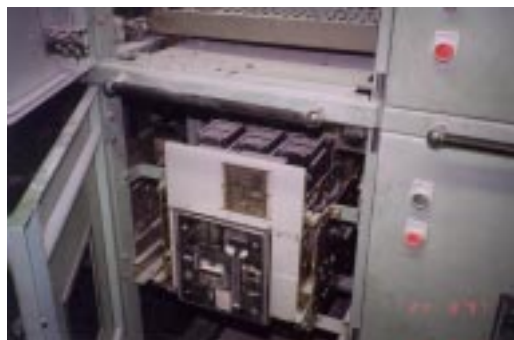
**Hyundai type circuit breaker**

The source of the fire appeared to be an internal fault in No.2 generator air circuit breaker. The circuit breaker for No.2 generator was manufactured by the Hyundai Electric Engineering Co. of Ulsan, Korea. The data plate carried the following details:

**Hyundai Electric Engineering Co. Ulsan, under licence to Terasaki, HAT 25 3-pole, 660 volt, 50-60 Hz, 2,500A, ambient temp. 45°C. LR approved**

At the time of building, *Goliath's* Hyundai-manufactured circuit breakers were on the Lloyd's Register Type Approved List, however when no.2 was due to be replaced after the fire it was found that such circuit breakers were no longer listed. The Marine Incident Investigation Unit contacted the Lloyd's Register Type Approval Department in Croydon, UK, to establish why Hyundai-manufactured circuit breakers had apparently been removed from the type approval list.
