Departmental investigation into the  
collision between the  
Australian flag bulk carrier  
**RIVER YARRA**  
and the tug  
**W J TROTTER**  
in Moreton Bay, Queensland on 31 August 1997

**Report No. 123**

**Australia**  
Department of Workplace Relations  
and Small Business

Published: June 1998

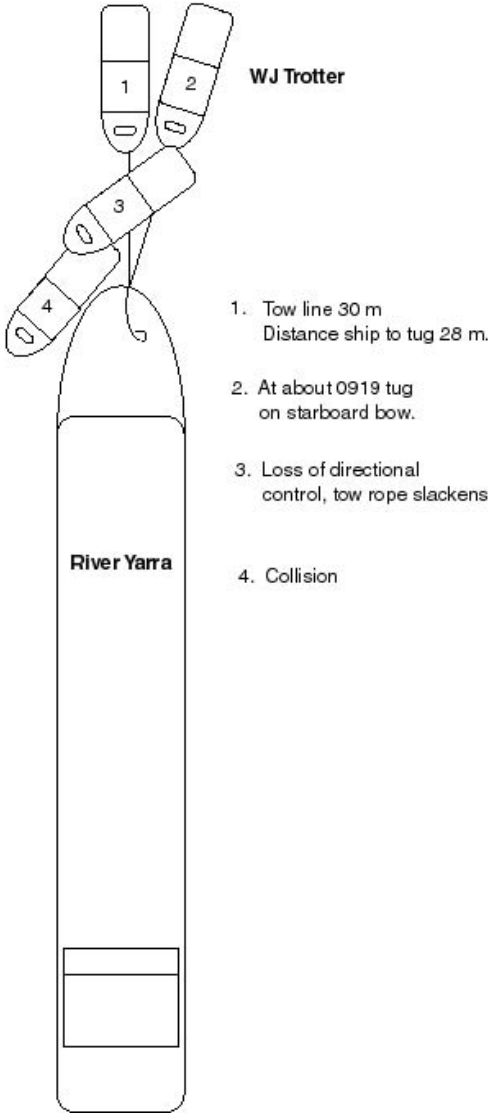
Diagram showing relative position of tug and ship

The evidence is that the slack on the tow rope resulted from a decrease in distance between the vessels, caused by the uncontrolled sheer of the tug across the bows of *River Yarra*.

The Tugmaster realised that towing at speed while manoeuvring astern did have inherent dangers, but he did not realise the extent of such hazards. It would seem that in attempting to realign *W J Trotter*, the Tugmaster lost immediate directional control of the tug. The tug then sheered over to *River Yarra*'s port side, resulting in the collision.
