**Departmental investigation into
the grounding of the
Singapore registered container ship
NOL CRYSTAL
in Moreton Bay, Queensland on
26 September 1997**

Report No. 124

in Moreton Bay, Queensland on 26 September 1997

Published: May 1998

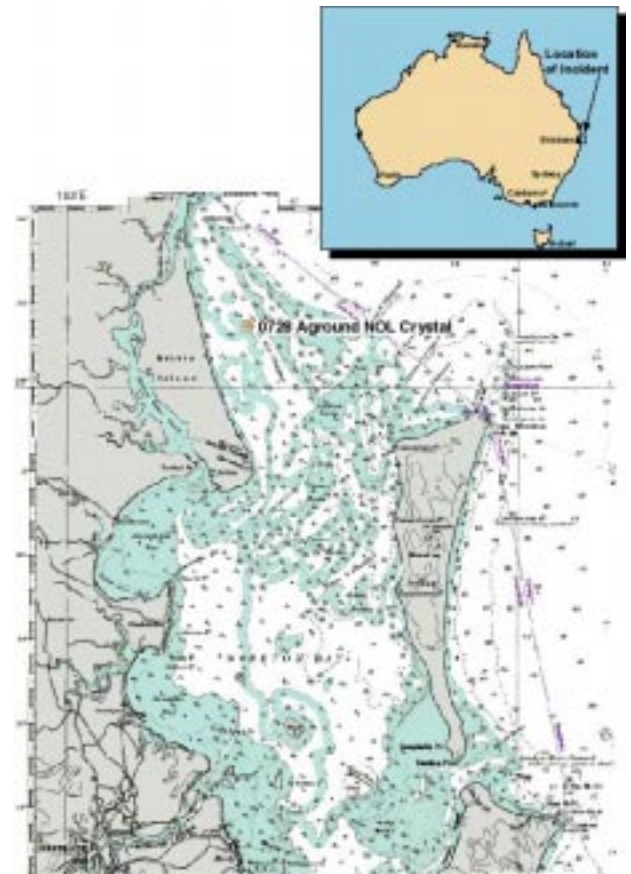
Portion of chart Aus 364 showing location of incident

The ship reached a heading of 300° and had started to turn to starboard when it grounded at about 0728 on a heading of 315°, in position 26° 56.3' South 153° 11.9' East, with NW8 beacon bearing 021° x 0.57 miles.

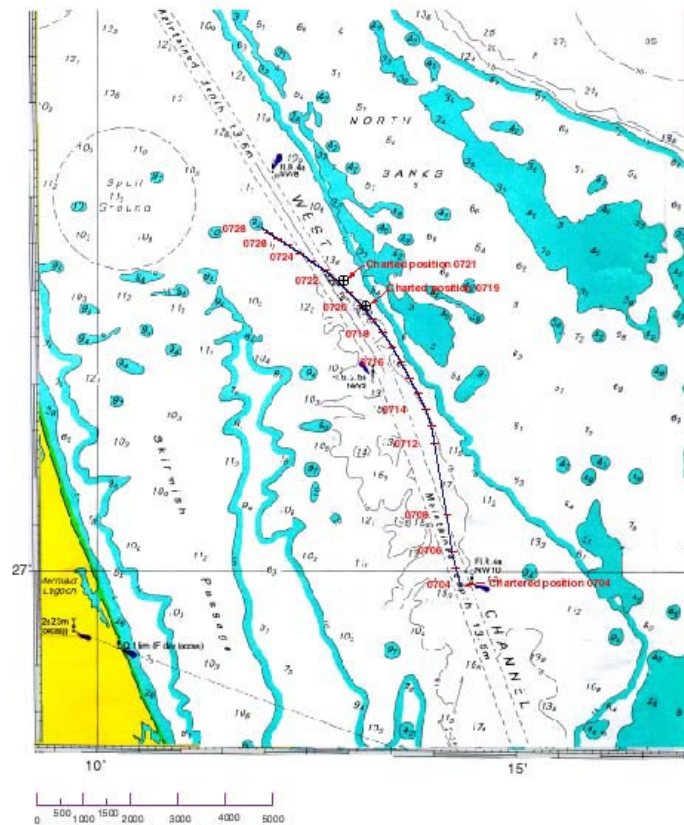
Portion of chart Aus 235 showing indicative course - NOL Crystal 0704 - 0728
(based on course recorder trace and speeds estimated from chart position)

vessel steadied for about one minute on 331° before an alteration of course at 0715 of two degrees over two minutes. Thereafter more helm was applied and the rate of turn increased to about three degrees per minute.

The Pilot stated that he put a clearing arc of 0.08 of a mile (150 m) around NW3 beacon, which marks the mid point of the channel. However, based on the courses steered from 0704, the ship would have passed outside this range, probably by a margin of at least 350 m.

The alteration to 300° at about 0722 was an over-correction. The untimed position marked after rounding NW3 and the positions plotted at 0719 and 0721 suggest that the ship would have regained the channel about 0.6 of a mile before NW8 beacon. The alteration in the transit bearings between the two beacons would have been slow and would barely have changed over the period of two minutes.
