Departmental investigation into the
collision between the Australian fishing vessel
TERESA
and the Cypriot bulk carrier
ATLANTIS TWO

off Termination Island, WA on 28 September 1997

Report No. 125

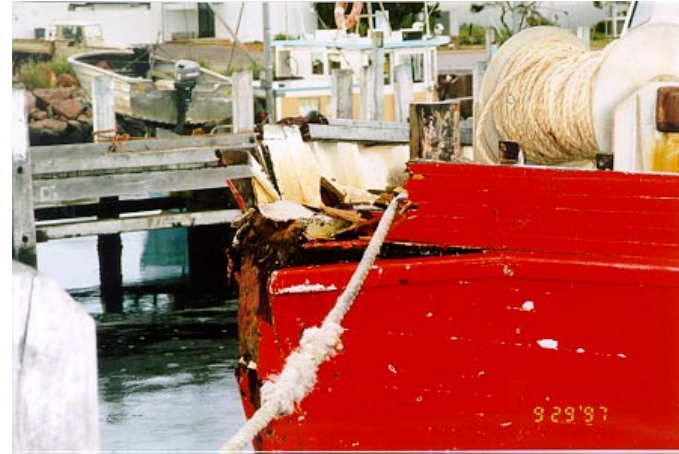
The skipper grabbed a torch from the wheelhouse, then worked forward, looking overside for signs of damage to the hull. Forward of the wheelhouse he found a large portion of the bulwark at the bow was missing and, as *Teresa* drifted back on the wind, the anchor rope snagged on the damaged bulwark on the port bow. The Skipper collected a fishing float from aft, attached it to the anchor rope, then cut the rope. At this point he checked the time and saw that it was 2250, by which time the other vessel had moved well clear. He also looked up to check the anchor light and saw that it was still lit.

Teresa. Damage to bow.

The force of the impact was quite heavy, shearing two coach bolts in the fishing vessel's stem post, almost as if *Teresa* had been driven into the ship's side. It is possible the anchor rope caught for a while on the lower portion of *Atlantis Two's* bulbous bow, causing the fishing vessel to move forward. Then, after *Teresa* had bounced off and clear, the scope, or slack of the anchor rope was pulled up by *Atlantis Two's* bow before the rope pulled clear. This could account for the rope lying slack on the surface.

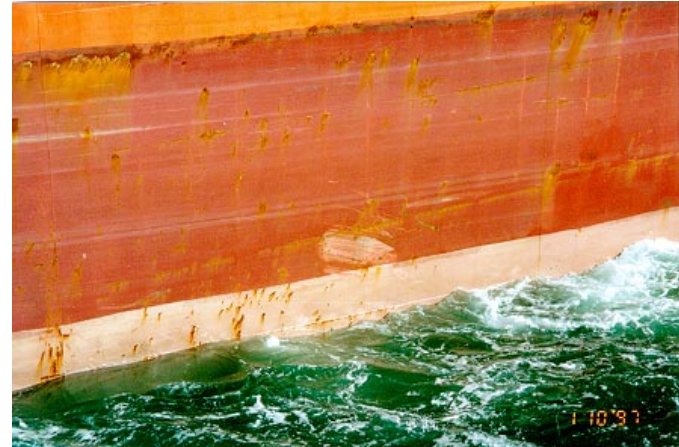
When *Atlantis Two* berthed at Thevenard on the morning of 1 October 1997, the vessel bore a recent contact mark on the hull, low down on the starboard bow. Under scientific examination, particles of red paint taken from this contact mark matched the hull paint of *Teresa* and particles of paint deposited on the damaged bow of *Teresa* matched the boot-topping paint of *Atlantis Two*.

The paint samples obtained from both *Teresa* and *Atlantis Two* were examined by the Scientific Branch (Canberra) of the Australian Federal Police. Using infra-red spectroscopy, the scientist found that the red paint removed from *Atlantis Two* showed no significant differences from *Teresa's* hull paint, and the red-brown paint removed from *Teresa* showed no significant differences from *Atlantis Two's* boot-topping paint. He concluded that a two way transfer of paint had occurred, compelling evidence that the two vessels had collided.

Atlantis Two. Contact mark, starboard bow area.
