**Departmental investigation into  
the grounding of the Panamanian cargo vessel  
Pine Trust  
in Denham Channel, Shark Bay,  
Western Australia, on 13 October 1997**

**Report No. 126**

**Australia**  
Department of Workplace Relations  
and Small Business

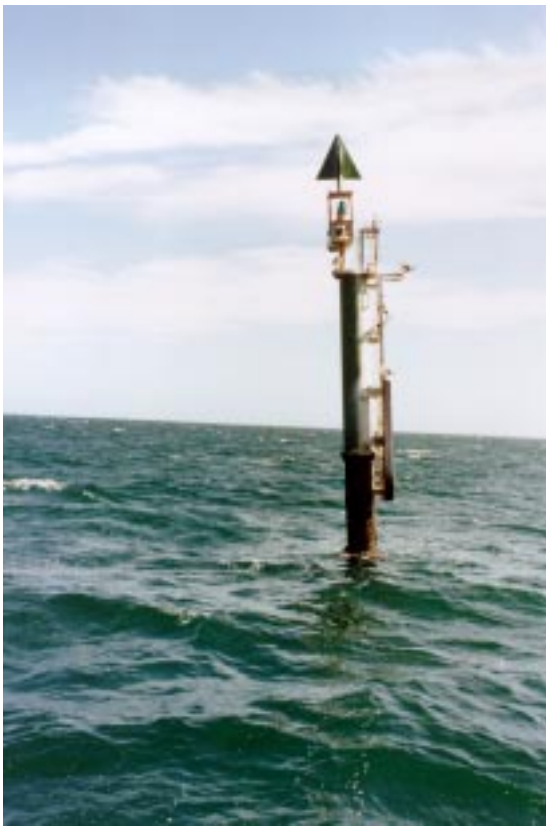
**Beacon No.9**

View to starboard view obscured by mast and wheelhouse structure

Critically, from where he was standing, to starboard of the centreline at the fore end of the bridge, his vision on the starboard side was obscured by the intervening mast and wheelhouse structure. However, he could see a beacon he knew was No. 10, fine on the starboard bow. At this time, No. 10 beacon would have been about 5 miles off, fine on the starboard bow. The ship, making about 11 knots would pass the beacon in a little under 30 minutes.

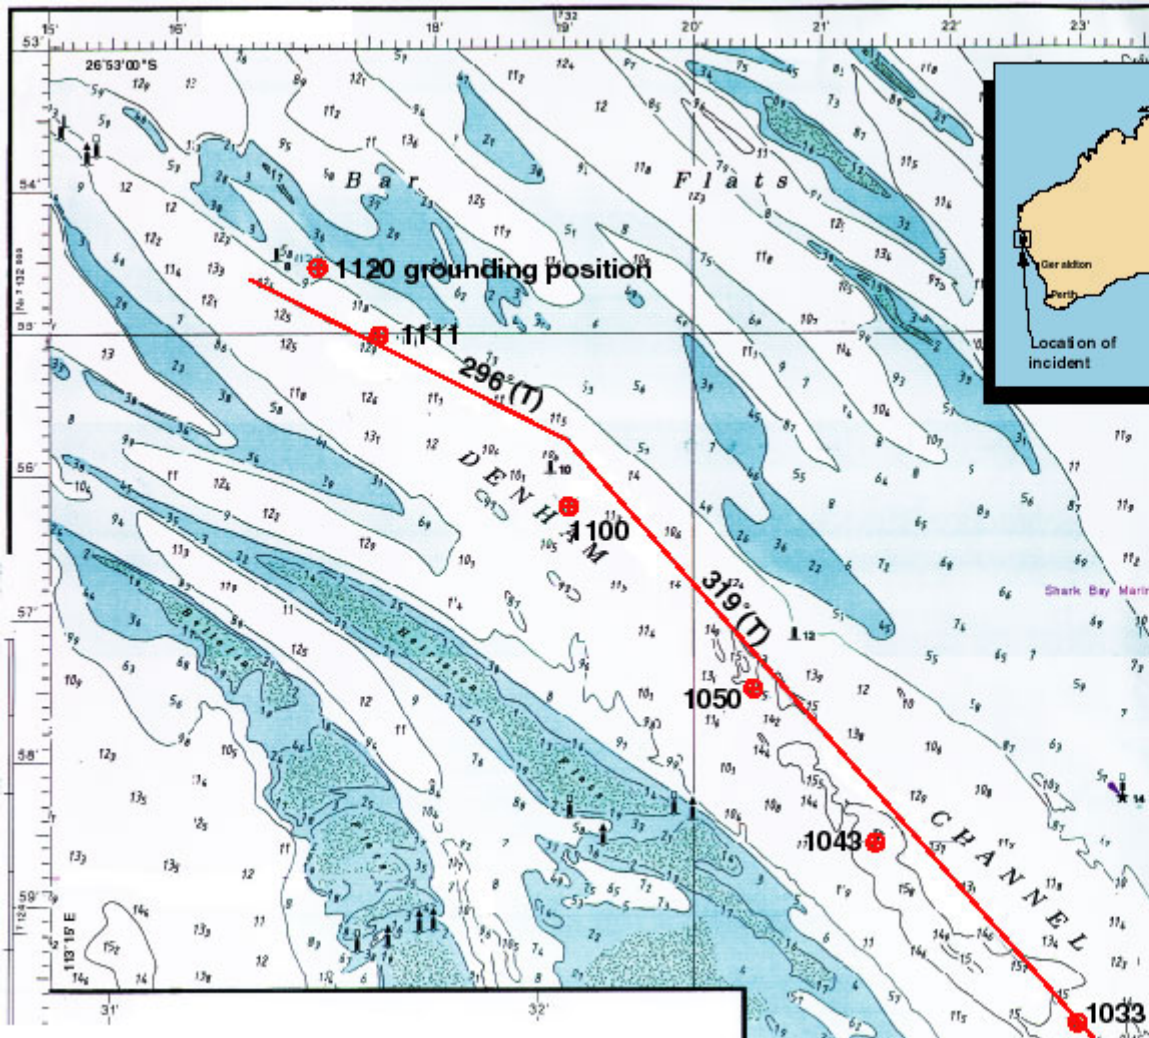
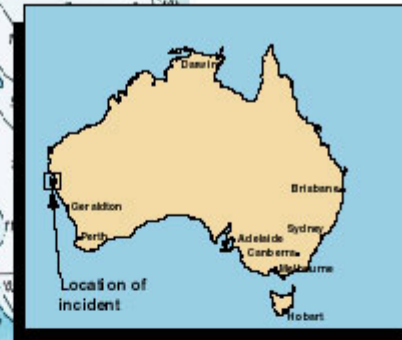
No effort had been made by the ship’s staff to check that DMH 661 was updated. As a result, the Third Mate was using an out of date numbering system and when he mentioned No. 10 beacon, he was in fact referring to No. 9 beacon. Although the Pilot stated that he was not in any way confused by this, in the Inspector’s opinion, this would have caused some confusion in the Third Mate’s mind, and possibly some loss of time when the Third Mate queried the Pilot at about 1111.

Portion of chart DMH 661 showing:

- a) incorrect beacon numbers
- b) beacons shown incorrectly as unlit
- c) topmarks not shown

Although the ship had not received the local notice issued by the West Australian Department of Transport, in January 1996, it would have been easy to compare chart DMH 661 with Aus 749. The ship’s staff could also have used Admiralty List of Lights, Volume K, to update details of beacons in chart DMH 661.

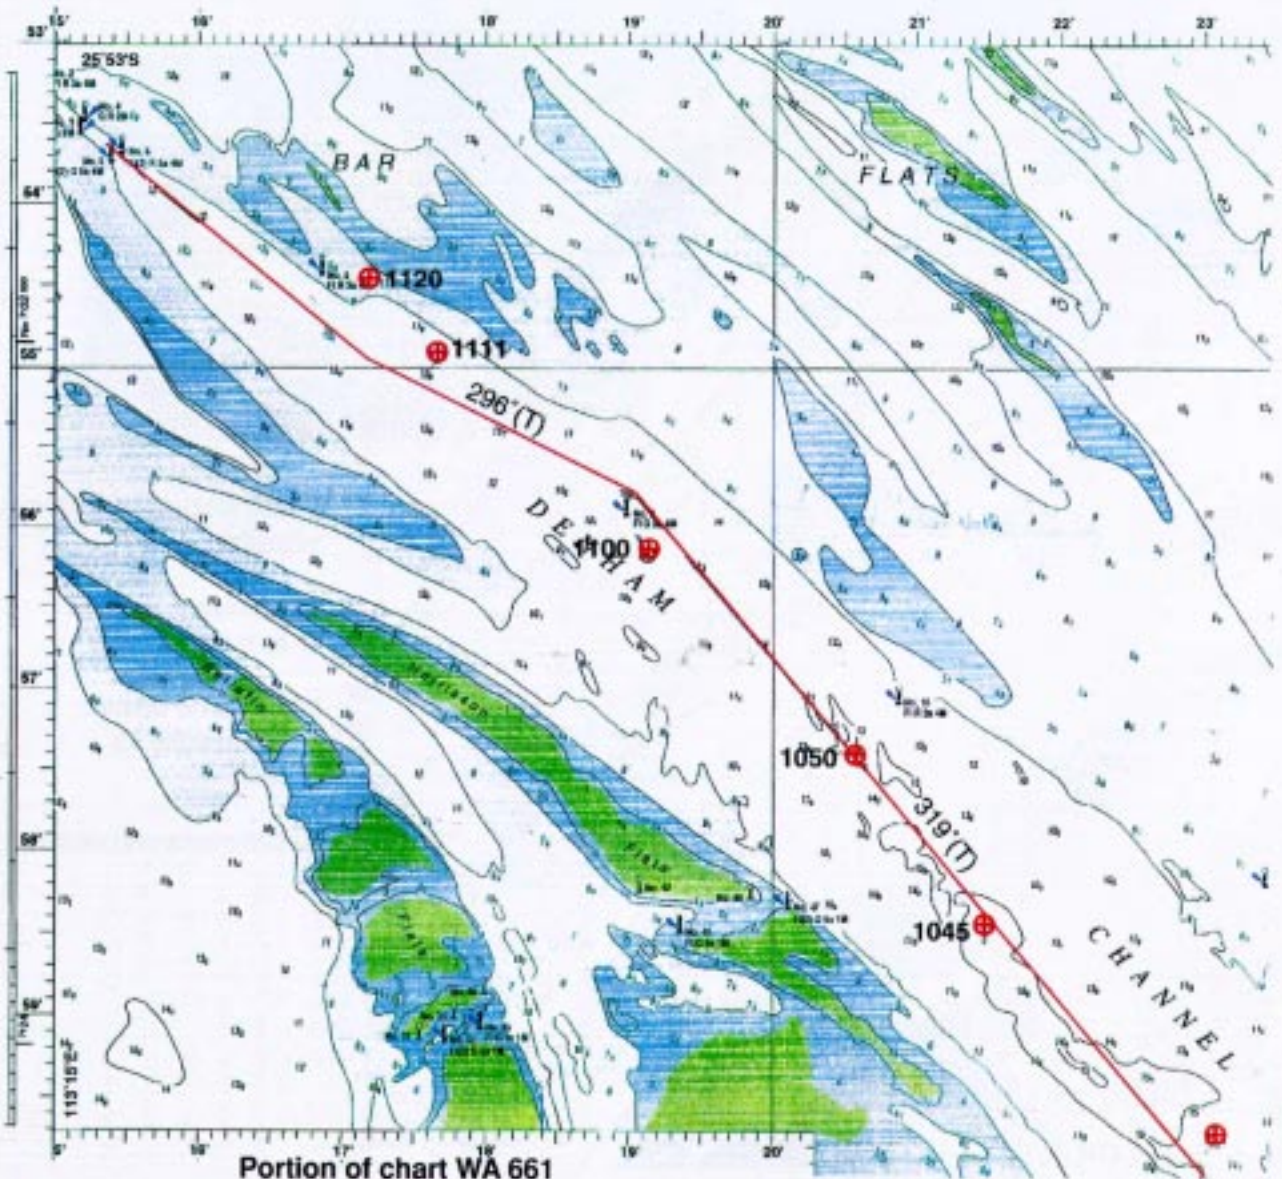
Portion of chart WA 661 showing corrections to:

- a) beacon numbers
- b) lights on beacons
- c) topmarks
