Departmental investigation
into the accidental release of the free-fall lifeboat
and injury to a crew member aboard the Bahamas flag
geared bulk carrier
MAERSK POMOR
at Gladstone, Queensland on 2 January 1998

Report No. 128

Australia
Department of Workplace Relations
and Small Business

Published: August 1998

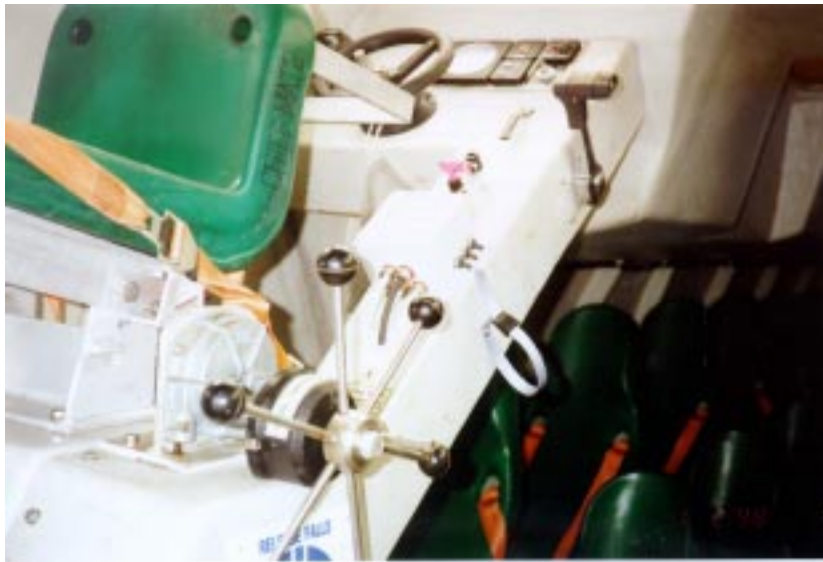
Coxswain's seat and controls

The coxswain's seat is located towards the after end of the lifeboat, on the port side, it faces forward and is raised above the level of the other seats. For launching, the seat is secured in a backwards reclining position. Stencilled on the inboard side of the seat are the words "CHIEF MATE".

The steering wheel, compass, engine ignition and rpm tachometer are located on a console immediately in front of the coxswain's seat, while the engine control, similar to a car's automatic transmission control lever, is located on the inboard side of the console.

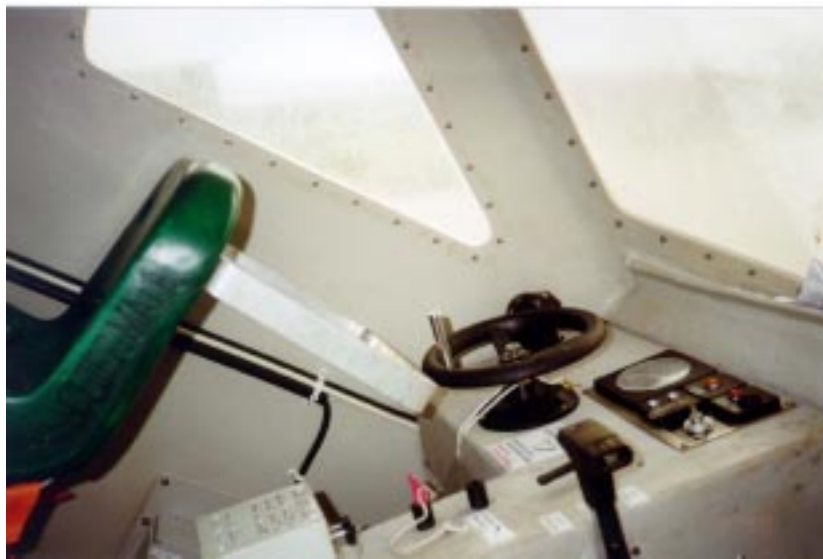
Steering wheel

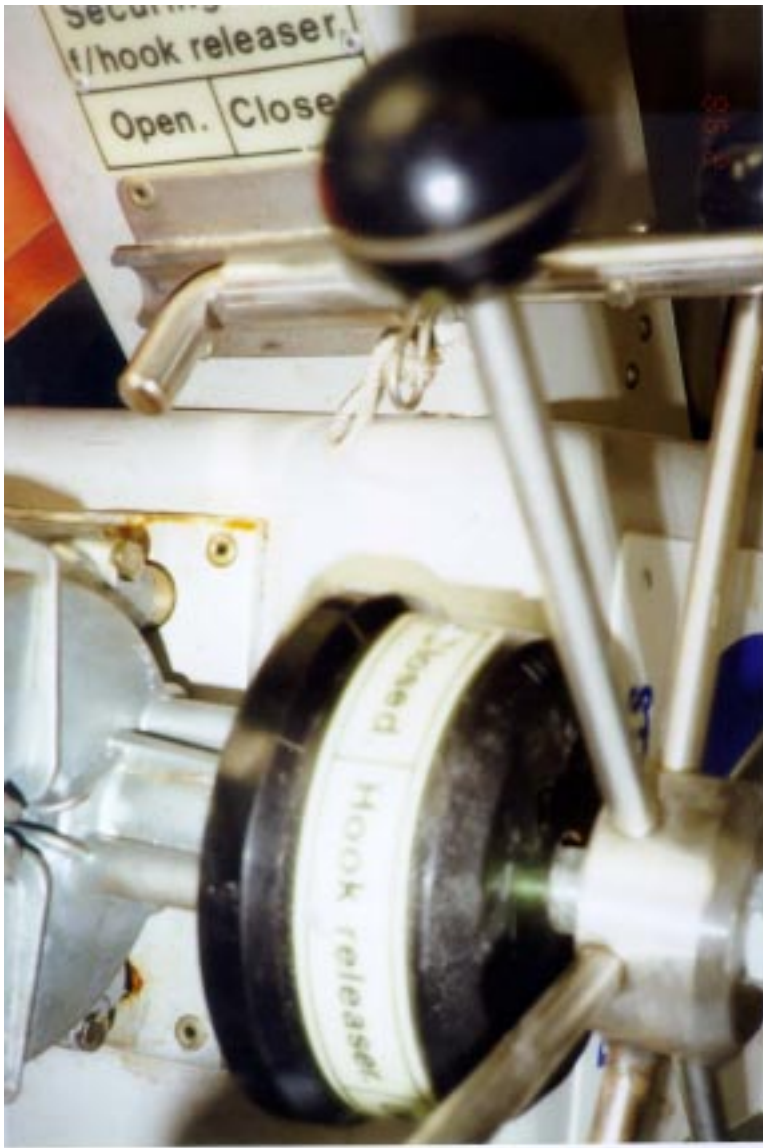
Lifeboat release gear

The release gear, for launching the lifeboat, incorporates a spoked, rimless wheel, located adjacent to the inboard side of the coxswain's seat. To prevent accidental operation of the release gear, the wheel is locked by a stainless steel slip bolt, passed between the spokes, and in turn is prevented from accidental removal by a locking pin.

All instruction labels relating to the release of the lifeboat are in the English language. The release gear is clearly labelled "Hook Releaser", with the open and closed directions of movement, also with an IMO safety

label for “release falls” with a warning note that misuse of the release gear can injure or kill. The securing bolt is also labelled, “securing bolt, hook releaser” and the open and closed positions are marked.
