**Departmental investigation into a
lifeboat incident and
injury to crew aboard
CITY OF BURNIE
at Burnie, Tasmania
on 15 March 1998**

Report No. 130

Australia
Department of Workplace Relations
and Small Business

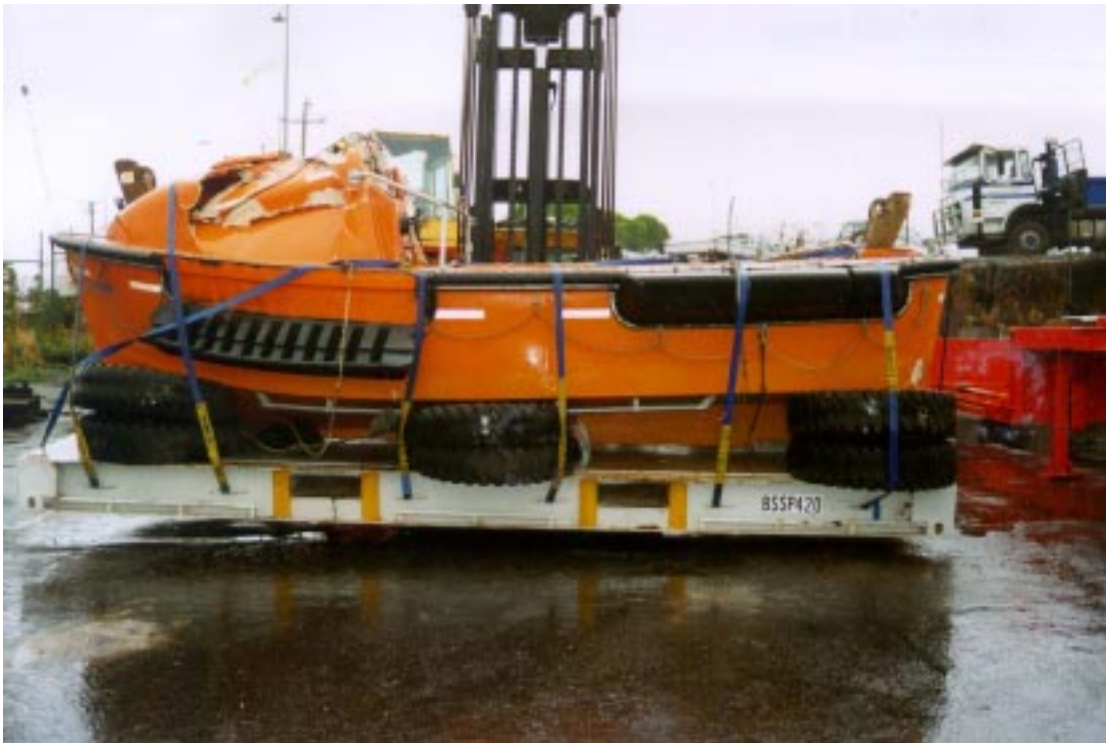
Although the lifeboat suffered extensive structural damage to both the canopy and the hull, the damage was not beyond repair.

City of Burnie showing damage to canopy

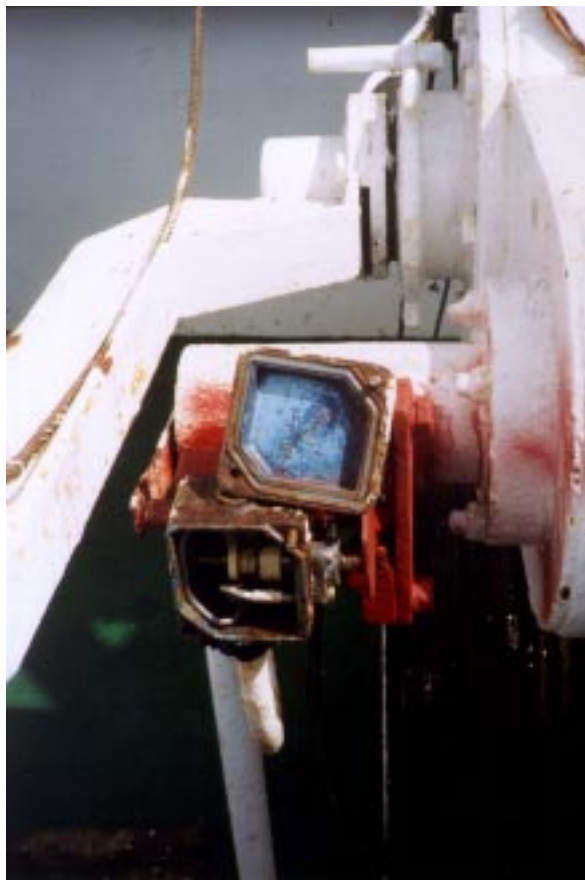
Immediately after *City of Burnie* was secured back at the berth, the fault in the electrical supply system for the port lifeboat winch motor was traced to the safety cut-out switch on the winch itself, the winch handle protection switch. There was a hairline fracture in the cast alloy cover-plate of the switch, which had allowed salt water to enter and subsequent corrosion had caused an open circuit.

The crack in the switch cover-plate was very fine and there were no signs of sharp or heavy contact. It was not obvious and could have been easily overlooked during the regular maintenance schedule on the winches.

From the type of fracture, it is possible that it was caused by unequal tightening of the securing screws.

Safety cut-out switch on winch
showing fractured cover plate

- The fracture, at some earlier date, of the winch safety switch cover plate, which had allowed the entry of salt water, causing corrosion within the switch and an electrical open circuit.

- Particular attention to be paid to the winch safety switches and davit cut-out switches during the weekly maintenance inspections of safety equipment.

- Auditing of safety committees by shore management to ensure issues are actioned and closed out.
- The installation of secondary, magnetic cut out switches which cannot be by-passed.

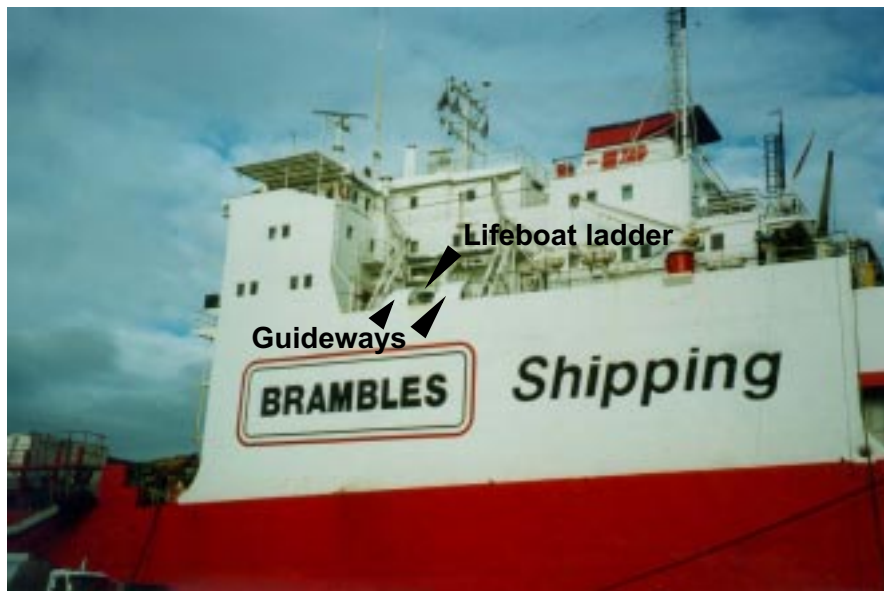
City of Burnie
Showing broad whaleback guideways

The situation is made worse by the lack of a safe landing place on the deck. The design of the NOR davit system incorporates two guideways, to prevent the lifeboat landing on the deck in the event of an adverse list, or heavy rolling. On board *City of Burnie* these guideways consist of two broad, “whaleback” structures, the space between which is taken up by the lifeboat ladder (see photograph above). The broad design and placement of these guideways prohibit safe, unimpeded, transfer from the lifeboat to the deck. Crew members, therefore, remain in the lifeboat until it has been turned-in and housed. A number of crew members expressed unease with the arrangement, but it had become an accepted practice.

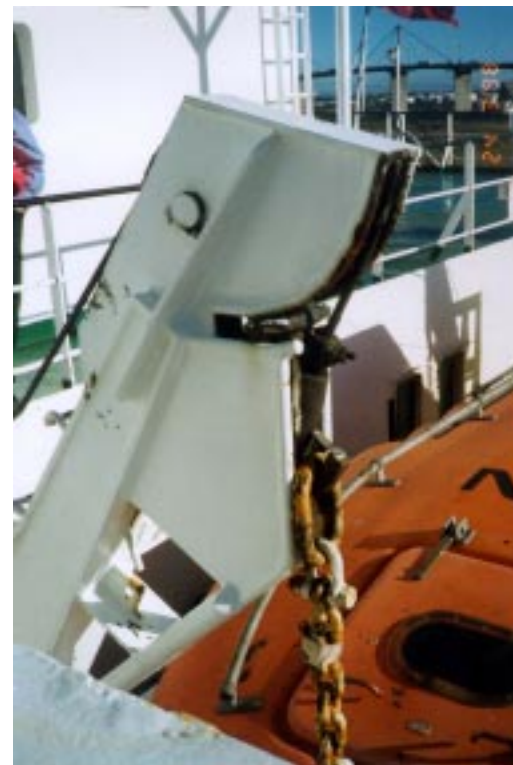
The design of the davit, using a single wire fall, has also proved problematical, in that the wire twists, causing the staghorn hook to fail to align itself correctly with the housing slots in the davit heads. As a

Single wire staghorn hook of type fitted aboard *City of Burnie*

result, members of the boat's crew have to physically twist the hooks around, which in the case of enclosed, or partially enclosed lifeboats, means standing in an exposed position. The hooks also have a propensity, because they have had to be twisted into position, to slip out from the slots again during resumed hoisting. It was because of this problem that the 2nd Mate was concentrating on the davit heads rather than on the position of the davits themselves.
