## Incidents at sea

Departmental investigation  
into the collision between  
the Panamanian bulk carrier

ETERNAL WIND

MELINA T

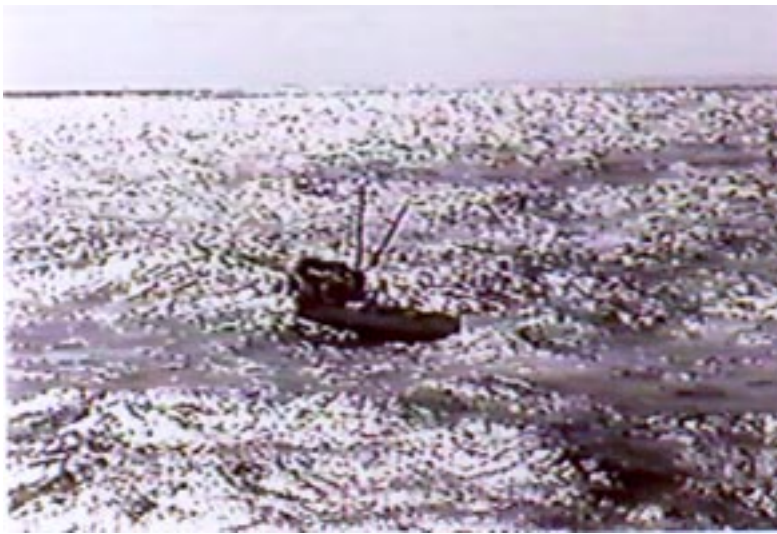
**Melina T**  
Hull concealed by swell

With a height of gunwale above the water of about 2 m, except at the bow, where it increased to about 3 m,

*Melina T*'s hull would have been hidden from view when lying between the 2-2½m waves running at the time. However, the deckhouse would have been visible to other ships all the time and the 20 m fishing vessel would have been in full view when on top of a wave.

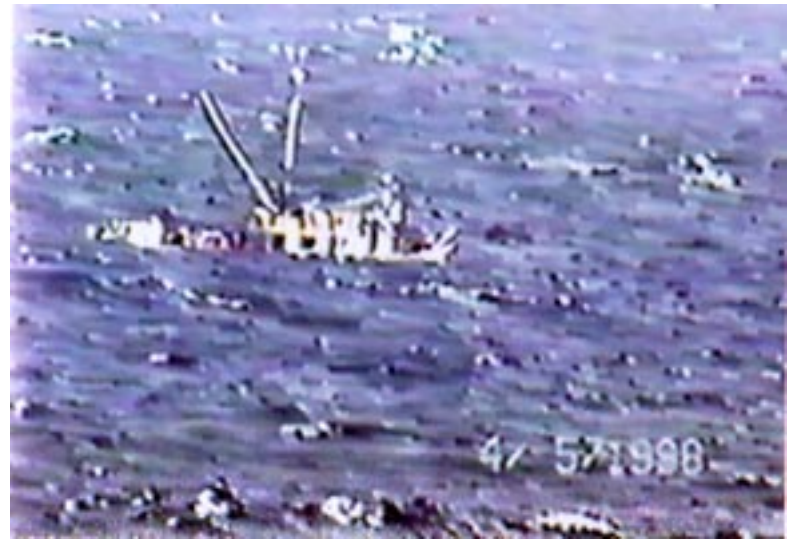
**Melina T**  
In reflected glare

The 3<sup>rd</sup> Mate claimed that the reason for his not seeing *Melina T* was that he was blinded by the reflected glare of the sun. The strong glare was evident in a video film of the rescue, shot by one of the *Eternal Wind* crewmembers, but despite this, the 3<sup>rd</sup> Mate was not wearing sunglasses. At 0800, the sun was on an azimuth of 067½° (six points on the starboard bow) at an altitude of 26° 20' and at 0810 on an azimuth of 066½° at an altitude of 28° 25'. *Melina T* would have been 40° off the sun, towards the bow, and the glare/dazzle should not have been too problematic in that direction.

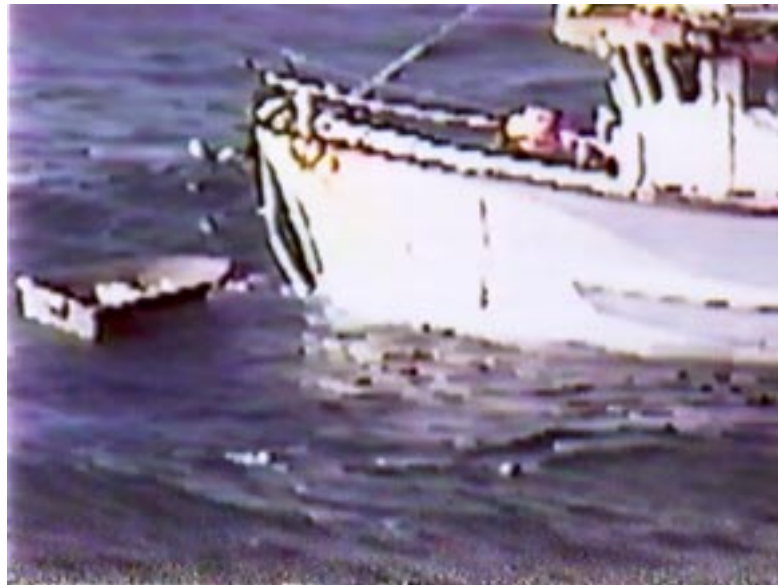
Initially, the rate of flooding was not too fast, but the hull was well open at the stem and *Melina T* settled slowly by the bow, flooding the bunk space. The force of the impact had also sprung the planks from the bulkhead between the bunk space and the engine room and the engine room also started to flood. The Skipper and deckhands tried plugging the gaps at the sides of the bulkhead with rags, towels and clothing, but the securing nails, which were closer to the engine room side of the bulkhead, prevented this from being done effectively.

**Melina T**  
Sprung stem

The crew's efforts to stem the flooding into the engine room were thwarted by the placement of the nails securing the hull planking to the transverse bulkhead. The force of the collision had sprung the planking from the bulkhead, allowing the passage of water into the engine room as the bunk space flooded. The crew tried plugging the gaps, but the nails had been driven in close to the engine room side of the bulkhead, preventing the packing materials from being pushed in. In all probability, *Melina T* would not have foundered had the crew been able to prevent the engine room from flooding.

It is further considered that the positioning of the nails securing the hull planking to the athwartship bulkhead, being close to the engine room side of the bulkhead, prevented effective plugging of the gaps and contributed to the foundering of *Melina T*.
