Incidents at sea

Departmental investigation
into the collision between the
Australian Flag tanker
BARRINGTON
and the tug
AUSTRAL SALVOR
in the
Brisbane River, Queensland
on 27 April 1998

Published: January 1999

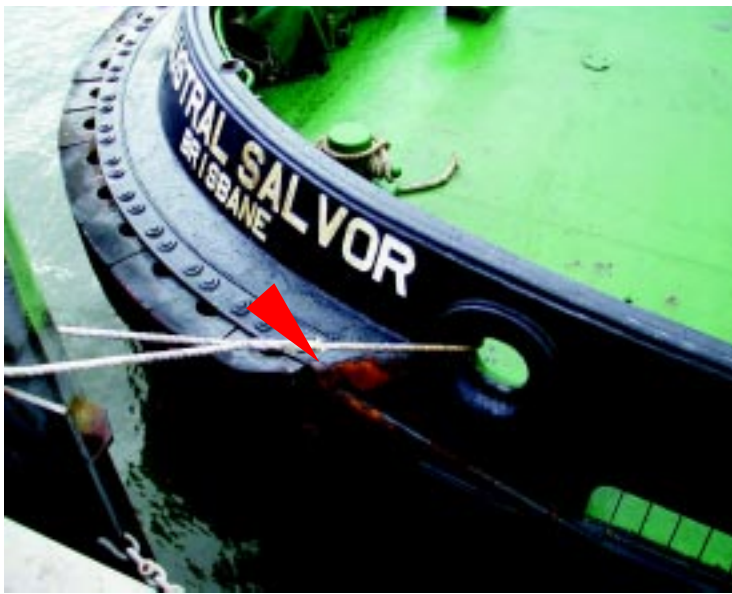
The Tugmaster told the engineer to check for damage to the tug and he found that there was a small split in the weld in a bracket at the side of the tug aft. He checked the steering flat to make sure that there were no dents or ingress of water and informed the Tugmaster that there was no significant damage.

Bracket on Austral Salvor that caused damage to shell plating on Barrington

Damage to *Barrington* occurred in way of the port fuel oil storage tank. The damage was caused by a steel bracket on *Austral Salvor's* starboard quarter landing against *Barrington*, breaching the hull.

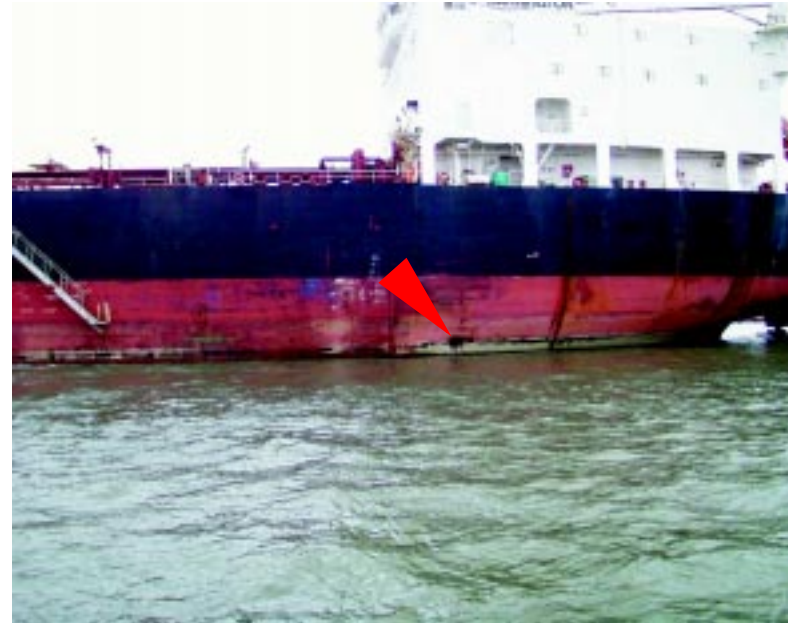
The engineer on *Austral Salvor* was passing through the interior accommodation of the tug when he felt a bump. He did not think the bump was excessive, but when he got out on deck they were abeam of *Barrington* and he could see oil spilling from the ship. An engineer on *Barrington* called to him and asked him where the plating was holed and he pointed to the tank just aft of the cofferdam. The tank was marked on the ship's shell plating 'HFOS'; the port heavy fuel oil storage tank.

Location of holed shell plating on Barrington

- 5 The collision caused indentation and penetration of *Barrington's* hull in way of the port heavy oil storage tank. Both the indentation and penetration of the shell plating were caused by contact with a steel bracket on the tug, which was used to attach the after fender to the stern of the tug.
- 6 The training regime, training manual and instructions provided for prospective Tugmasters would seem to be comprehensive and were not contributing factors in this incident.

Permanent repairs were carried out to the damaged area at a repair berth in Brisbane and the vessel was able to load its cargo and proceed on the next voyage shortly after the incident.

On 29 April the ship shifted to Cairncross Dockyard where permanent repairs were carried out. Repairs were completed on 1 May and the ship moved back to the Ampol Wharf the same day to load its cargo, eventually sailing from Brisbane on the night of 2 May 1998.

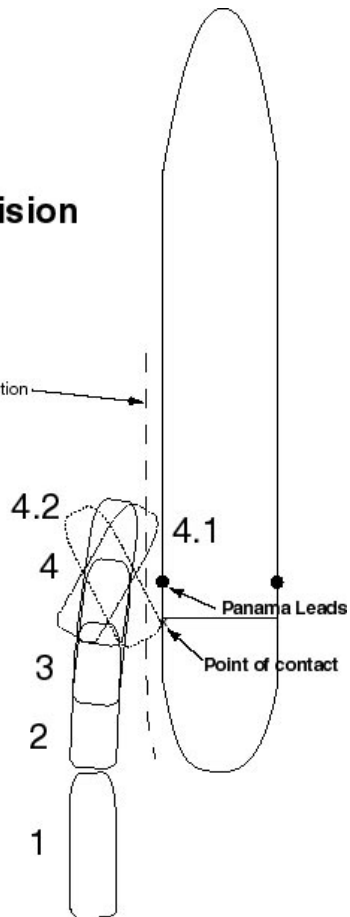
Barrington/Salvor collision reconstruction

Estimated limit of interaction

- 1 1640 approaching ship
- 2 1641 10m off, closing in
- 3 1642 8m off, closing in
- 4 1642½ 6m off, sheer starts
- 4.1 1642¾ Tugmaster arrests sheer
- 4.2 1643 Stern swings in and contacts ship

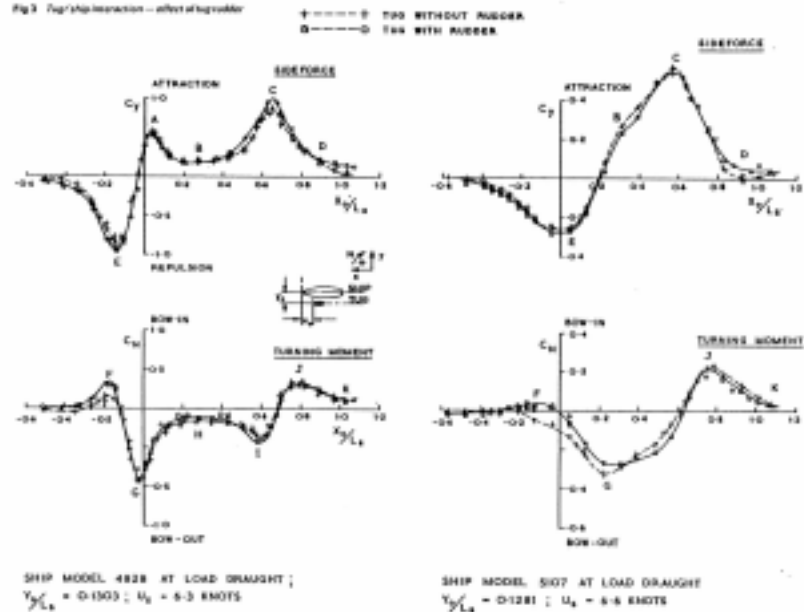
Fig 3 Tug/ship interaction - effect of tug

Tug/ship interaction: side force and turning moments

However, advice received from the designer of the tug suggests that the effects of interaction should have been experienced when the two vessels were 3 ½ - 4 metres apart, given the low speeds of both vessels. On this basis, interaction would not have occurred until the Tugmaster took the controls.

On the evidence available, it is probable that the initial sheer was not caused by interaction. However, once the tug's stern had closed within a few metres of the ship after the sheer of the bow had been corrected, there may well have been a stern-in turning moment caused by interaction.
