Departmental investigation
into a fire in the
engine room aboard
the Netherlands Dredger
Leonardo Da Vinci
off the port of
Dampier, WA
on the 11 June 1998

Published: January 1999

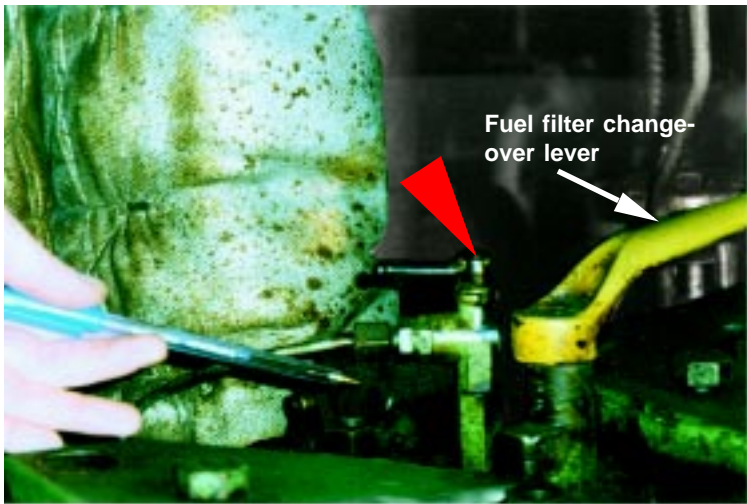
Fuel filter change-over lever

No 3 shut-off cock handle in place

No 2 shut-off cock handle missing

During the investigation it also became apparent that, although it had not contributed to the fire, there had been a slight fuel oil leak from the spindle of the No. 1 diesel engine fuel filter change-over lever. This had first been recorded in the Chief Engineer's workbook seven days before the fire, with subsequent daily entries indicating new "O" rings were required. The time required to change the "O" rings is about one hour, but the Chief Engineer did not consider the leak of sufficient significance to stop the dredging operation in order to effect the change.

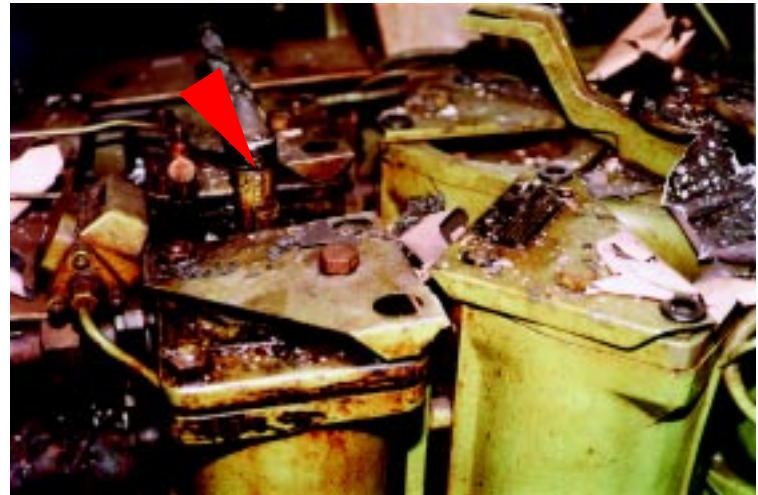
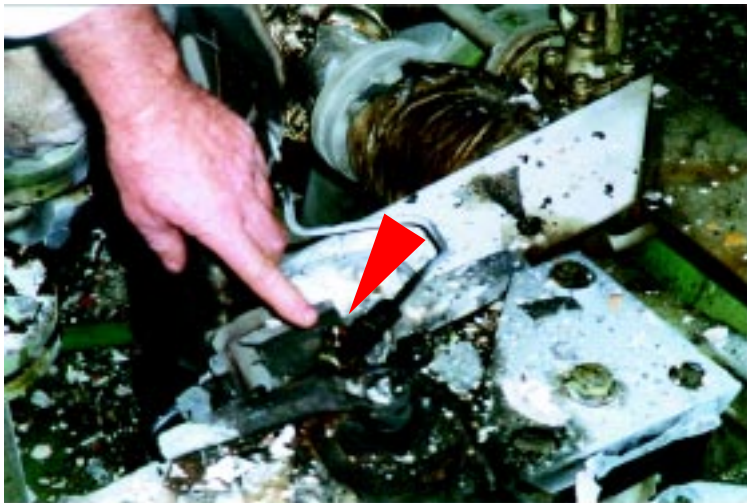
No 1 shut-off cock spindle bonnet missing

On investigation, the handle and spindle bonnet of the shut-off cock to No. 1 diesel filter differential pressure indicator were found to be missing. This had allowed diesel fuel, under 8 bar pressure, to spray upwards, on to the hot exhaust trunking of the engine, the heat of which had ignited the oil.

The handle, which is attached by a screw to the top of the spindle, also serves as a keep, or locking device, securing the spindle bonnet. During the course of the investigation it transpired that the handle had been missing for some considerable time. It is apparent that with the handle (the locking device) removed, the threaded bonnet had vibrated loose.

The handle was also found to be missing from No. 2 diesel filter differential pressure indicator shut-off cock, however in that instance the spindle bonnet was seated tightly. According to those interviewed, the handle
