Incidents at sea

Departmental investigation into
the contact by the
Panamanian container ship
MSC KATIE
with the container ship
DL D SYDNEY
in Swanson Dock, Melbourne
on 18 June 1998

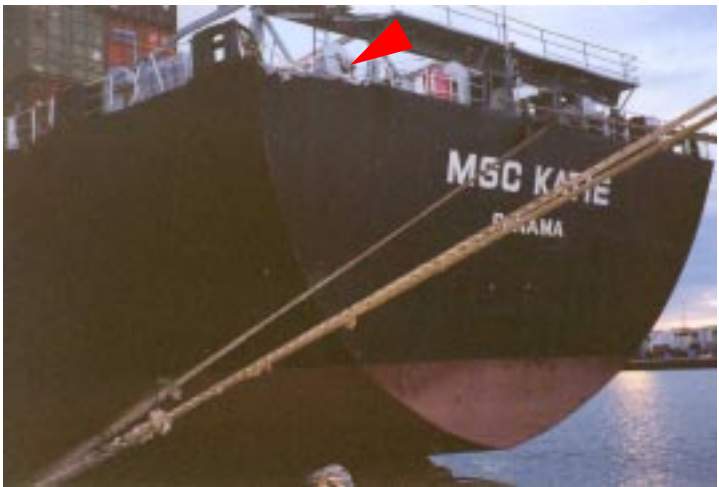
MSC Katie sustained damage to the shell and deck plating right aft on the port quarter, also to deck fittings and to container support pillars and access platform in that area. *P&O Nedlloyd Sydney* sustained scratching and indentations on the stem plating, plus a 280 mm vertical fracture in the plating and damage to the gangway, which came in contact with a bollard on the wharf as the ship was pushed astern.

MSC Katie damage to port quarter

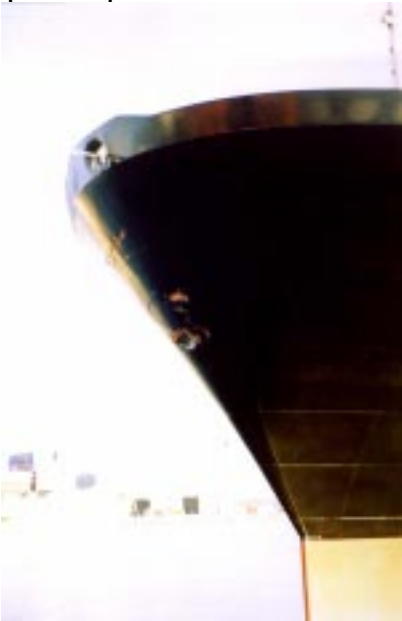
P & O Nedlloyd Sydney damage to bow
