**Departmental investigation
into the grounding of the
Australian flag bulk carrier
FITZROY RIVER
at the port of Weipa
on the 24 August 1998**

**Navigation Act 1912
Navigation (Marine Casualty) Regulations
investigation into the grounding of the
Australian flag bulk carrier
FITZROY RIVER
at the port of Weipa
on the 24 August 1998**

Published: June 1998

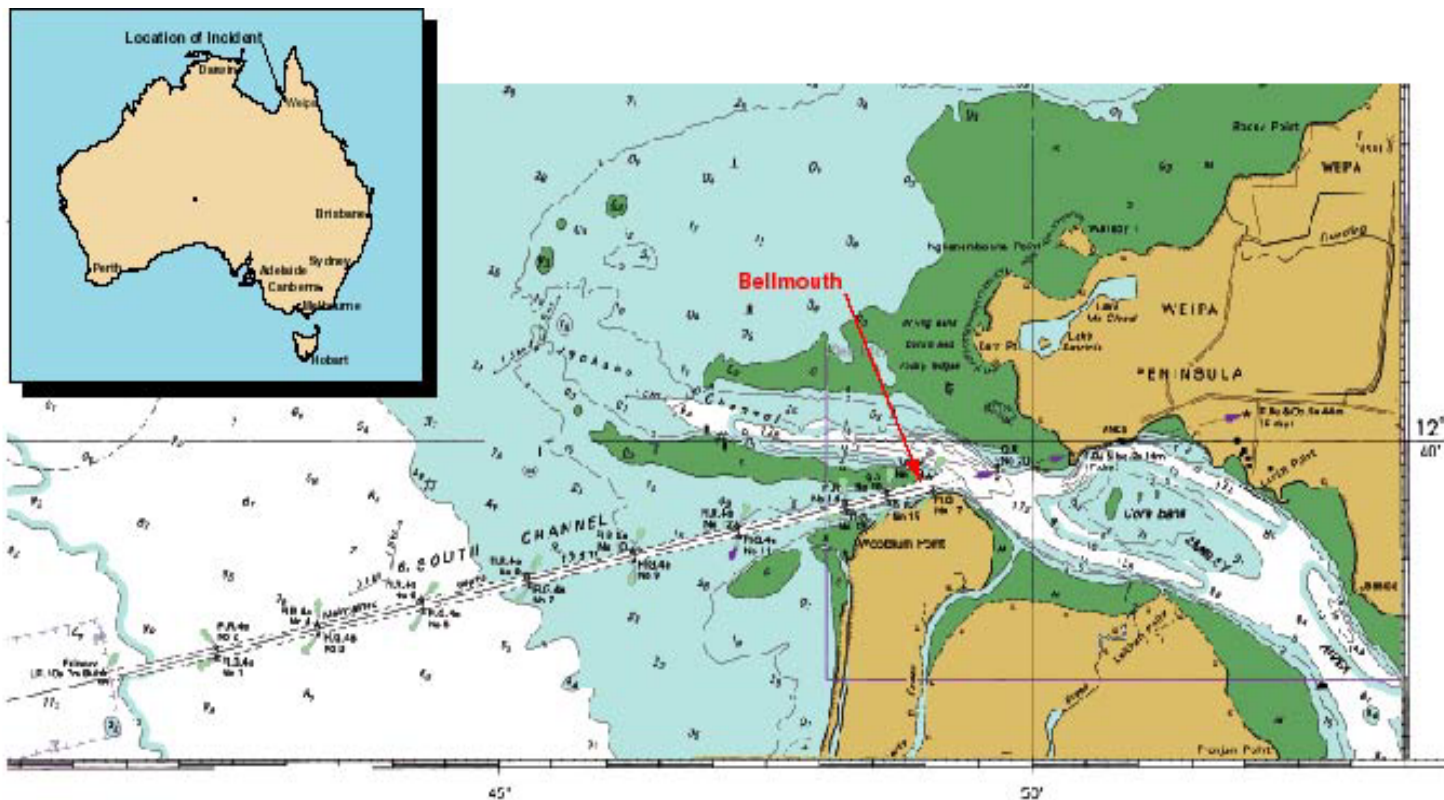
Portion of chart Aus4 showing entrance channel to Weipa

The ship’s heading had reached 240° when the bow grounded on a spit of shoal water extending about 200 m east-north-east from Bn.18, which marks the north bank of the inner eastern end of South Channel. Immediately the engine was put to about 70 rpm astern, but the ship proved to be securely aground with the bow about 130 m from Bn.18 on a heading of 243°.

The southern edge of the spit was dredged in 1980 increasing the width of the entrance to the South Channel by about 100 m at the eastern extreme – by about 80 m between Bn.17 and Bn.18. Bn.18 was moved about 50 m to the north. However, a spit of shoal water still exists, extending about 240 m ENE from Bn.18.

Bn.18 marks the north side of the eastern end of South Channel and is sited about 27 m from the toe of South Channel. However, the shoal water extends about 240 m east-north-east of the beacon to the ten meter depth contour. It was this tongue of shoal water on which *Fitzroy River* grounded although the ship's bow seemed to be swinging clear of the beacon itself.

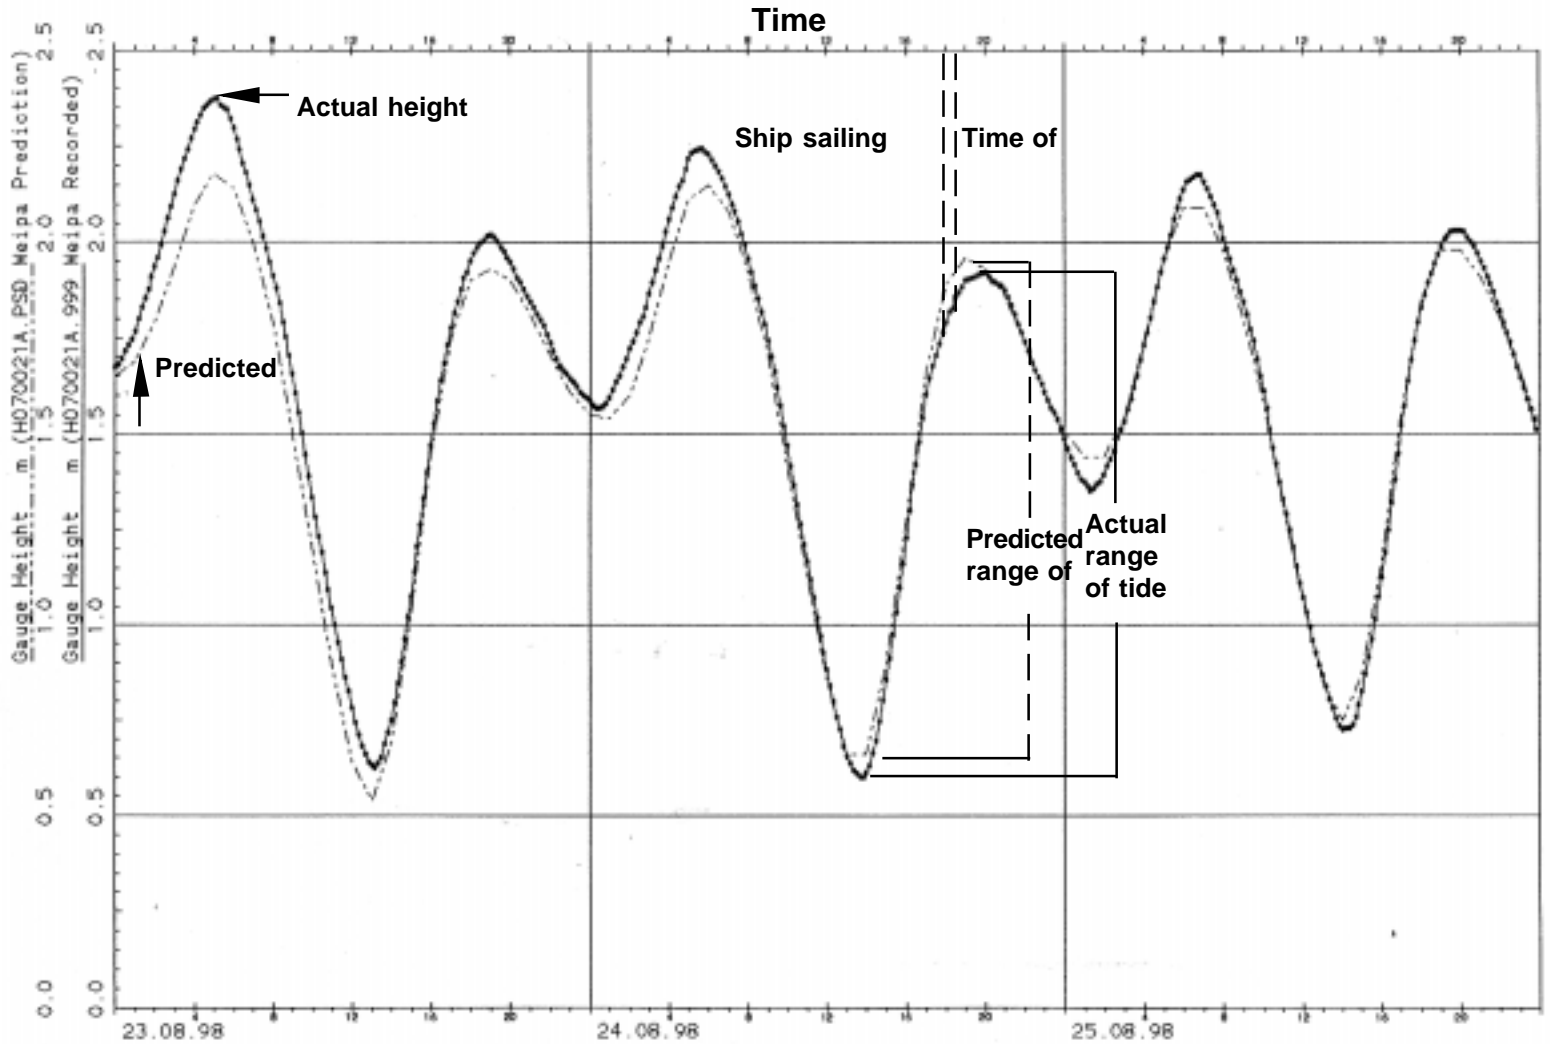
Weipa tidal gauge recorder trace
23 August - 25 August 1998

The Master stated that he made due allowance for the anticipated southerly set of the tide, but there seemed to be less set than he anticipated. He attributed the grounding to this cause. He provided a comparison of predicted and actual tidal times and heights, as recorded by the Queensland Department of Transport, for the period 0000, 23 August 1998 to 2400, 25 August 1998.

“With the on-set of south easterly weather the actual tide heights fail to reach the predicted levels. Generally 30 to 36 hours after the wind has increased to a steady velocity, around 20 knots, the actual tide heights are about 25 to 30 centimetres down on prediction.

The meteorological conditions over the preceding days would not, in all probability, have had any significant effect on the rate of tidal flow.

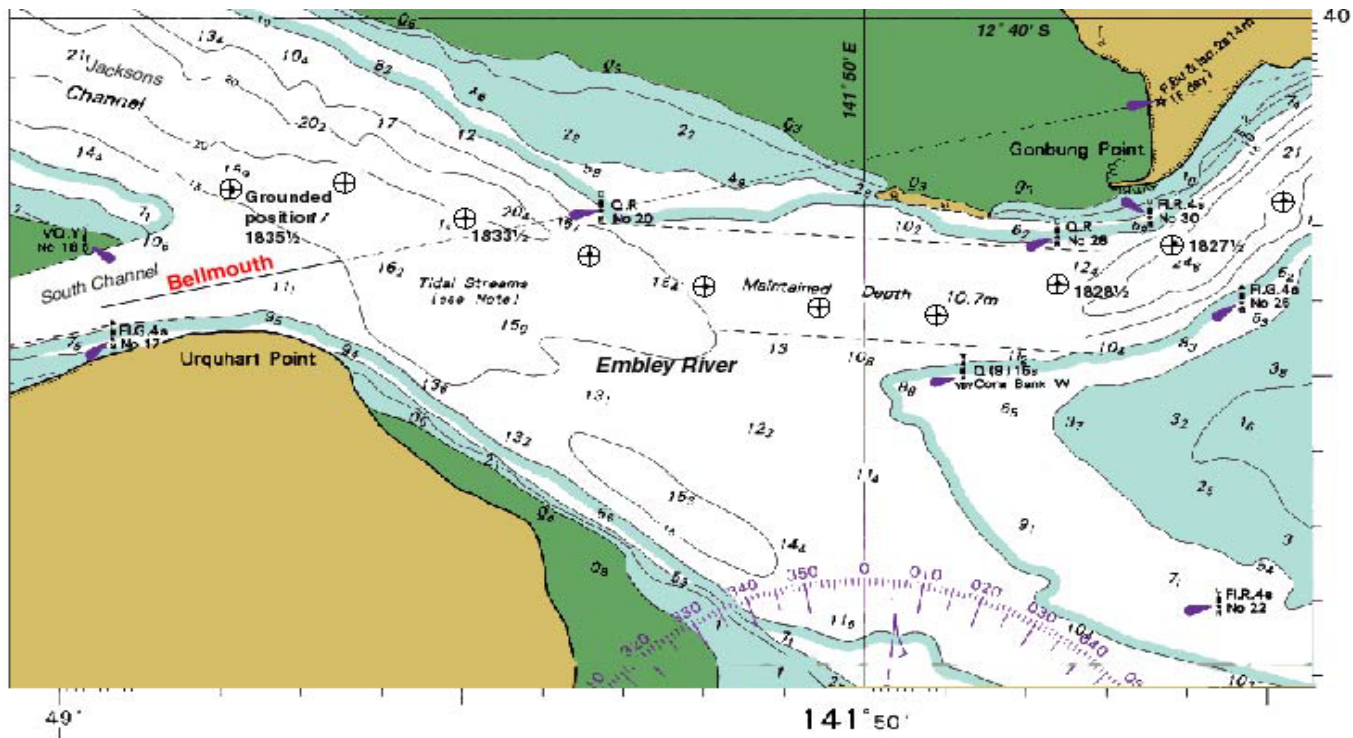
Portion of Chart Aus4 showing positions 1826 - 1836 on 24 August taken from GPS plotter

At 1835:30, when *Fitzroy River* had reached a heading of 240° the turn to port stopped and the Master realised that the ship had grounded.

The engine was put to about 70 rpm astern, but the ship proved to be securely aground with the bow about 130 m from Bn.18 on a heading of 243°. The bridge was in position 12° 40.24' South 141° 49.20' East, 264°x1.14 miles from the front leading light on Gonbung Point.

At 1827 the ship entered relatively deep water (>2 times the draught) for about one minute before reaching the area of minimum depth between Bn.28 and Bn.20, where the under keel clearance reduced rapidly to 0.8 m. This rapid shelving or "step" would cause extra sinkage, reducing rudder response.

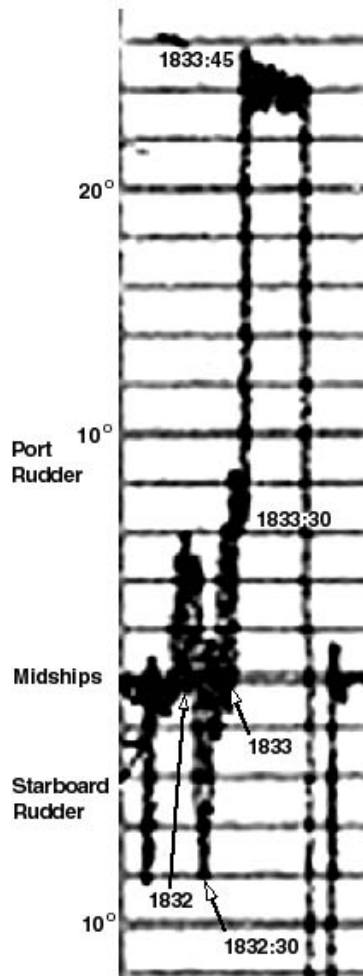
Course Trace

The rudder angle indicator section of the course recorder was not recording the actual rudder applied. Subsequent tests showed that the trace was in error both when port and starboard rudder was applied. These errors seemed uniform and can be correlated with the actual rudder movements.

Port Rudder - degrees		Starboard Rudder - degrees	
Recorded	Actual	Recorded	Actual
6	10	7	10
11	20	12	20
20	30	21	30
22	Full (35)	21	Full (35)

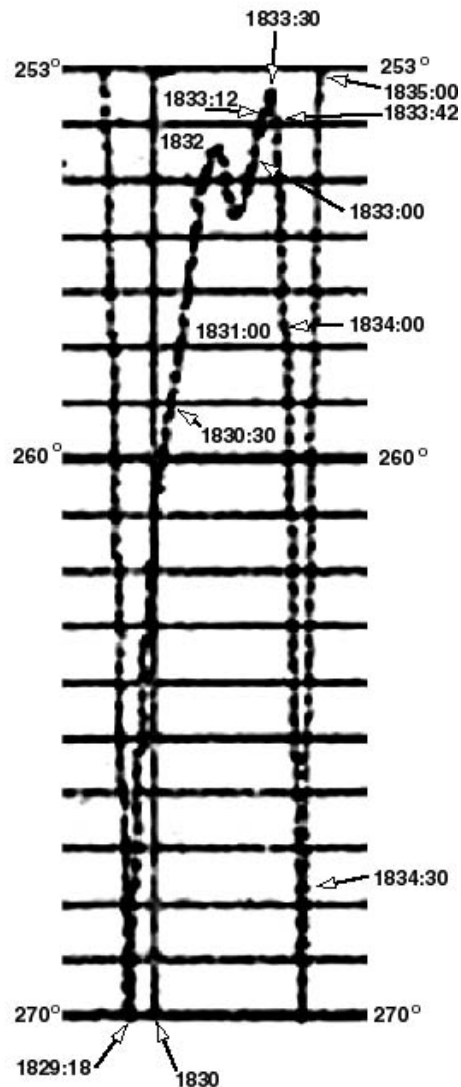
Enlargement of course recorder trace 1829 - 1835

At this time the minimum UKC increased from 0.8 m to about 10.0 m, which should have improved the steering characteristics.
