**Departmental investigation
into the the fire
aboard the Australian flag
oil tanker
HELIX
at Brisbane, Queensland on
17 October 1998**

HYDRAULIC PUMP JOINT FAILURE MV HELIX

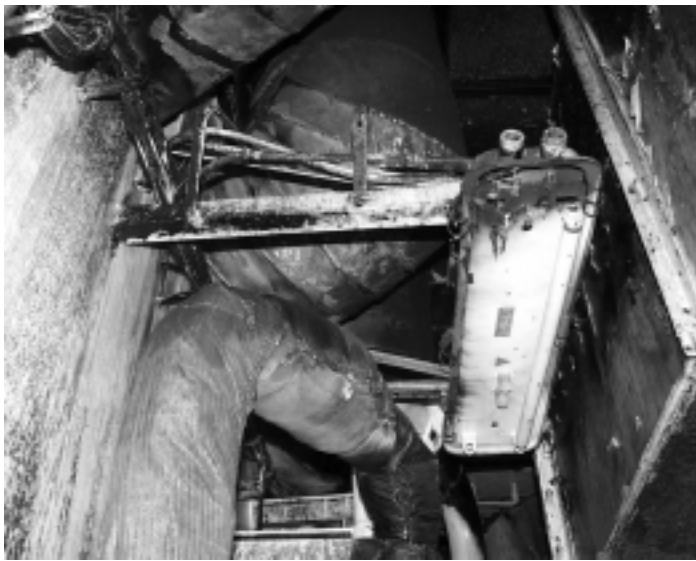
Fire damage immediately aft of hydraulic room bulkhead
Small lagging fire occurred on this pipework

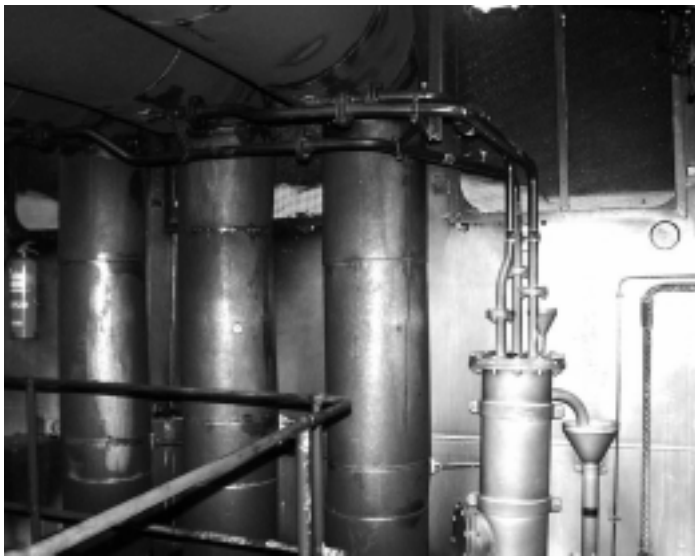
Smoke damage around diesel exhaust trunks above hydraulic room

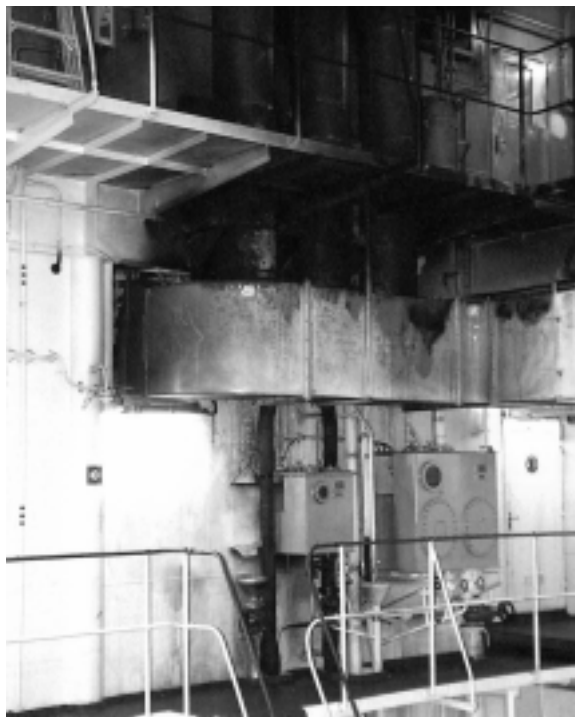
Smoke damage at top of engine room

Looking forward towards top of hydraulics room bulkhead

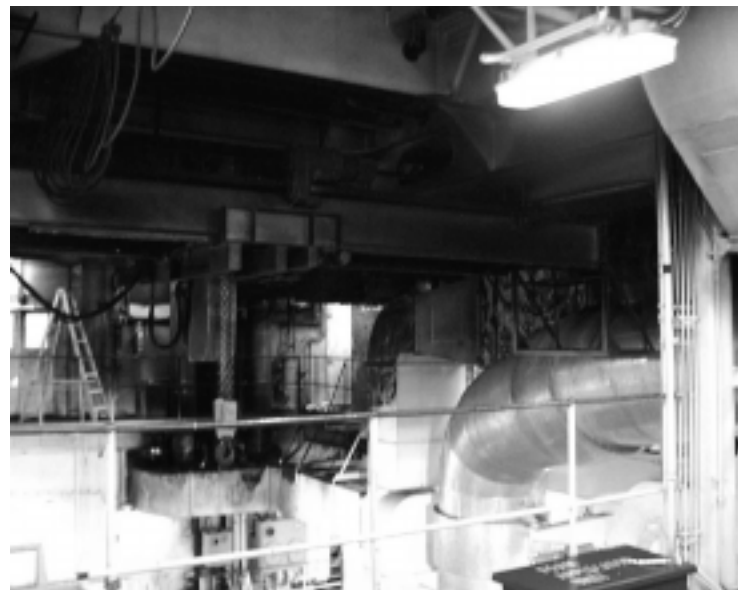
Smoke damage outside hydraulic room

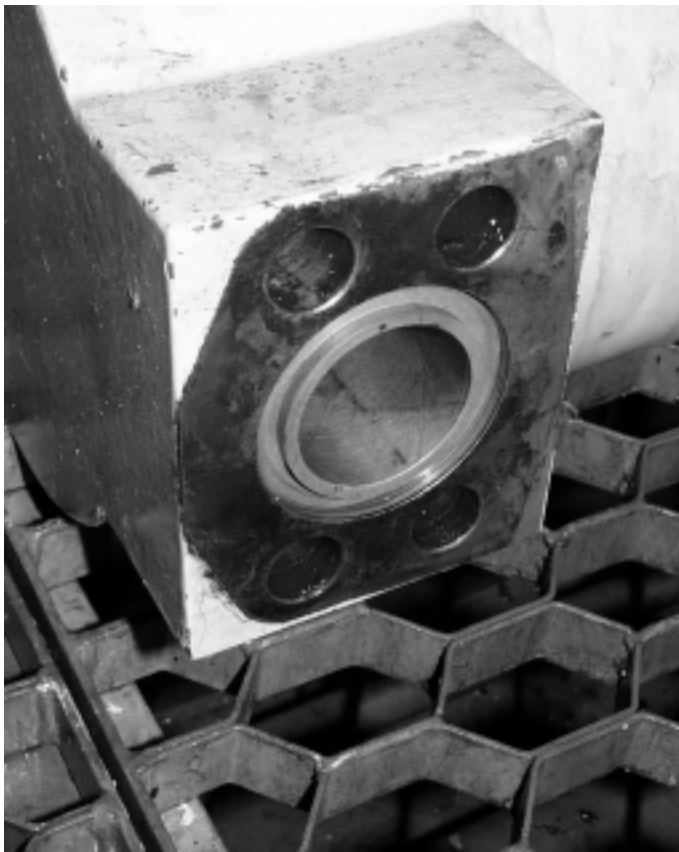
Damper body joint face

The bolt clearance holes in the attachment flange of the pulsation damper, where it joins the pump body, were found to be worn due to relative movement of the parts. Some fretting marks were evident on the two mating surfaces and the split O-ring was distorted. The thread in one of the holes in the pump body was damaged but the depth of the hole was 32 mm allowing sufficient clearance for the end of the bolt; the

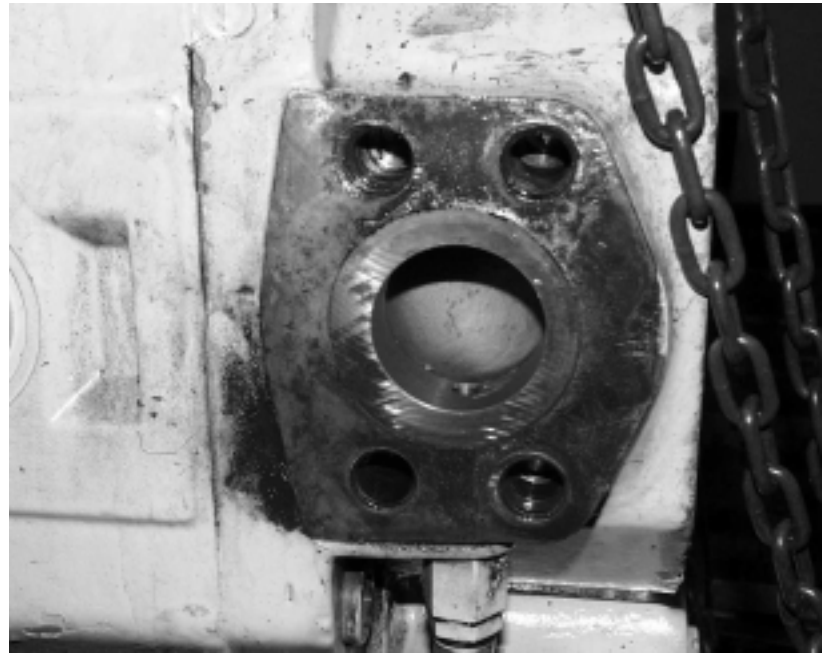
Pump body joint face

The supporting bracket, at the pump drive end, for the pulsation damper/filter unit was distorted and cracked across the bolt holes. Significant marking due to vibration was found on the pump flange where the bracket was secured.

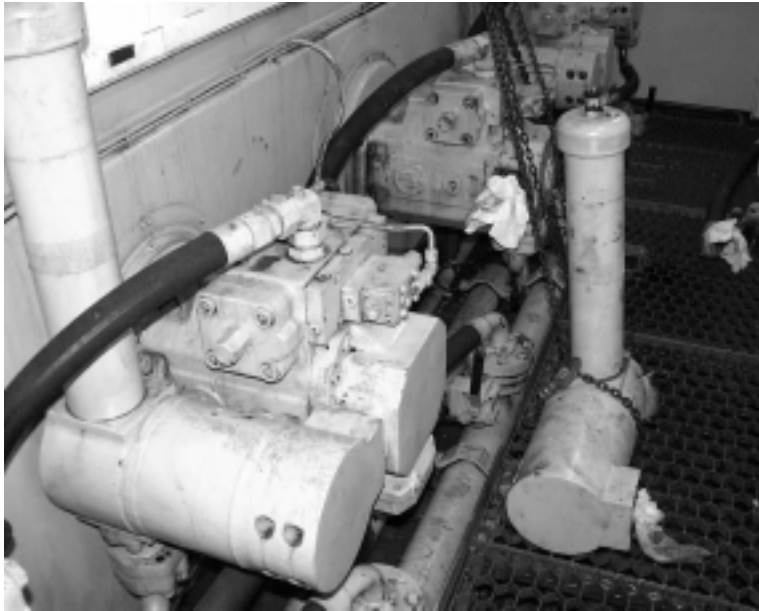
Hydraulic pumps (No.3 damper/filter unit removed)

At the time of the incident, No.3 hydraulic pump was in use for the cargo discharge. Following the fire, it was found that the two upper set bolts, securing the pulse damper unit to the HP outlet flange of the hydraulic pump, had failed approximately 180 mm below the heads of the bolts. The two lower bolts were found slack. The upper eye in the bracket securing the other end of the pulse damper to the pump body had failed (see photo bottom page 12). The effect of these failures was to allow the pulse damper to move relative to the body of the hydraulic pump and for the joint to open up to the point where the O-ring had failed, allowing the escape of hydraulic oil under high pressure.

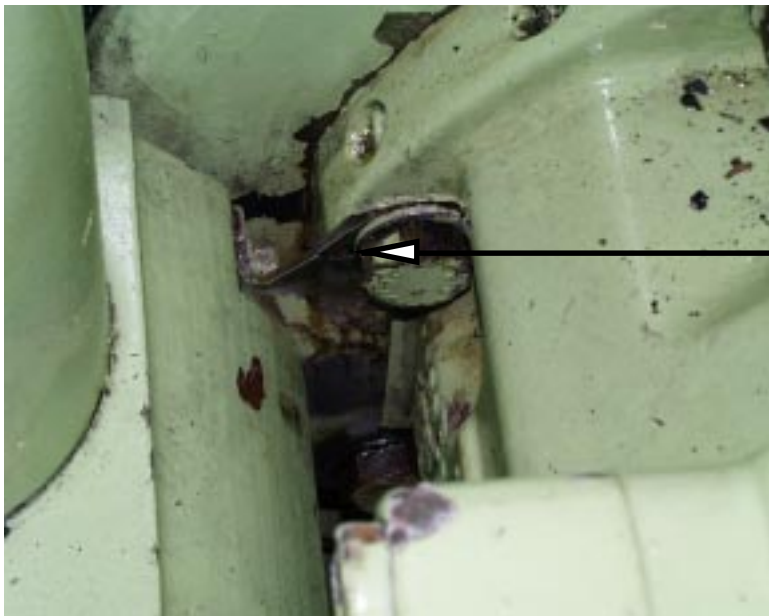
Failure

**Broken
bracket on
No. 3 pump**

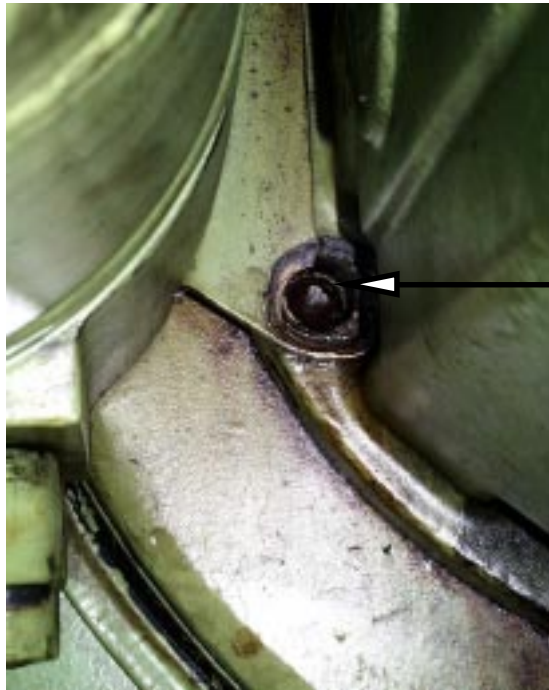
Failure

The report on the examination stated that the two failed bolts had fractured as the result of fatigue crack growth. The remaining two (intact) bolts had no obvious indications of crack growth.

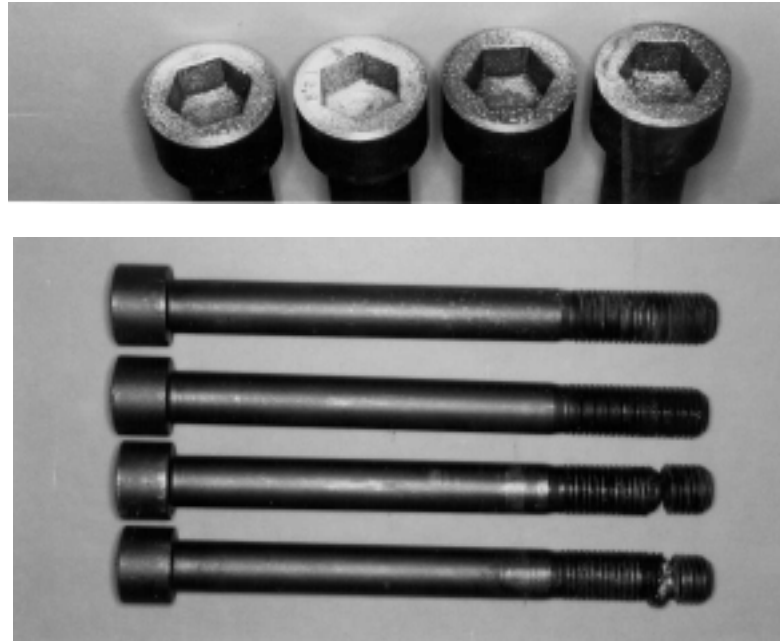
Figure 2. Cap screws from the failed pulsation damper filter/bypass hydraulic pump joint, as received.

An examination of the features of the two fractured screws indicated that the failure of one screw preceded the other.

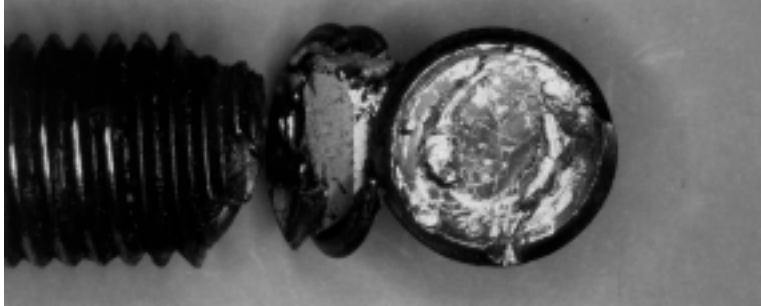
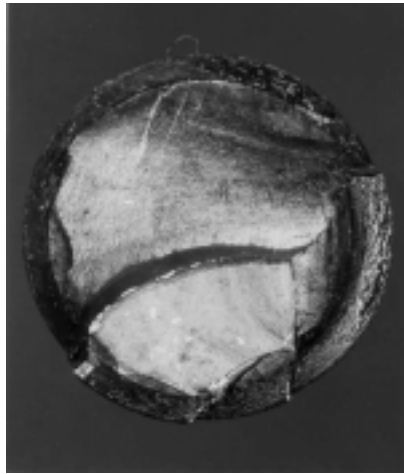
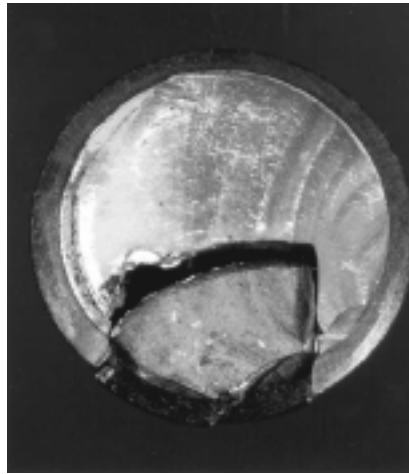
Fatigue crack growth in the first screw to fracture was caused by an alternating stress state aligned with the axis of the screw. The plane of crack growth was normal to the axis of the screw. Fatigue cracking initiated in the root of the thread engaged in the pump housing, two thread forms from the joint surface. Following the growth of this initial fatigue crack and the accompanying changes in load transfer further fatigue cracking initiated in the screw from the thread root closest to the joint surface. The growth of multiple cracks resulted in the liberation of the small section of the screw, see figure 3.

Figure 3. First screw to fracture, showing multiple crack growth. A detailed view of the primary fatigue fracture is shown, bottom right. A detailed view of the secondary crack (liberated section of the screw removed) is shown, bottom left.

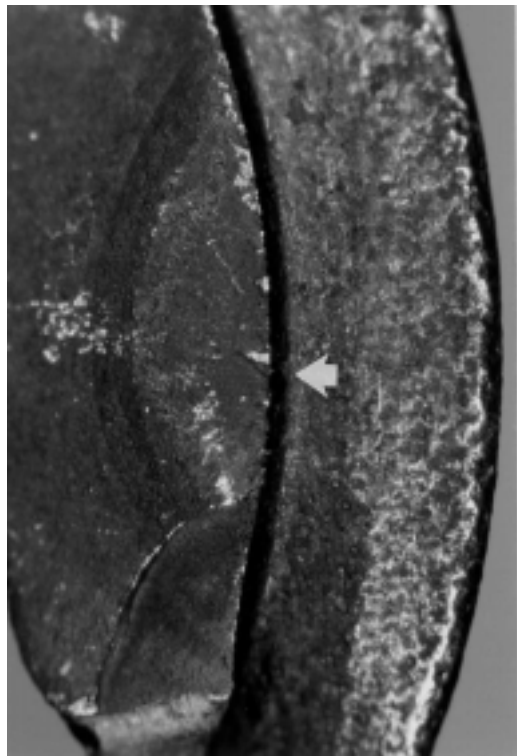
No gross material abnormalities or geometric discontinuities were observed to be associated with the initiation of fatigue cracking during a nondestructive inspection of this screw, see figure 4

Figure 4. Detailed view of the site of primary fatigue crack initiation.

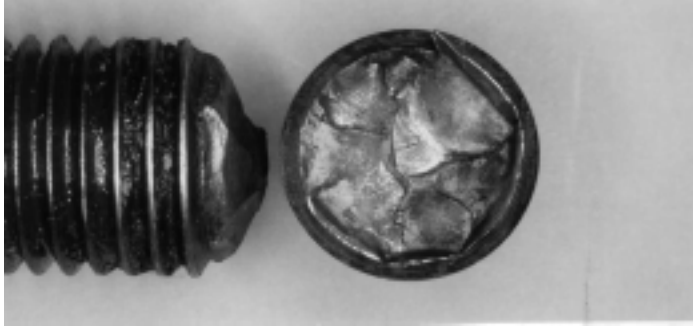
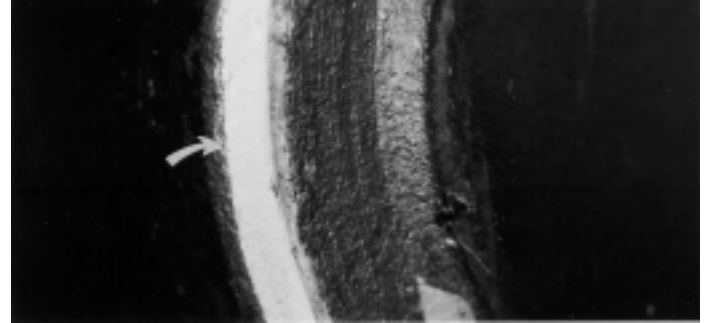
The features of fatigue crack growth in the second screw are consistent with the application of alternating, rotating, prying loads under the head of the screw. Fatigue cracking initiated at a number of sites in the root of the first engaged thread. Crack growth extended on planes inclined to the axis of the screw, see figure 5. This type of fatigue crack growth is consistent with a loosening of the bolted joint following the fracture of the first screw.

Wear on the edge of the bearing surface of the cap screw head is consistent with an alternating prying loading condition created after joint loosening.

Figure 5. Fatigue fracture, second cap screw. A detailed view of the wear on the edge of the cap screw head is shown at the bottom of the figure.

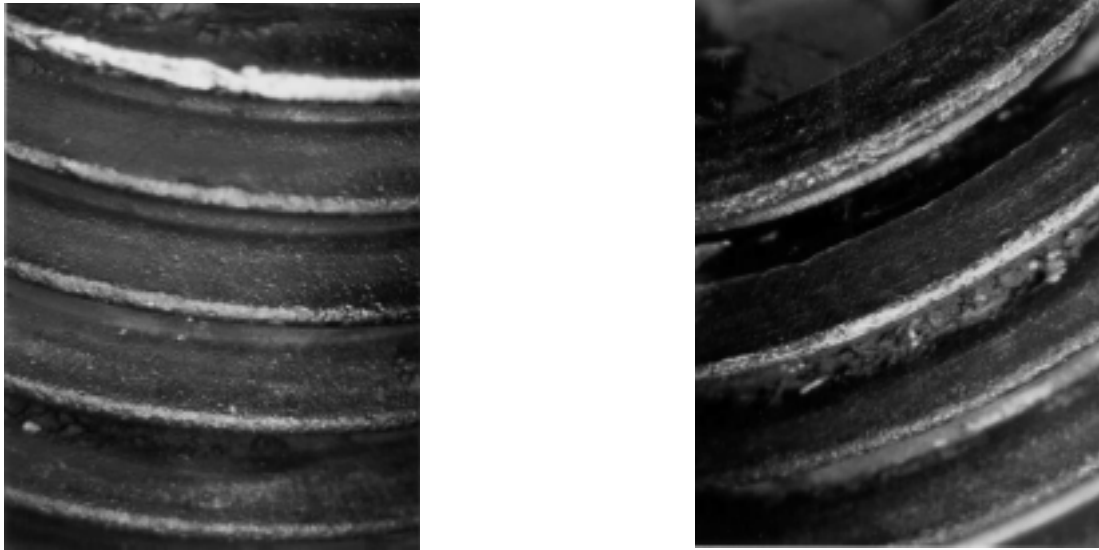
It was notable during the examination of the bearing surfaces of the threads and screw heads that there was little evidence of interaction with the mating surfaces in the pump housing and damper assembly, see figures 6 and 7. This lack of surface interaction (scoring, ploughing) may indicate a low assembly torque and, consequently, a low preload in the screw.

The breakaway torque of the cap screws installed in the remaining hydraulic pumps was reported to be 250Nm, considerably less than the specified 640Nm. This low value of breakaway torque supports the hypothesis that the preload in the cap screws created during assembly was inadequate

Figure 6. Detailed views of the loaded thread flanks of an intact cap screw from the failed joint (left) and the cap screw that fractured first (right).

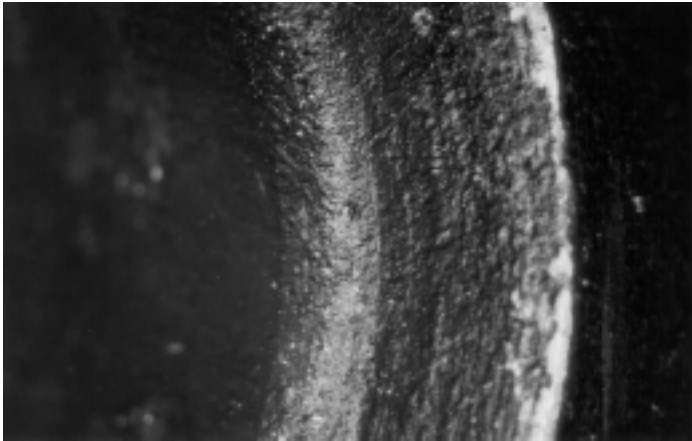
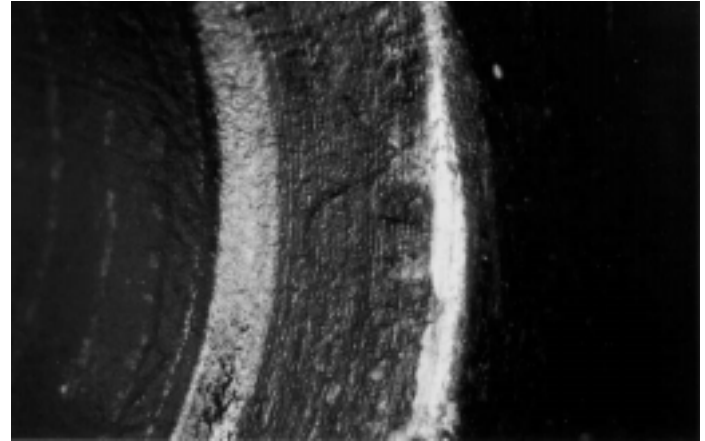
Figure 7. Detailed views showing the bearing surface under the heads of two cap screws from the failed joint.
