**Departmental investigation
into the grounding of the
Singapore flag
livestock carrier
NORVANTES
at the port of Karumba
on the 19 November 1998**

Published: July 1999

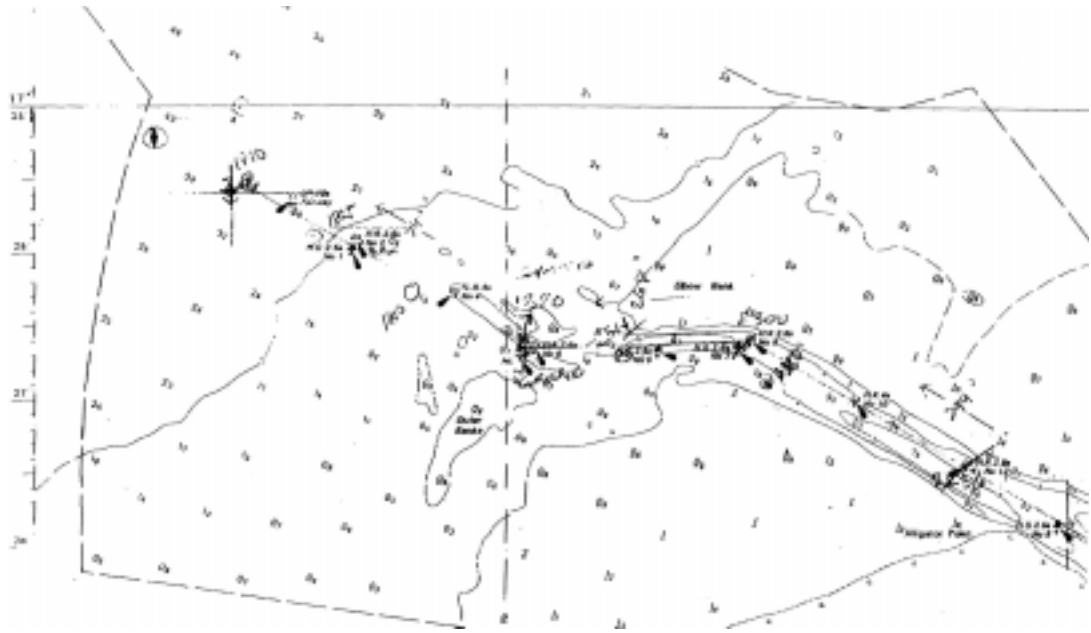
Photocopy of inset on chart Aus 303 supplied by Norvantes

supplied to the Inspector that the chart was the edition issued on 9 June 1995, rather than the edition issued on 27 June 1997. As a result the *Norvantes'* chart showed the channel and its navigation aids as they existed before June 1997. The chart did not show the correct numbering or position of the channel markers, nor did it show the additional markers. The ship's chart showed twelve channel marks between the fairway buoy and Karumba Point, while the 1997 chart shows eighteen markers.
