Departmental investigation
into the grounding of the
Australian flag bulk carrier

IRON SPENCER

Port Hedland,

on 3 December 1998

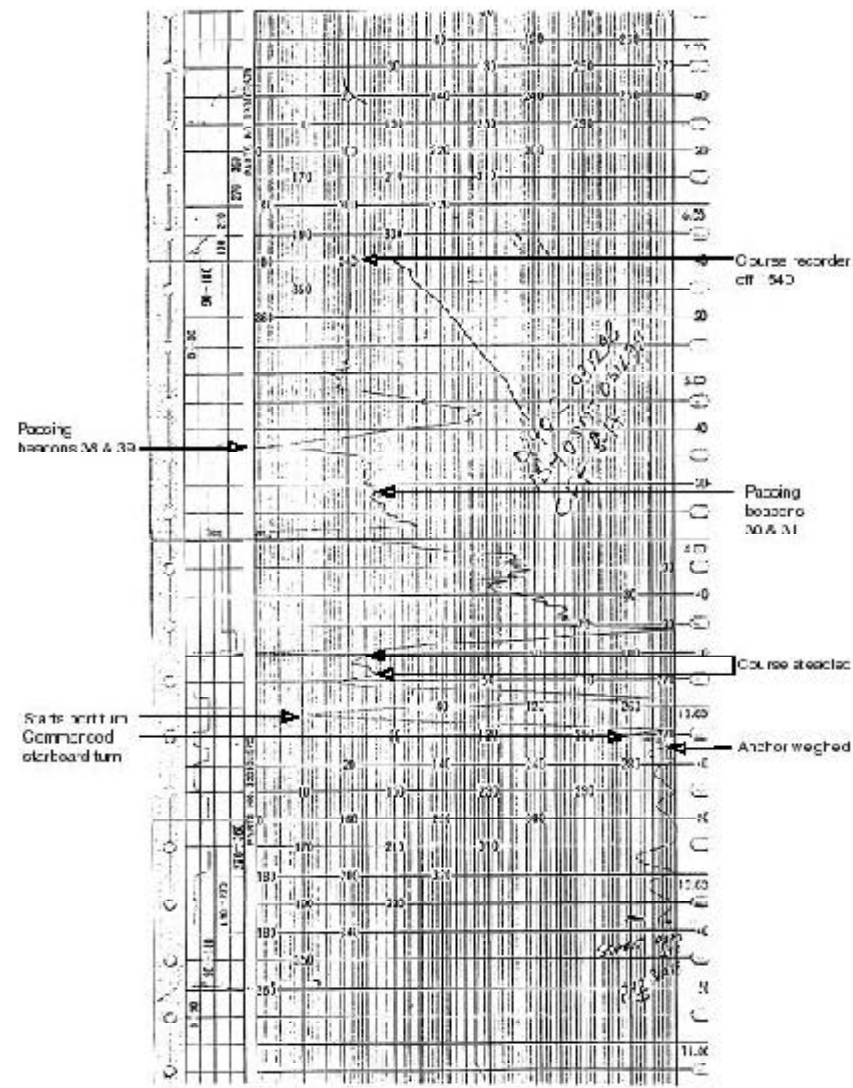
Iron Spencer - course recorder chart

The course recorder trace indicates that at 1246, when the anchor was logged as being aweigh, the heading was 092°. The initial turn to starboard is indicated as starting at about 1249 when the ship's head was 079°. The turn was made at about 16°/min. Between 1256½ and 1257 the rate of turn to 7°/min and the ship reached a heading of 170° at 1257½. The ship then turned to port.

The course recorder trace indicates that, soon after 1257, the ship's head started to turn to port. Once established, the rate of turn to port was about 12°/min. At 1300 the ship's head was about 140°, at 1305 about 068°.

At 1309½ the ship reached a heading of 018°, before settling on a course of about 022° for about 9 minutes until 1319. It was during this period that the engine revolutions were increased from half ahead to manoeuvring full ahead.

At 1319 the ship resumed its turn to port and at about this time full port rudder was applied on the advice of the Mate. Between 1319 and 1320 the ship's head changed from 014° to 332°, a rate of turn of 21°/min. Examination of the course recorder trace shows that at 1322¼ the ship's head was 330° and the rate of turn slowed significantly for about 60 seconds to 7°/min. At 1323¼ the ship's heading was 323° and the rate of turn increased.

When evidence from the 2nd Mate and the charted positions are considered, it is quite possible that either of, or both, the decreases in the rate of turn noted above between 1322¼ and 1323¼ and 1325 to 1327, indicate contact with the Minilya Bank. If, as reported, the ship's speed fell from 10 knots to 1.8 knots, the ship's speed would have fallen from about 310 m/min to about 56 m/min.

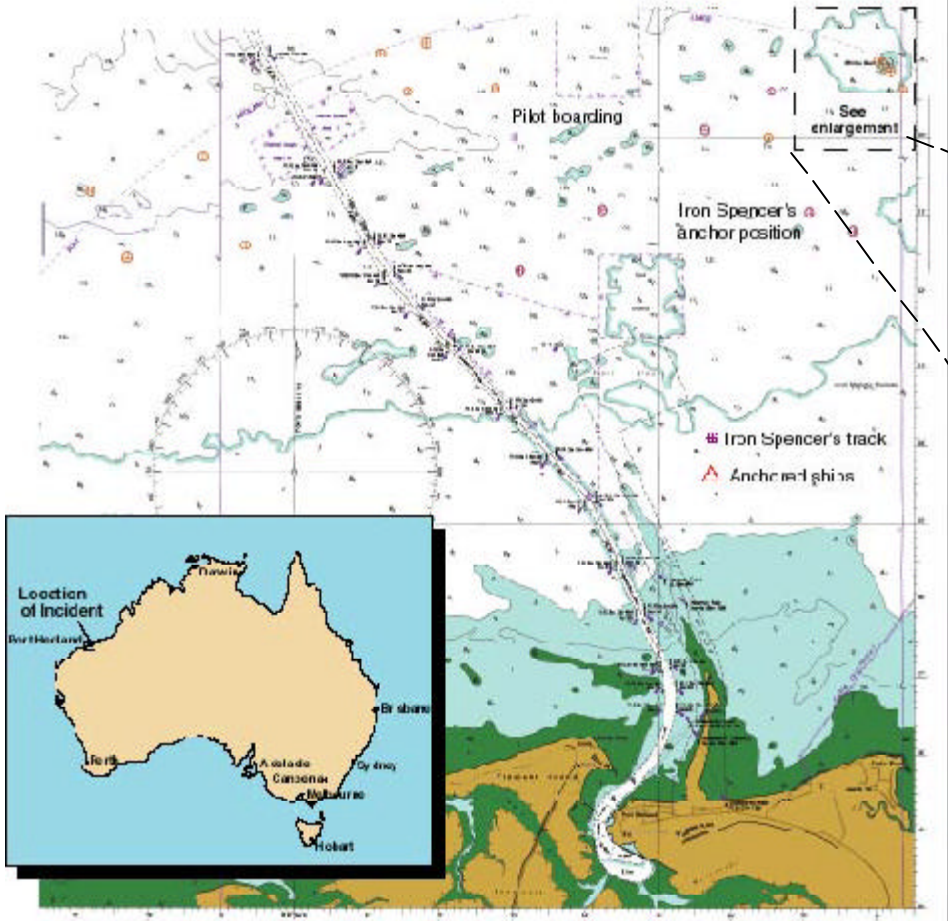
Portion of chart aus 53 with Iron Spencer's position at anchor and track

The anchor was dropped at 0707 and, at 0736, the vessel was brought up with 7 shackles in the water. Beacon 26 was bearing 264° x 5.96 miles. This position was 2 miles south-south-west of Minilya Bank. The Bank has a least charted depth of 1.9 metres.

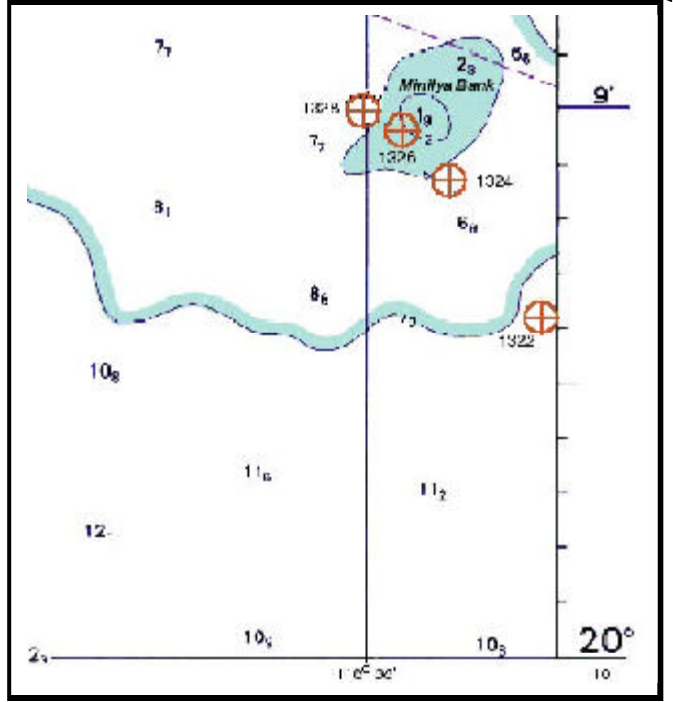
Portion of chart Aus 52 showing GPS positions of Iron Spencer in the vicinity of Minilya Bank

The Master realised that by now *Iron Spencer* was further north than he wanted. He told the Mate to fix the ship's position by GPS. The Mate took the position from the GPS, applied the necessary corrections to the latitude and longitude and plotted the position on the chart. He thought that the position could have been obtained between 1319 and 1322, but he put the time down as 1322 on the chart. The position put the ship on the 10 m contour,

about 4 cables south-south-east of the 1.9 m depth on Minilya bank. The Mate immediately told the Master of the proximity of the bank and advised the Master to put the wheel hard over to port to avoid it.
