Departmental investigation  
into the fire aboard the  
Australian flag oil tanker  
*TASMAN*  
in the port of Melbourne,  
Victoria on  
19 December 1998

## **Navigation Act 1912 Navigation (Marine Casualty) Regulations investigation into the fire aboard the Australian flag oil tanker *TASMAN* in the port of Melbourne, Victoria on 19 December 1998**

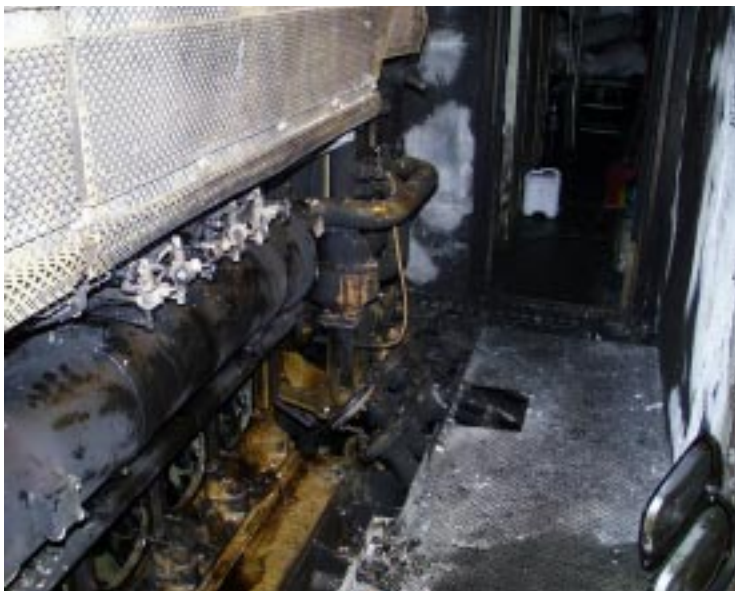
FIGURE 2

Examination of the fire scene after the incident showed that the area of most intense heat damage was in the port aft corner of the generator room, consistent with the observations of those involved with firefighting. The point of lowest burn was in the bilge in this port aft corner (fig. 2 & 3 ) and from here, damage extended up the aft end of, and up the port side of, no. 1 generator.

**Port aft corner of generator space – bilge fire occurred here**

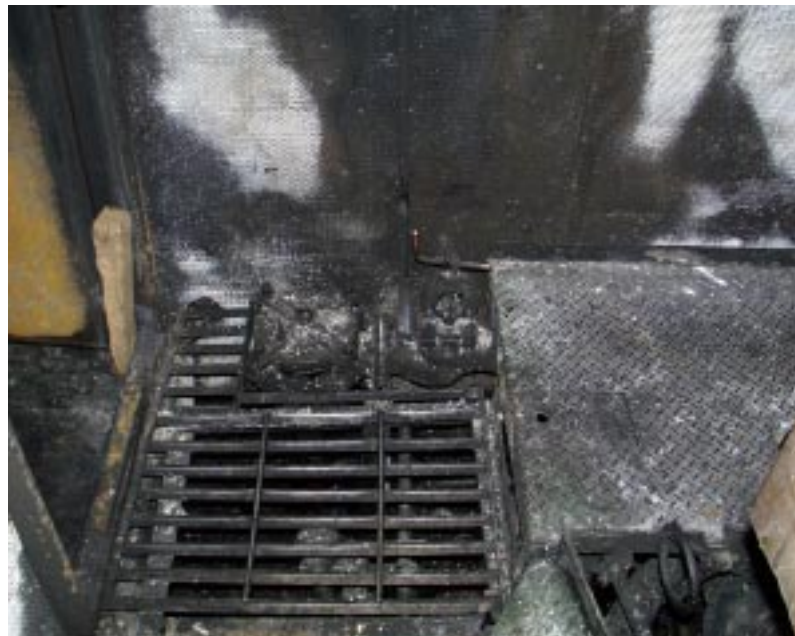
FIGURE 3

Flames rising from the bilge up the port bulkhead of the space had melted the perforated aluminium sheet cladding which covers the rockwool insulation. Although the rockwool itself would not burn, indications are that it had acted as a wick, drawing oil, or oily water, up from the bilge. Pools of solidified aluminium were found on the steel deckplates forming the walkway along the port side of the engine. Heat and smoke, trapped beneath the deck plating, had extended across the width of the aft end of the generator room, blistering paintwork on pipes below the plates.

**View of port side of generator space – looking aft to steering flat**

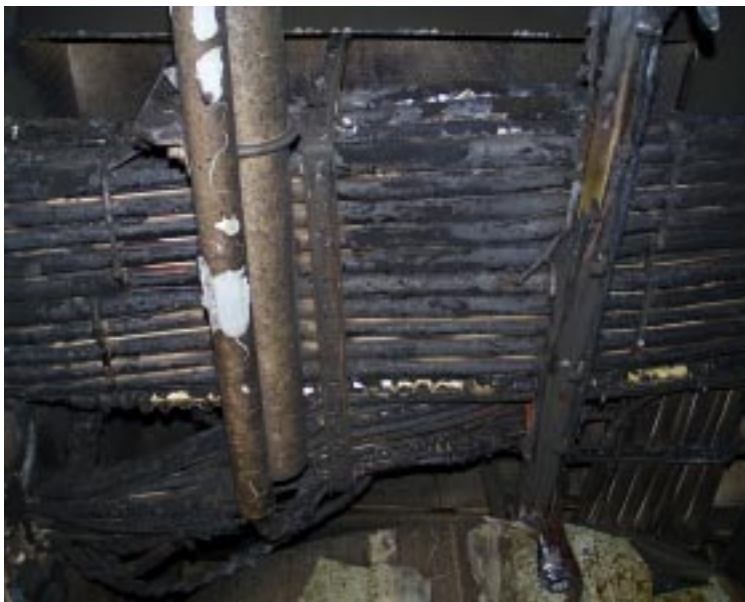
Following the extinction of the fire, an examination was made of the damage to no. 1/2 diesel generator room. It was evident that the most significant damage was to electrical cabling, as cable trays carrying the main power cables from the three generators to the main switchboard run along the deckhead above no. 1 generator. In addition to the power cables, a large number of control, monitoring, alarm and communications cables were also damaged by heat.

FIGURE 4  
Fire damage to deckhead cables and fittings

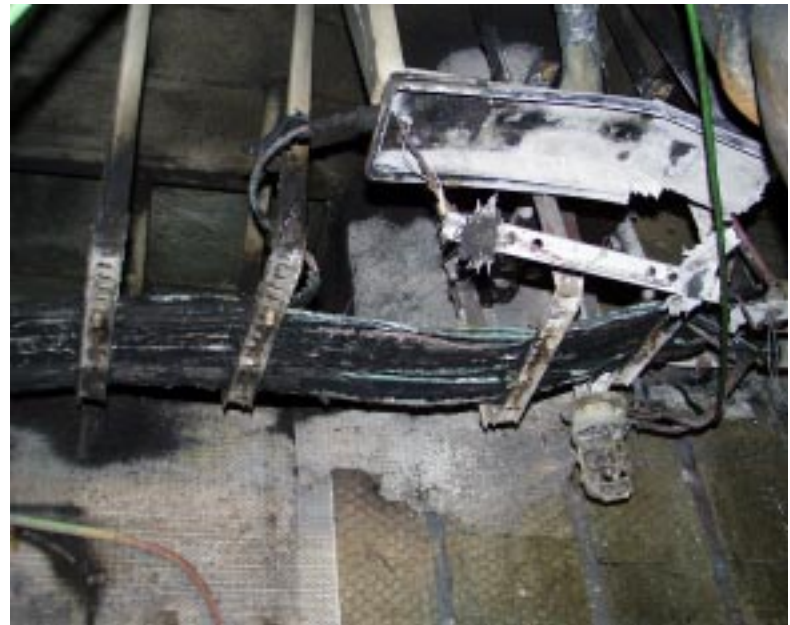
FIGURE 5  
Fire damage to deckhead cables and fittings

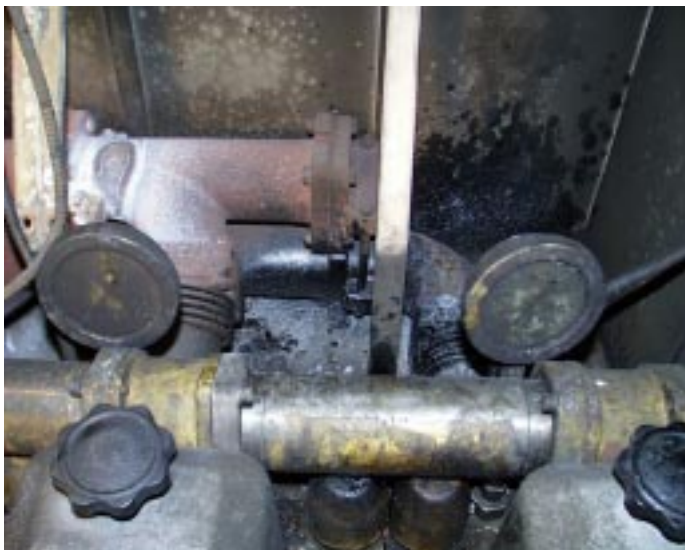
Considerable fresh residues of fuel oil were observed both on the inside of the exhaust casing at the forward outboard corner and also on the exhaust leading from no. 1 unit. (fig. 6,7&8) Neither of these positions, however, are directly in line with the space between nos. 1 & 2 cylinder heads, but it appeared that the spray from the failed joint may have been deflected off the bottom of a bracket which supports the covers of the exhaust hot box. This bracket is in line with the space between the cylinder heads.

FIGURE 6  
**Residue of fuel oil spray  
 within exhaust casing**

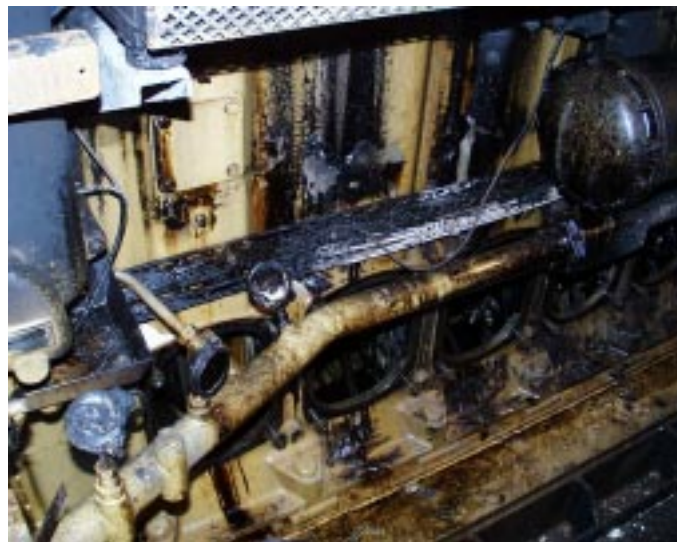
There remained, nevertheless, numerous stripes of scorched and burned paint down the side of the engine crankcase, extending from the top of the engine entablature down to the engine bedplate, along the full length of the engine. There are two possible causes for these burns. The first, and considered the most probable, is that these stripes were caused by burning fuel oil flowing down the side of the crankcase. The other possibility is that the burned paint was caused by radiant heat from the flames which were rising up the bulkhead at the outboard side of the walkway.(fig. 7)

The dark stripes of heavy oil flowing, or dribbling, down the side of the engine would absorb the radiant heat, while the relatively clean, light coloured cream paintwork would reflect much of the heat thus, when the oil had

been hosed off, leaving the burned and blistered paint in the form of stripes.

FIGURE 7  
**Port side of engine showing  
 stripes of scorched paint**

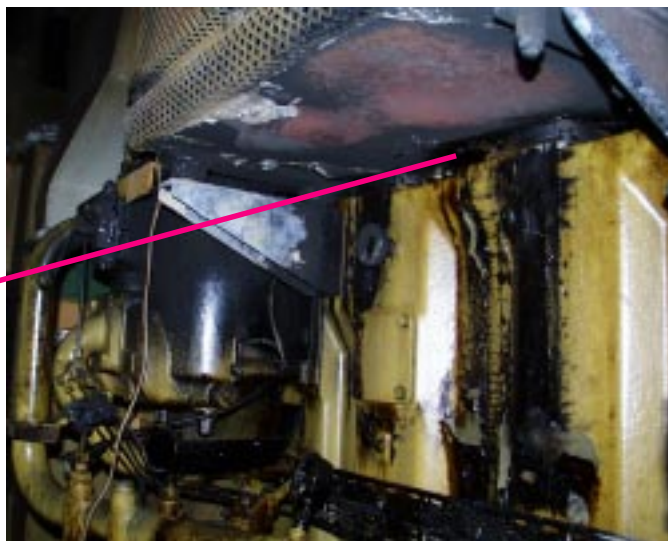
The flange which had parted was in line with the space between nos. 1 and 2 cylinder heads. This space connects directly to the port side of the engine, within the covers of which are contained the exhaust manifolds. The bottom of the exhaust box is raised above the level of the top of the engine entablature by approximately 40 mm and it is evident that it was through this gap, between the exhaust box and the top of the entablature, that the leaking fuel oil had escaped down the side of the engine. (fig. 6,7&8)

Oil flowed from gap here

FIGURE 8  
**Underside of exhaust casing,  
 port side of no. 1 generator**

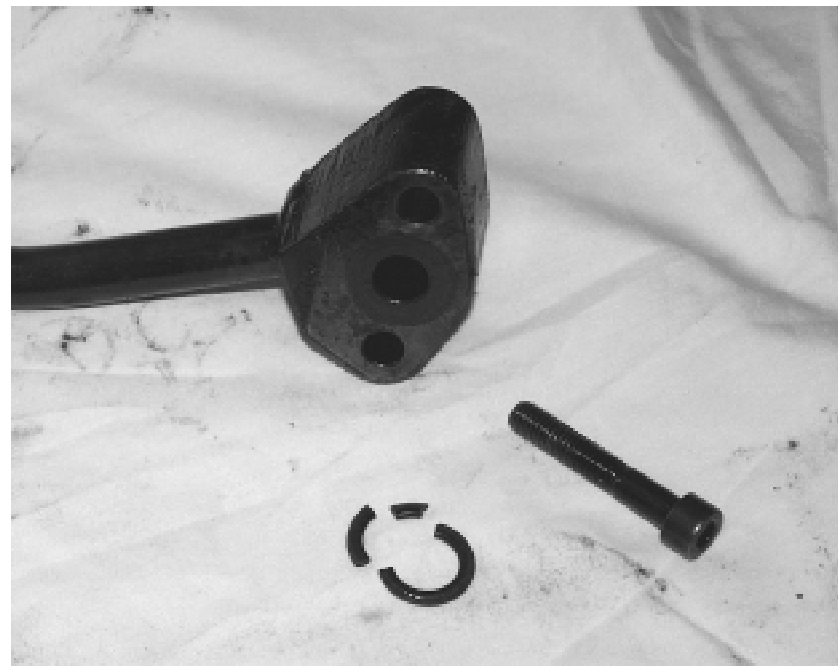
FIGURE 11

Shortly after the fire, ship's staff examined no. 1 diesel generator and removed the hot box covers from the fuel gallery. It was noticed that, on no. 2 unit, the upper of two Allen screws, was missing from the flange where the fuel suction pipe joins the fuel pump. The missing screw was reportedly found lying on the entablature. The other screw was found to have loosened, allowing the flange to part from the fuel pump body. The O-ring in the joint had broken into three pieces. (figs. 6, 7&8)

The two 8 mm × 45 mm allen screws which had secured the fuel suction pipe flange to the pump body were examined. The upper screw, which was reported to have fallen out and later found on the entablature, was stamped 'B109 18' on the side of the head, while the lower screw, which had remained in situ, although loose, was stamped M9 on its upper face. The two screws were subjected to non-destructive hardness tests and, although of different manufacture, returned similar results.

**Pipe flange, 8 mm allen screw and pieces of O-Ring**

The O-ring which had failed, at the joint of the suction pipe on no. 2 fuel pump, was found after the incident to be in 3 pieces. It was not clearly established, however, when the two breaks had occurred. ASP suggested in submission that these breaks had occurred after it had been removed from the joint. Compared to a new O-ring it had evidently hardened considerably, either during the 2,079 running hours since the fuel pump had been re-fitted, which the engine builder considered most unlikely in such a relatively short period, or it had been re-used at the time of the 20,000 hour overhaul. The latter possibility was adamantly refuted in a submission from ASP.

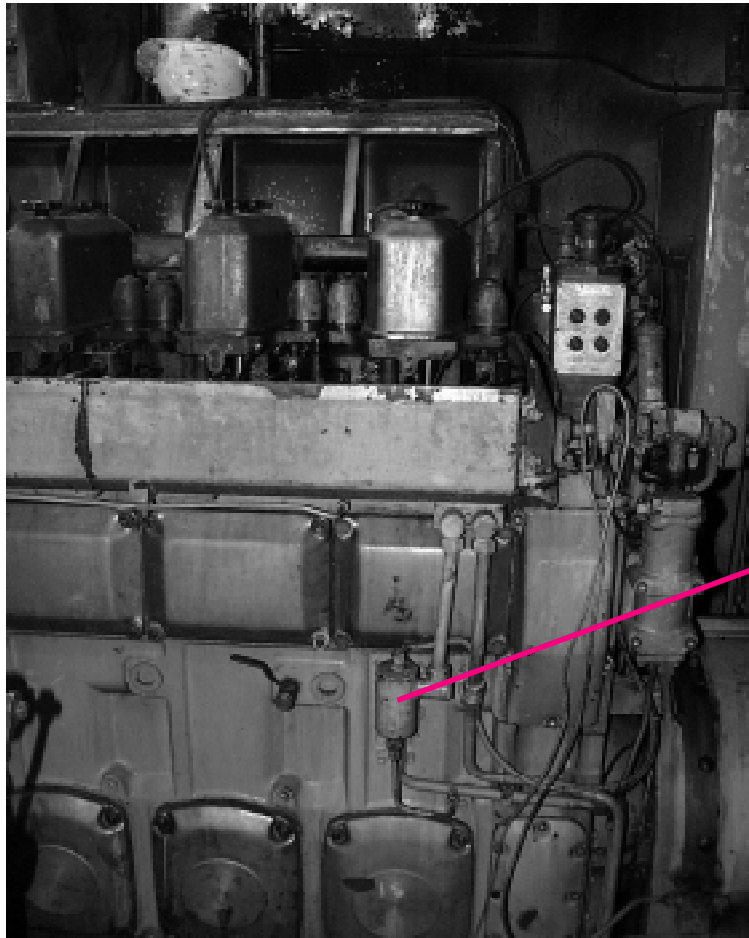
FIGURE 12

The hot box has, at each end, drains which lead down to the fuel oil drain tank. At the forward end, only, there is incorporated into the drain a fuel oil leakage alarm. (fig. 12). The leakage alarm is so designed that small amounts of fuel leakage, which may be considered normal, pass freely to the drain tank down a small pipe, connected to the main drain. However, a substantial quantity of fuel leakage will cause fuel oil to back up in the alarm chamber, thereby activating the leakage alarm.

aft end, the siting of the fuel leakage alarm at the forward end of the engine results in fuel being able to build up to a theoretical depth of approximately 40 mm at the aft end of the fuel gallery before it reaches the forward drain and the leakage alarm. It is probably for this reason that the alarm for channel 12106 'Fuel oil leakage A.E.1' (no. 1 generator) did not activate until after the fire had already started (16 seconds after the fire alarm).

It is clear that the siting of the fuel leakage alarm was overlooked when the generator sets were installed and were orientated with the drive end forward. If the leakage alarm had been correctly sited at the aft end of the engine, there is clearly a possibility that the fire may have been avoided.

Fuel oil leakage detector
