Departmental investigation  
into a fire in the  
engine room aboard  
the Australian Antarctic  
Research and Supply Vessel  
**AURORA AUSTRALIS**  
off the coast of West Australia  
on 14 January 1999

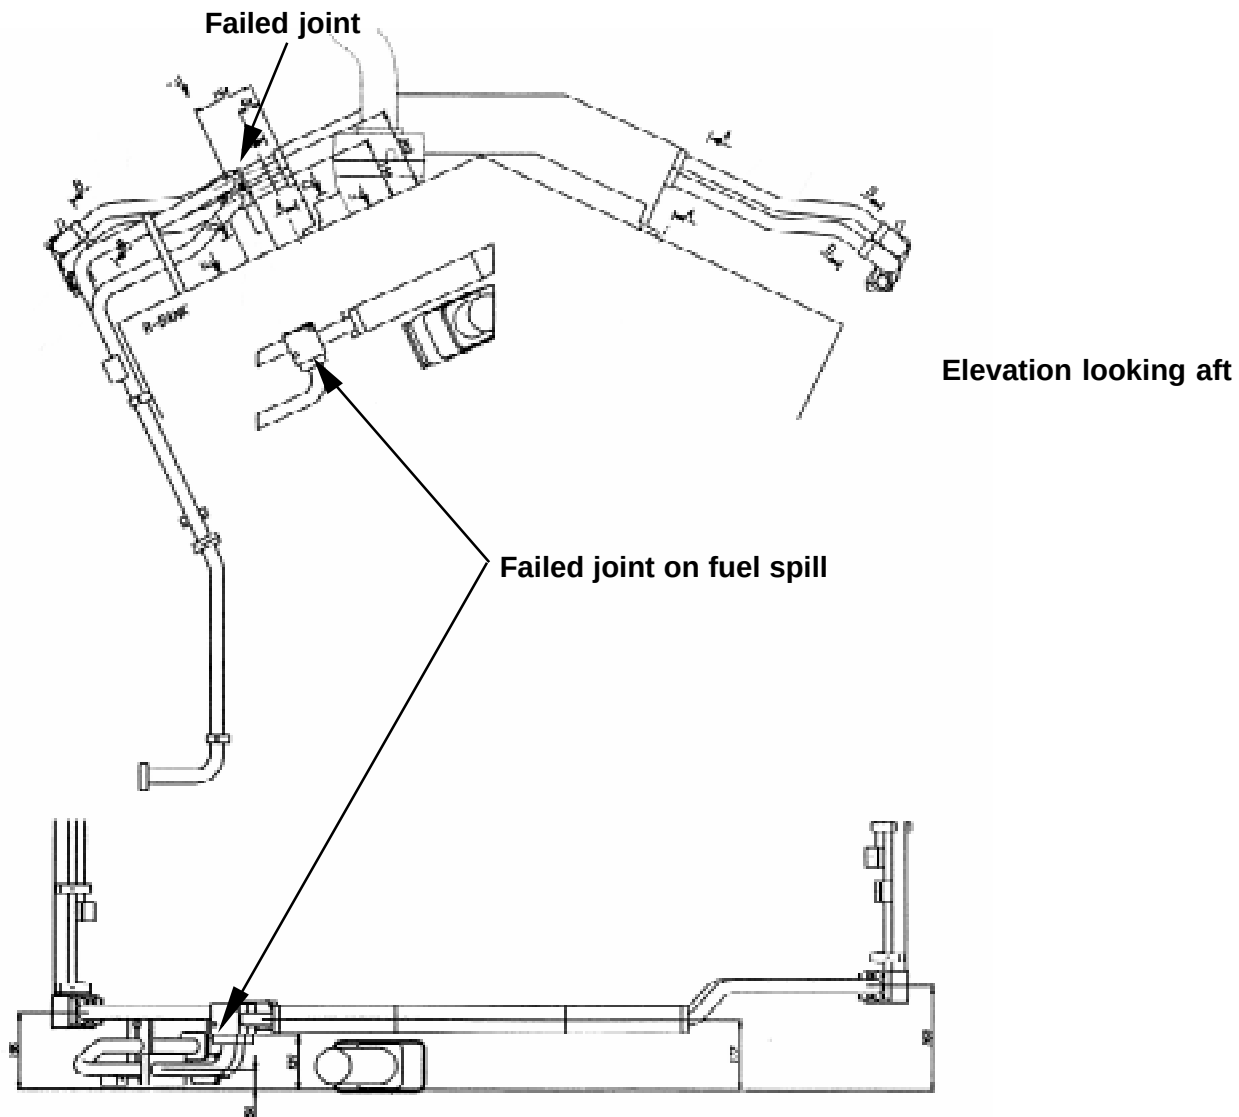
When the cover was removed, it revealed a failure of the flanged joint on the fuel return pipe, adjacent to the forward end of B bank, where it branches across the engine to the hot box of A bank. See diagram page 19. Of the four screws securing the flange, the upper two had broken, the left lower screw was quite loose and the fourth had lost its preload. The pipe had sprung and the joint had opened up about 3 mm. During the investigation the engine room staff reported that difficulty had been experienced fitting the LP fuel pipework and this is borne out by the fact that the pipe sprung when the screws failed.

Fuel supply and spill pipework at forward end of VASA 32 engine

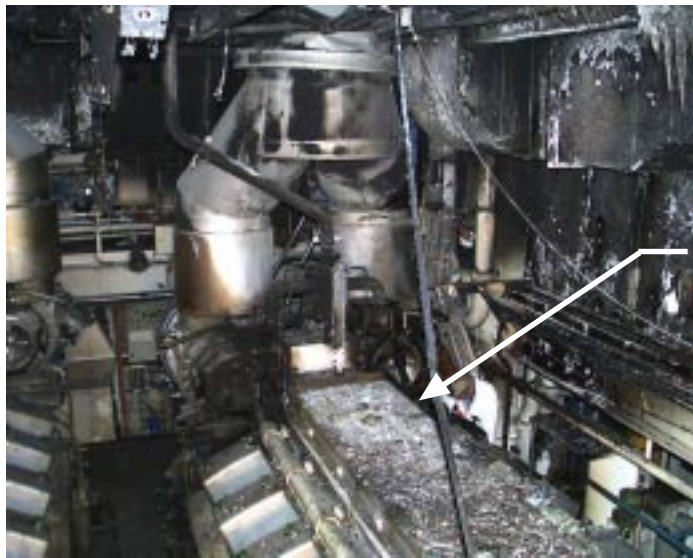
Fuel sprayed  
from this area

Fire damage around starboard main engine

Damage to the starboard main engine was limited mainly to rubber and plastic components such as cooling and vent pipes, some fittings and on-engine wiring.

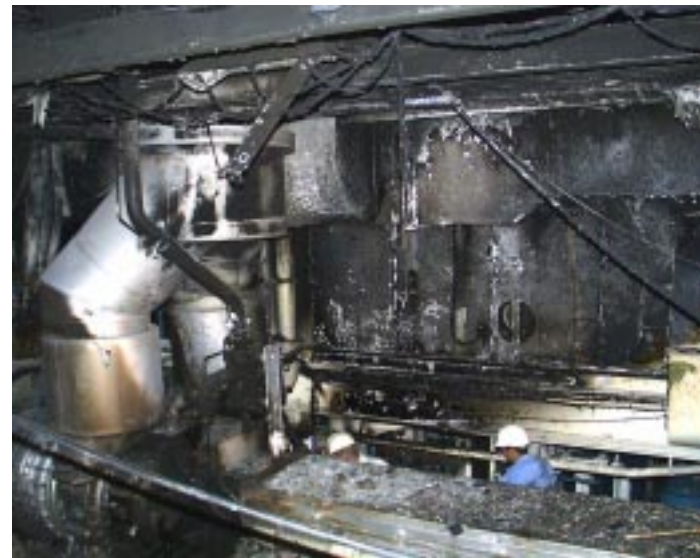
Fire damage around starboard main engine

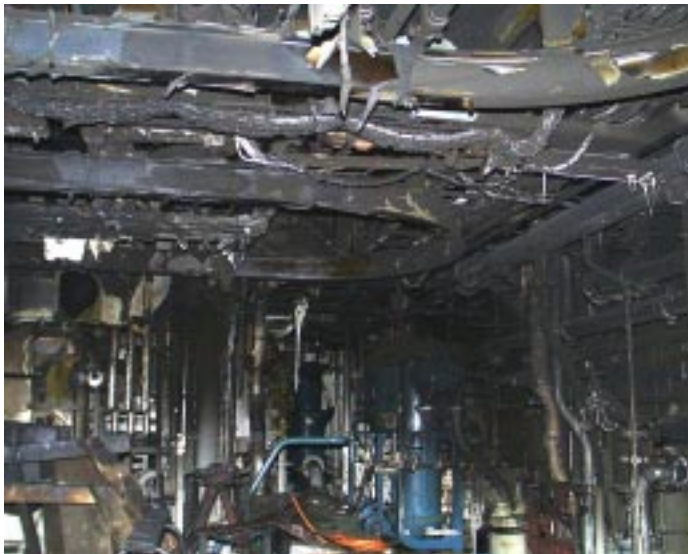
Damage to electrical cables under deckhead

It is usual, in incidents of this type, for even a relatively short-lived fire to produce enough hot gasses, which rise and become trapped against the deckhead, to rapidly cause severe heat damage to electrical cabling in cable trays. It was this effect that had caused the most serious and extensive damage. The fire damaged power cables, control and monitoring wiring and lighting throughout a large area of the engine room, both under the platform deck and the engine room deckhead. (See photos 20 ) It is also likely that charring of cable insulation caused most of the smoke which was generated during the incident.

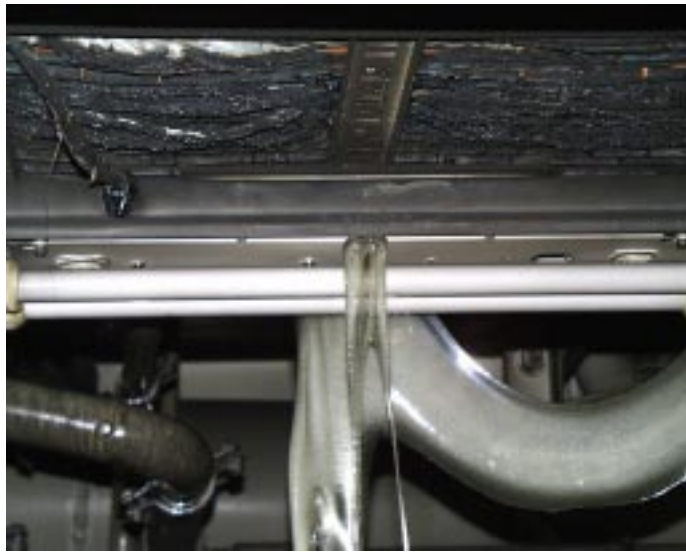
**Melted polycarbonate light diffuser**

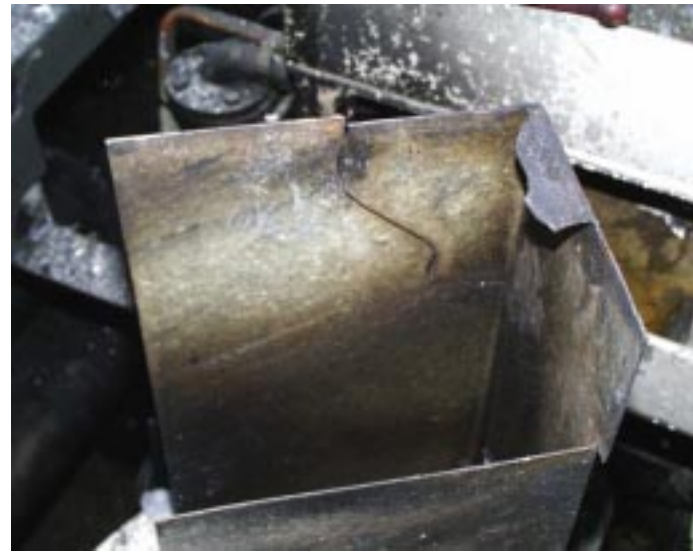
The spray of fuel was then found to have come through a narrow gap at the aft side of a sheet metal cover. The protective cover was secured over two flanged pipe joints where the low pressure (LP) fuel supply and spill pipes join the forward end of the engine. The origin of the spray, however, was still not visible from outside the engine, until the sheet metal cover had been removed. See page 21

**Damaged sheet metal cover in situ over failed joint**

**Fuel sprayed through gap here**

Wärtsilä VASA 32 engines are provided with sheet metal covers which shield the joints on the LP fuel systems outside the hot-boxes. The cover which was in place over the failed joint at the time of the fire, however, was not of Wärtsilä supply, but had been made up by shore contractors some two years earlier, as had the replacement cover adjacent to it. The cover was not a good fit, leaving a gap along the side adjacent to the engine. It was also badly cracked and had most of one end missing, the damage most likely having been caused by work-hardening from vibration. See photos, page 21

Other covers which were in place both on the starboard and the port main engines were well fitting, and showed no gaps such as existed at the aft side of the cover in question. The gap was exactly in line with the flanged joint which it was supposed to be protecting, with the result that the spray of leaking fuel issued directly through the gap.

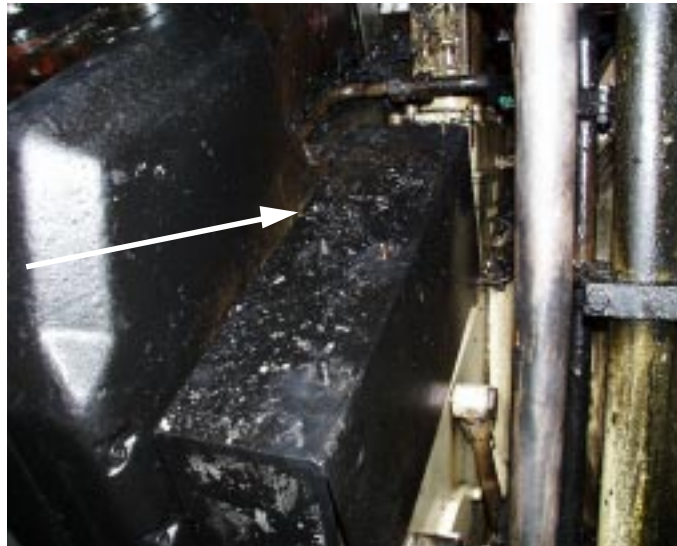
**Damaged sheet metal cover removed from engine**

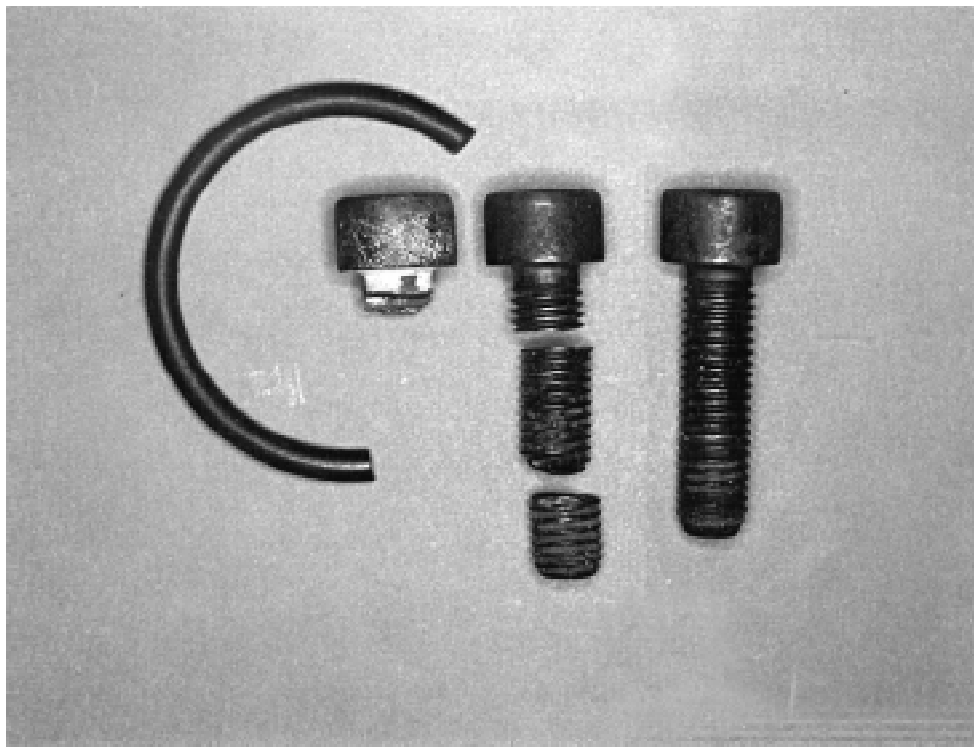
The shipowner supplied two complete screws and parts of two screws from the failed joint for metallurgical examination by ETRS. One screw head was missing. None of the three screw heads, with their small portion of attached thread, showed the reported distortion in the thread. See photos next page.

The O-ring was also examined and it was found that, as the rubber was firm with no visible degradation or cracking, it had not contributed to the failure.

**Screws and O-ring from failed flange joint, as supplied for examination**

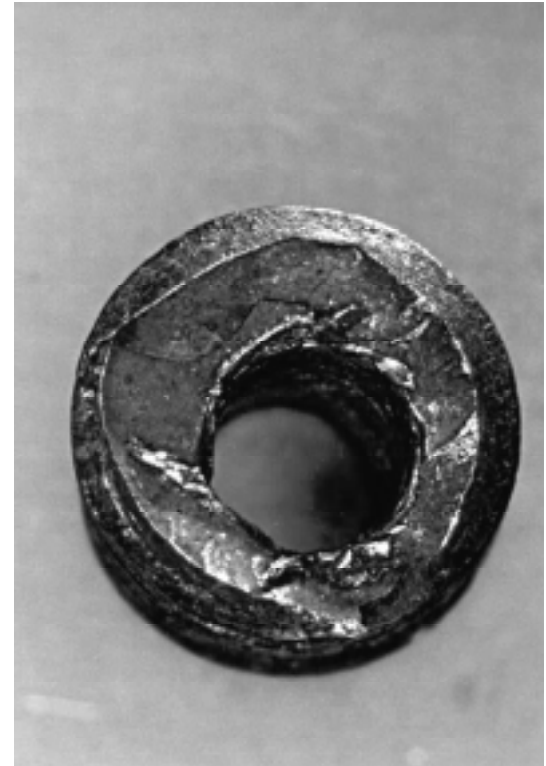
The report, commissioned by the shipowner, on the examination of the screws which were provided, contained no conclusions but in discussion stated that one screw, which had failed in high-cycle, low-stress, fatigue, had failed first. The other screw had started to fail in fatigue, but when the first had failed, this one had then suffered a fast fracture. The two intact screws from the flange showed no sign of over-tightening or fatigue.

**Fracture surface of one of the failed screws (drilled for removal from tapped hole)**
