**Departmental investigation
into the collision
involving the
Taiwanese bulk carrier
Cemtex General
and the fishing vessel
Tina
30 miles east of
Noosa Head
on 2 February 1999**

Navigation Act 1912 Navigation (Marine Casualty) Regulations
into the collision involving the Taiwanese bulk carrier
Cemtex General and the fishing vessel *Tina*
30 miles east of Noosa Head on 2 February 1999

Published: December 1999

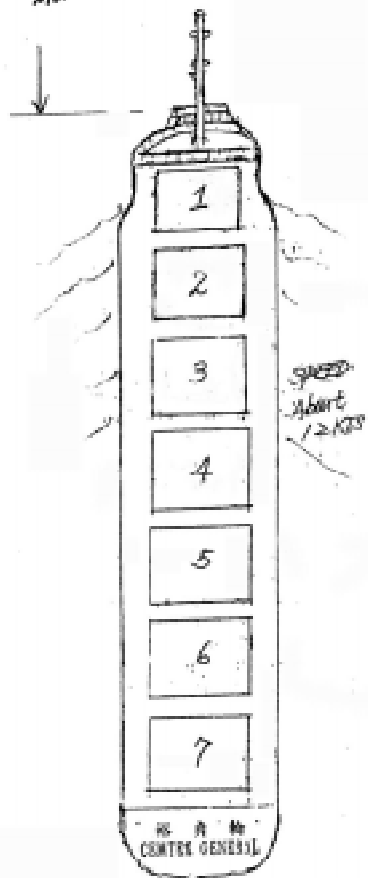
Diagram 1
About 300 mtr

The master sent the telex report to AusSAR before entering data for the next day's telex. He then went to the forward bridge windows from where he noticed a small boat, the fishing vessel *Tina*, almost ahead and close to the ship. The ship's heading was 358° (gyro), the boat was bearing about 350° or 345°, about 10° on the port bow and about 300 m off.

Master's sketch showing both vessels when fishing boat was first sighted

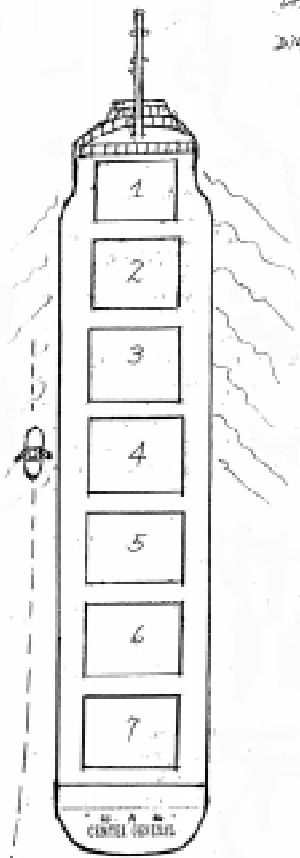
350°
DATE 2/2/1997
Diagram 2

Master's sketch of both vessels just prior to collision

saw the relative positions of the two vessels he realised that they would survive. Nevertheless, he was apprehensive as the starboard boom of the fishing vessel scraped along the ship's hull. He feared that *Tina* would be dragged by the ship if the boom was caught on the ship's rails. This did not happen and the trawler was pushed off the side of the ship by the boom as the ship went past. The boom was damaged by the impact.

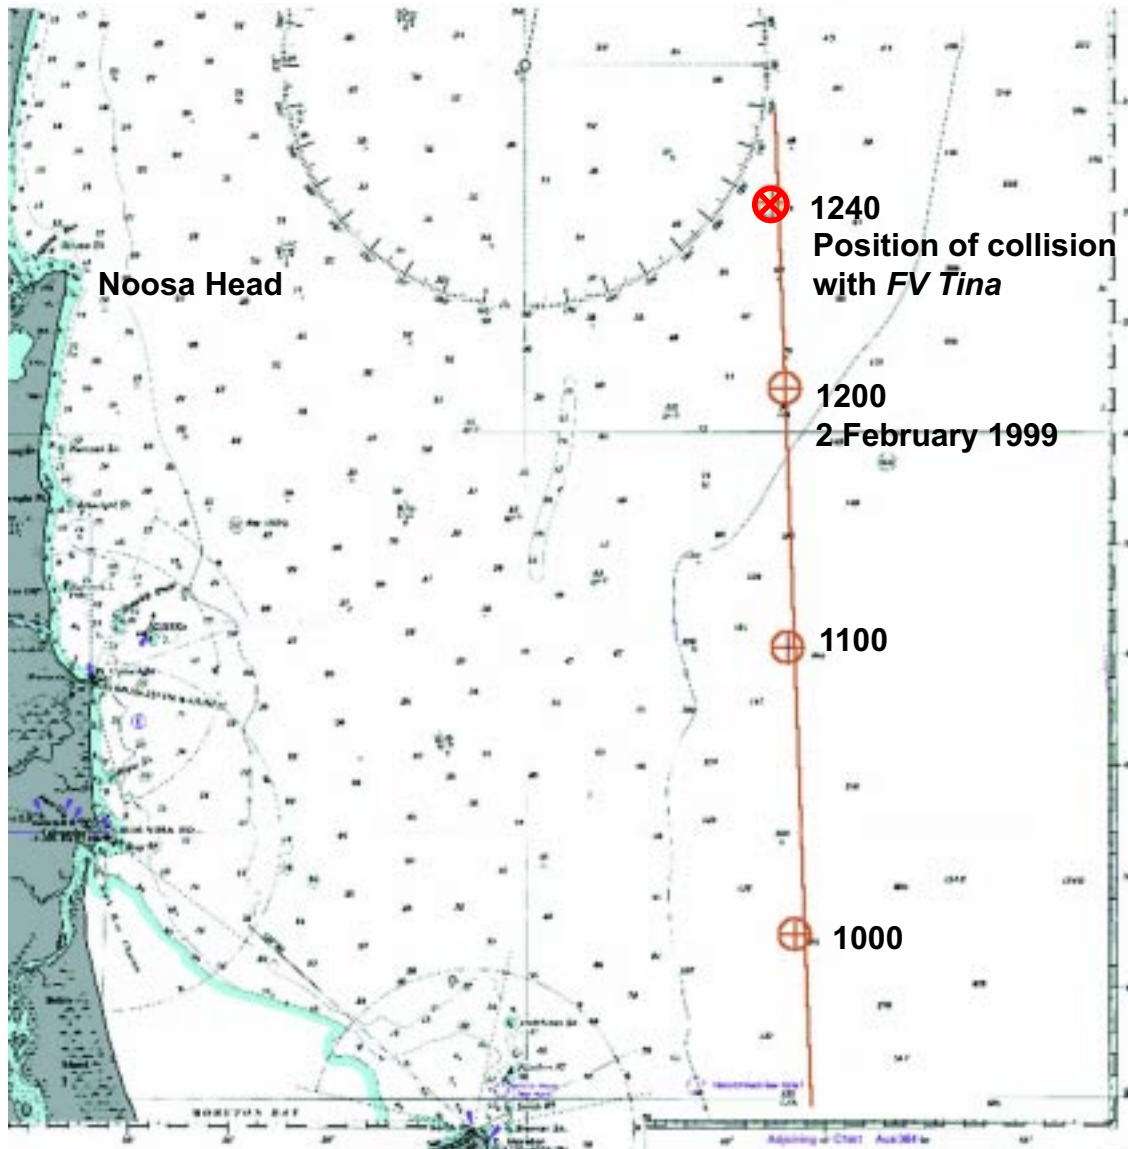
Portion of chart Aus 365 showing *Cemtex General's* track
