Report No 146

investigation into the near collision

*Olympic Symphony*

Australian Transport Safety Bureau

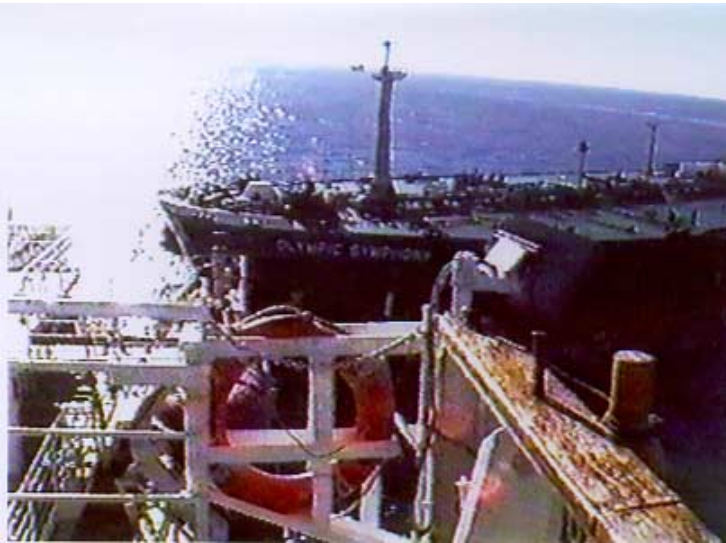
*Olympic Symphony approaching Proliv Sannikova*

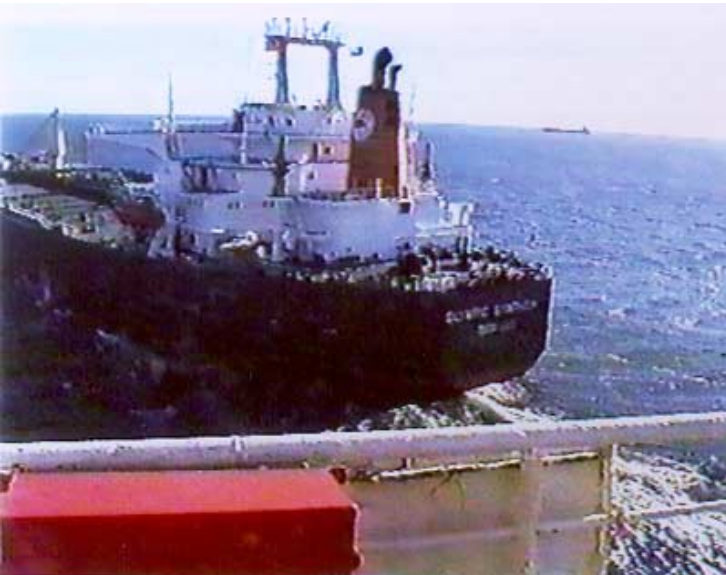
*Olympic Symphony clear of Proliv Sannikova*

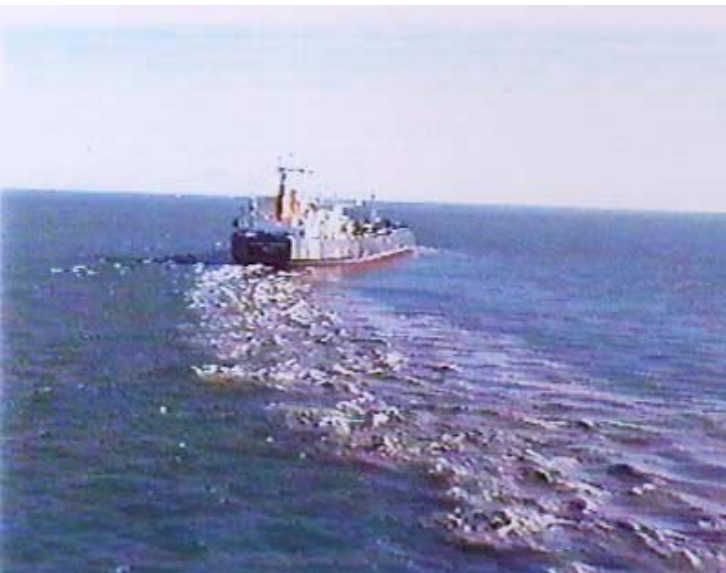
*Olympic Symphony in shallows*

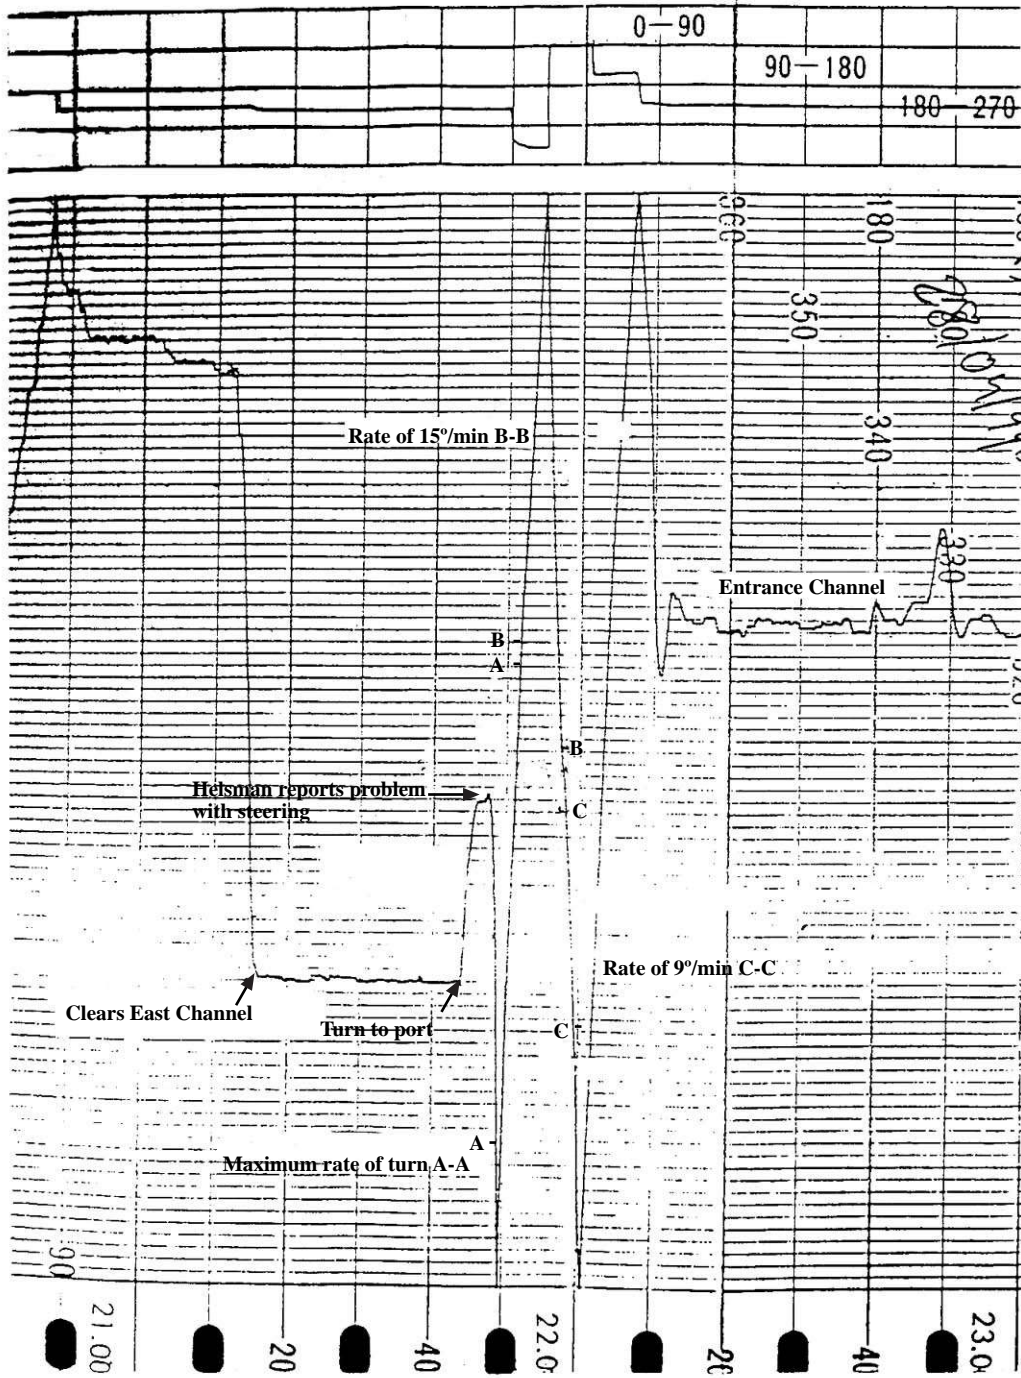
FIGURE 4  
*Olympic Symphony* - course recorder chart

The deck log recorded that, at 0755, the course was altered to 230°, then 220° and 215°(T). However, the course recorder trace indicates that the course was altered from 245° to 230° and that just after this, the steering failed (Fig. 4, pg.10).

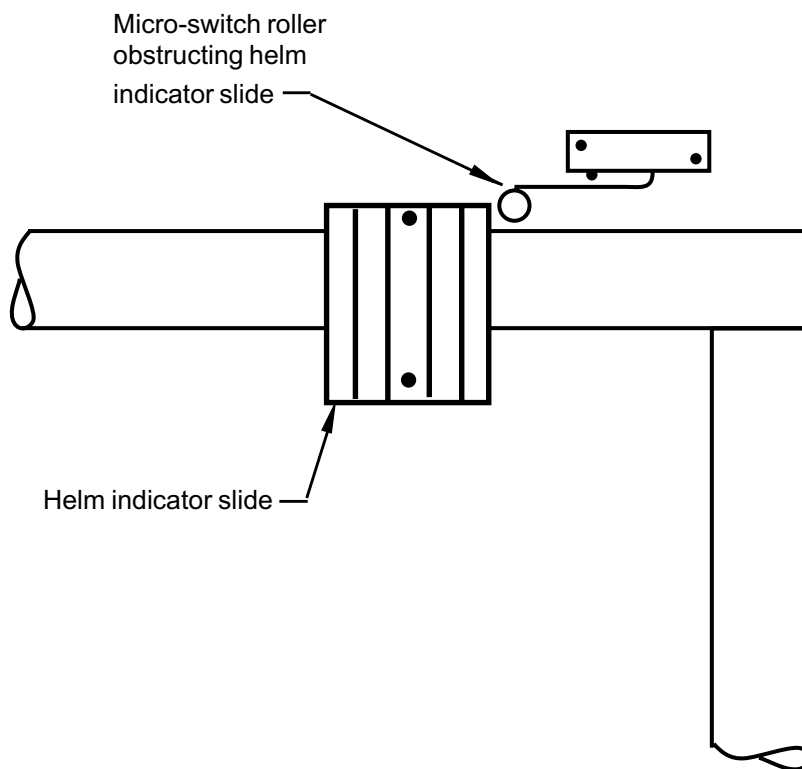
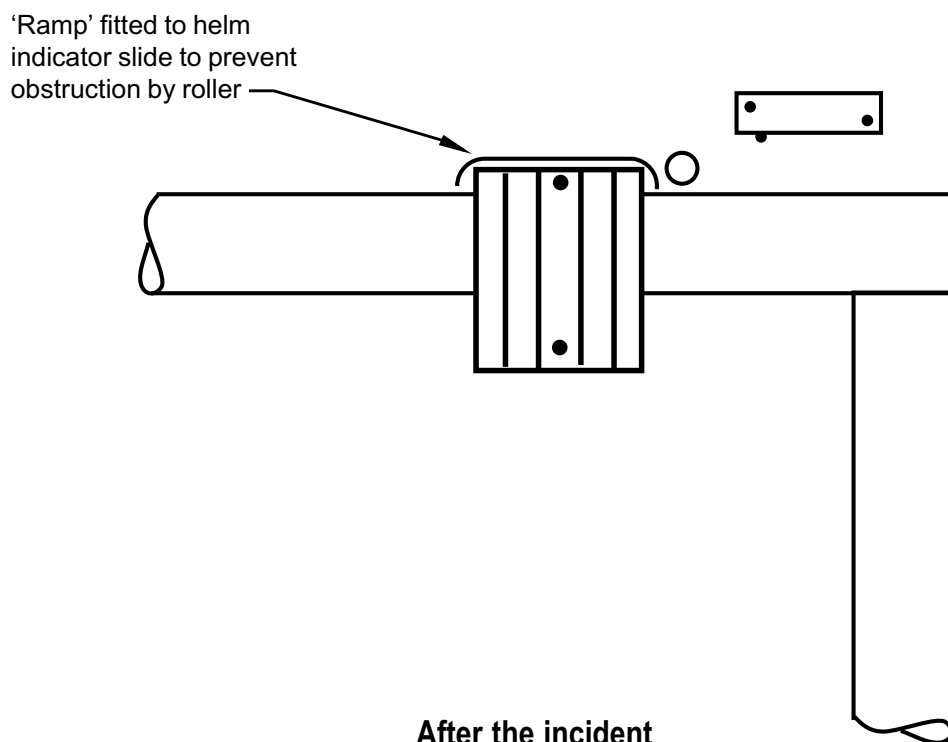
FIGURE 5

The technician also determined that the micro-switch roller for the 'helm off midships' alarm had jammed the helm indicator slide. The micro-switch roller was supposed to ride over the helm indicator slide (Fig. 5, pg14). No problems had been experienced earlier with the steering but on this occasion, as the vessel approached the entrance beacons on manual steering, the micro-switch roller failed to ride over the helm indicator slide. In doing this, it prevented the helm indicator slide from moving further to port than 5° to starboard. This then restricted rudder movements to angles between 5° to starboard and hard to starboard.

The only evidence of the cause of the failure was the micro-switch. The rudder should have been able to move to starboard from 5° to starboard at all times. There is no explanation for the pilot's recall that the rudder initially seemed locked at 5° to starboard.

**Micro-switch roller and helm indicator slide (not to scale)**

**Prior to incident**

**After the incident**

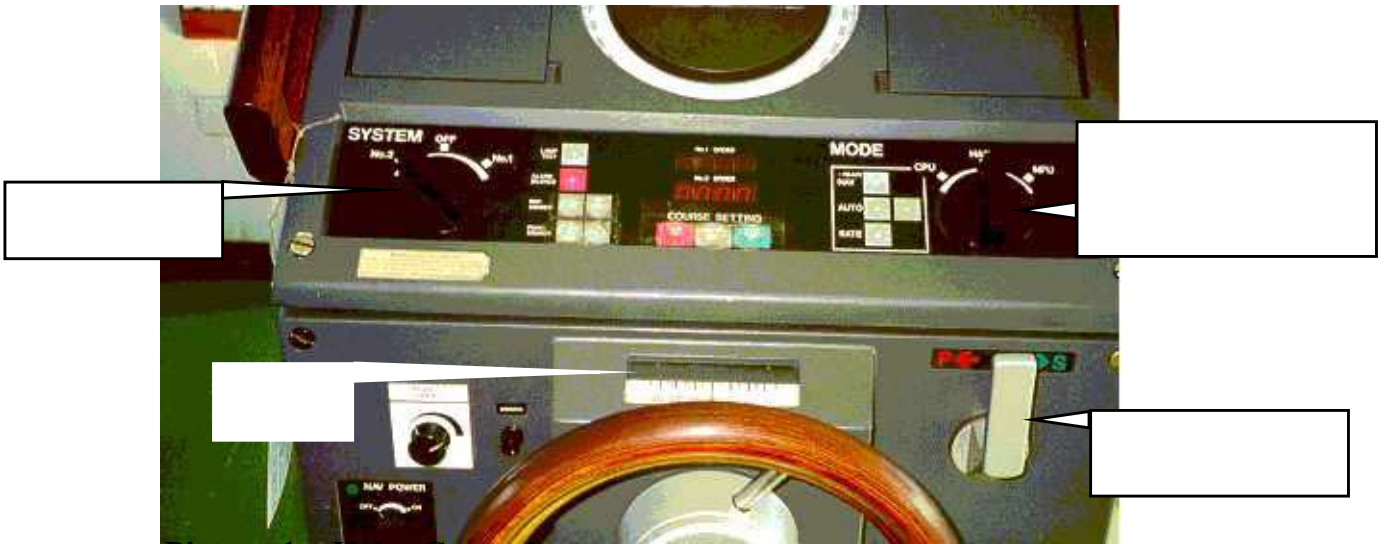
**Picture 1 – Helm Controls**

2. During and after malfunction, no attempts were made to changeover either between systems or to non follow-up steering with the changeover switches on the helm console (See picture 1, below).
3. Berthing was completed in the same mode of steering as that in which the malfunction occurred. Despite no cause for the malfunction being established.

1. Reported failure of helm order indicator to move when steering wheel was moved indicates possible failure of helm unit. Recommend unit be inspected by technician to ensure correct operation – AMSA to be shown copy of service report.
2. Recommend helmsman be trained in emergency steering procedures.

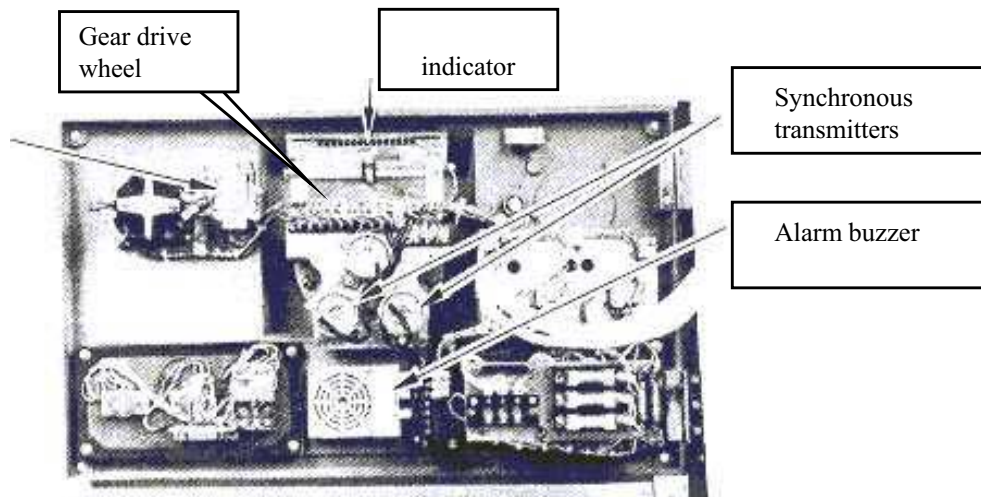
**Picture 2 – Back of helm unit panel**

Copy of technician's report is appended. In summary he found that a "helm off centre" alarm had been retrofitted to the unit; not by the manufacturer. This alarm consisted of a microswitch, which was activated by the helm order indicator pointer when in the centre position. When the malfunction occurred the switch presumably had moved into a position which prevented the movement of the pointer back to the centre position. As the pointer is geared into the synchro drives these also could not move. The wheel could still turn due to the friction clutch slipping. The problem was rectified as per the technician's report.
