Departmental investigation into
the grounding of the Panama flag
general cargo ship
NEW REACH
on Heath Reef,
Great Barrier Reef
on 17 May 1999

Navigation Act 1912 Navigation (Marine Casualty) Regulations investigation into the grounding of the Panama flag general cargo ship NEW REACH

On Heath Reef, Great Barrier Reef on 17 may 1999

Published: October 1999

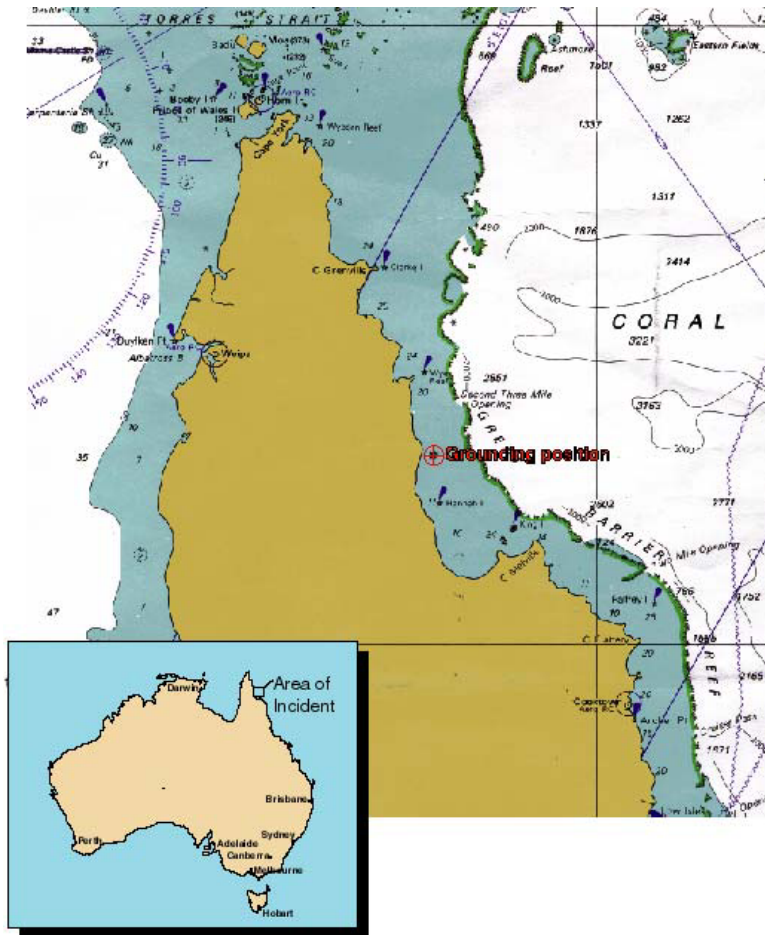
Portion of chart Aus 835 showing grounding position

Examination of the site of the grounding by officers of the Great Barrier Reef Marine Park Authority gave an uncorrected GPS position for the centreline of the grounding site as 13°28.72' S 143° 40.73' E. *New Reach* scoured an area of over 2000 m² of coral pushing the coral into two mounds, the larger being on the west side of the grounding site. The area of this site is consistent with the ship being aground from the stem to about 70 m from the stern.

Both the position and alignment of the grounding site as surveyed by the Authority are consistent with those reported by the pilot and recorded in the ship's records.

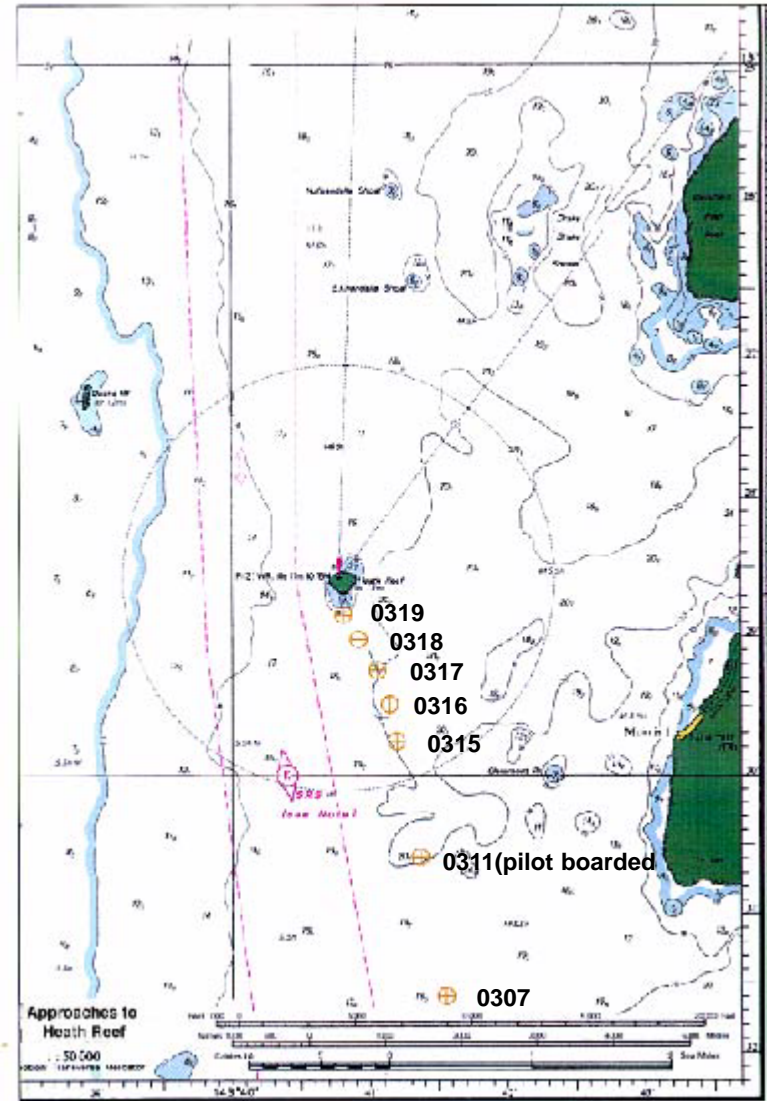
Portion of chart Aus 834 showing track of New Reach

After passing Fife Reef, the 2nd mate fixed the ship's position on two occasions. At 0249, the position plot put the ship 0.45 nm east of the course line. At 0307, the position was 0.55 nm to the east of the course line. The course made good between the two positions was about 350½°. On neither occasion did the 2nd mate draw the position of the ship to the pilot's attention.

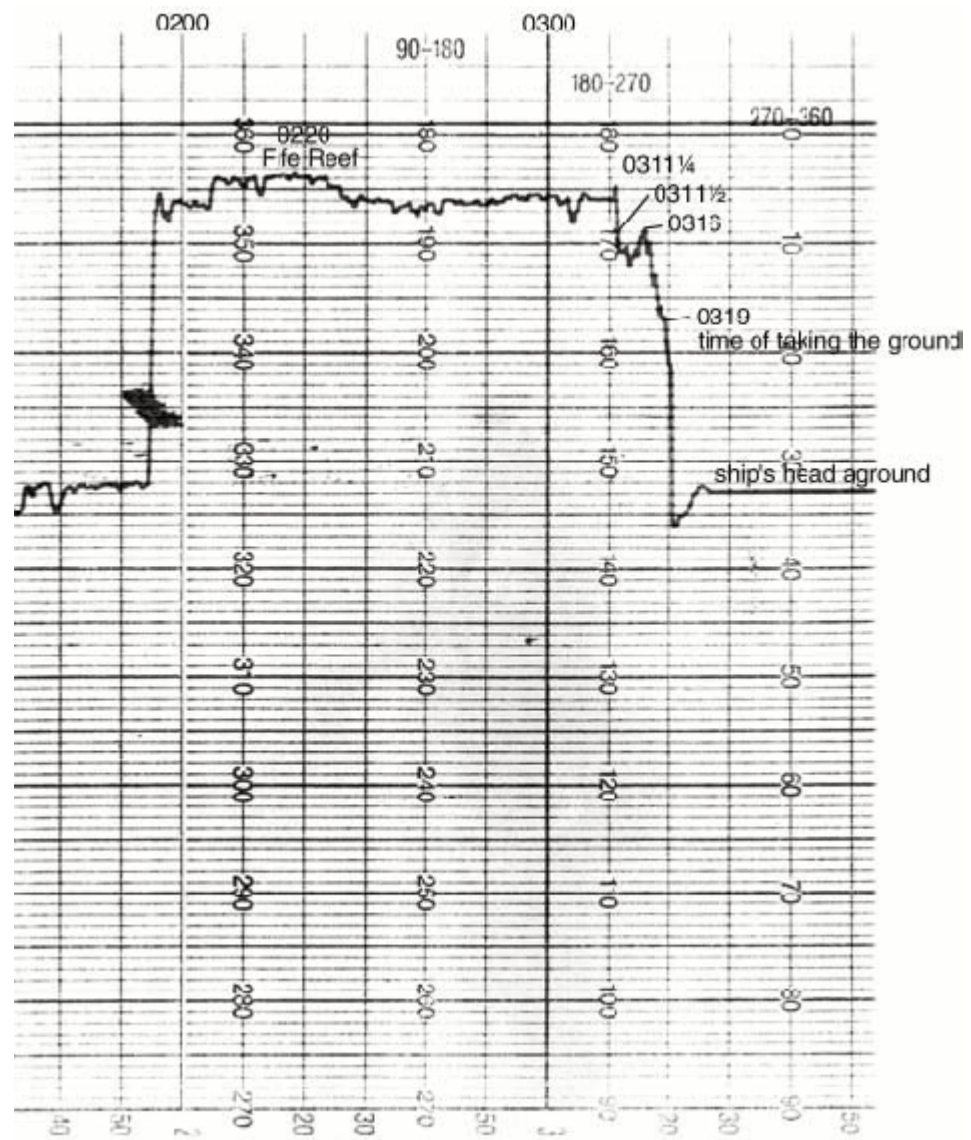
Section of course recorder Fife Reef to grounding

When the pilot realised the ship was out of position he altered course to port to pass on the west side of Heath Reef as originally planned. The course recorder showed an alteration of course at 0311¼ of 4° to port to a gyro heading of 350° (347°T). The duration of the conversation between the pilot and Reef Centre was one minute and 24 seconds. This would suggest that the 2nd mate touched the pilot's shoulder to alert him to Reef Centre between 0309½ and 0310, when the ship was 2.24 nm (about 4200 m) from the shoal water to the south of Heath Reef.

At 0310 the ship was travelling 426 m/min (13.8 knots or 7.09 m/sec) and was about nine minutes from grounding. Having been steady on a course for 4½ minutes, from 0311½ to 0316 the pilot ordered alterations of course, initially to 346° and then 343°. As the vessel reached a heading of 343° at 0319 the vessel took the ground. The *New Reach* had been turning at a rate of 2.6°/min.

By the time *New Reach* had reached a heading of 344°, looking at the radar screen and the signal return from the reef-edge, it probably seemed to the pilot that the ship would just clear the reef. Also, by 0318, Heath Reef light was to starboard of the forward derrick post and the bearing would have been opening. However, the shoal water to the south of Heath Reef extends 200 m below the surface and it was on this that the ship grounded.

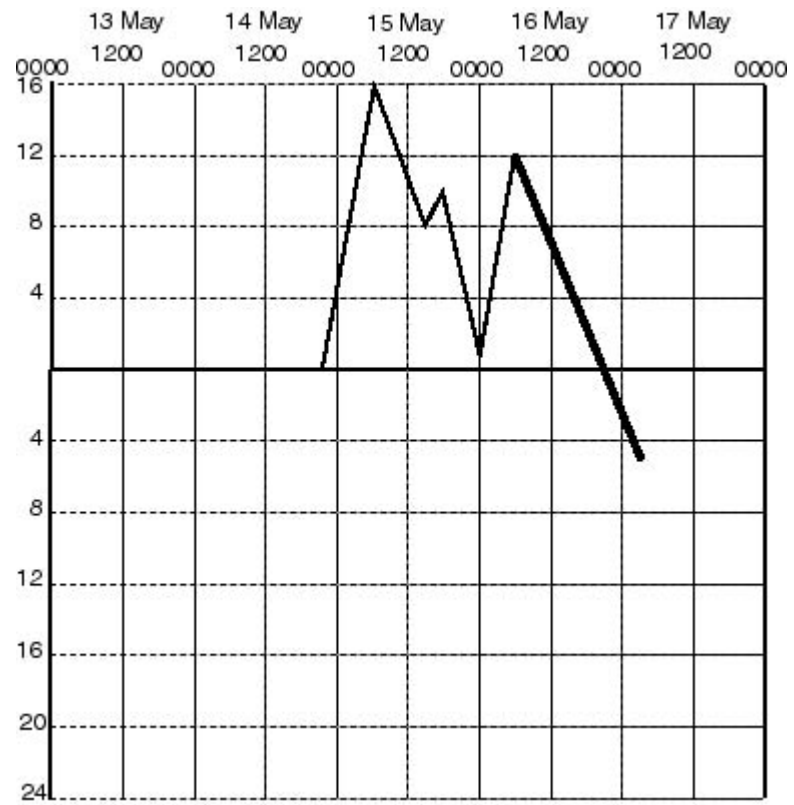
Pilot's sleep credit-deficit chart (assuming nil deficit 2200 on 14 May)

The pilot's actions or omissions strongly suggest that his performance was affected by fatigue. He had unintentionally fallen asleep after Fife Reef (at a time of reduced circadian activity). Although he had been woken in ample time to take action to avoid the grounding and despite the fact that the pilot knew *New Reach* was out of position, he did not establish the ship's position. Also, he was unable to manipulate the radar controls to display parallel index lines, although he had been using the controls regularly since boarding the
