**Departmental investigation
the release of oil from the
Italian flag motor tanker
LAURA D'AMATO
at Gore Bay, Sydney Harbour
on 3 August 1999**

Navigation Act 1912
Navigation (Marine Casualty) Regulations
investigation into
the release of oil from the
Italian flag motor tanker
Laura D'Amato
at Gore Bay, Sydney Harbour
on 3 August 1999

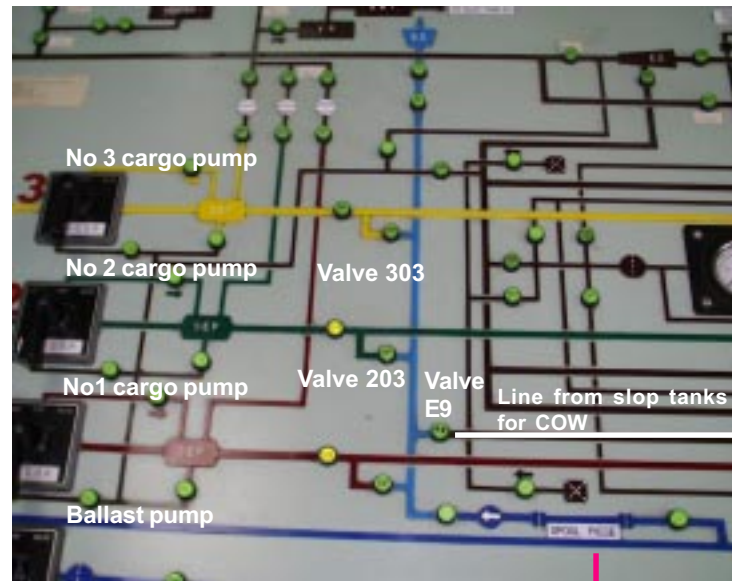
FIGURE 2
Section of *Laura D'Amato* cargo system schematic

There is no dispute that the oil that polluted Sydney Harbour on 3 August 1999 escaped through the sea-chest valves on the port side of *Laura D'Amato's* pumproom. The two sea valves were open and when the sea suction line was used as a crossover between the yellow (no. 3) line and the green (no. 2) pump, oil escaped to the sea. There was no mechanical or equipment system failure that could explain why the valves were open. The two valves had to have been opened either when the ship was alongside in Gore Bay, or open before the ship arrived.

73/78. In submission, the ship managers emphasised the point that the crossover arrangement conformed to the rules and was an arrangement found on new and existing tankers (submission page 29). A section of *Laura D'Amato's* cargo piping system line diagram is shown in fig.2.

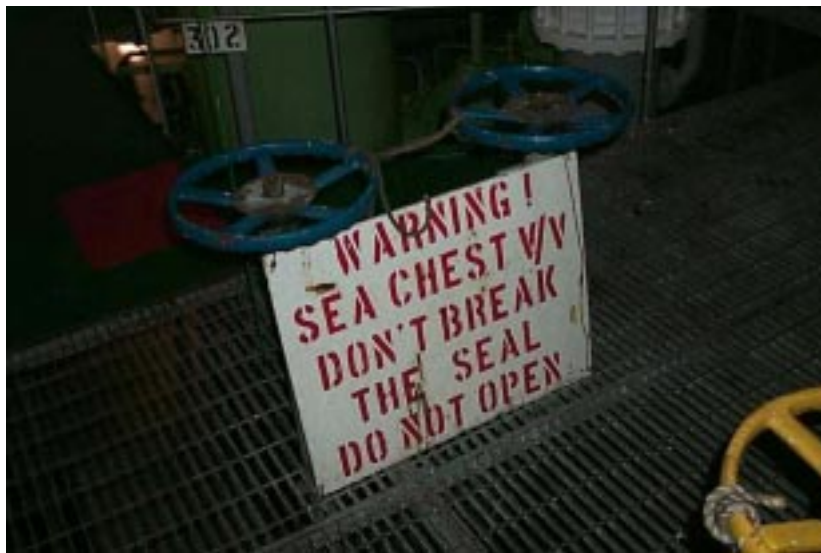
The mate and pumpman again tried to close the valves by hand and found that the valves were jammed hard open on their seats. The two men finally managed to close the valves with the aid of a large wheel key. In the process of closing the valves, the seals placed between the hand wheels by the cargo surveyors were broken.

Figure 4
Laura D'Amato's sea-chest valve actuating handwheels

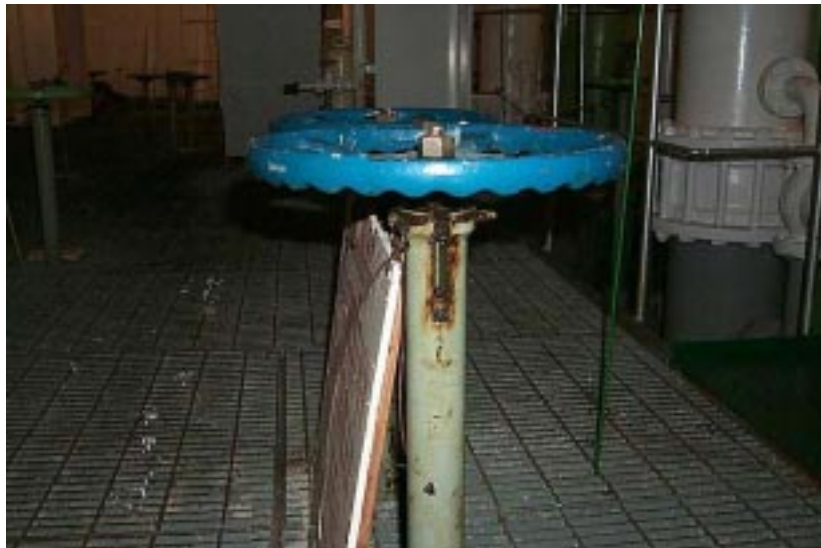
Figure 5
Sea-chest valve spindles showing position indicator

As the sea-chest valves were manually actuated, there was no automatic indication in the control room. Given the importance of these valves and the age of the ship, the lack of such an indication seems to be something of a deficiency in the system.

In submission, the ship managers noted that automatic indicators were not commonly fitted to manual operating valves. In researching the issue, they could find only one instance of a similar incident. However, they noted that such a modification was relatively simple and that installation of such a system was under review.

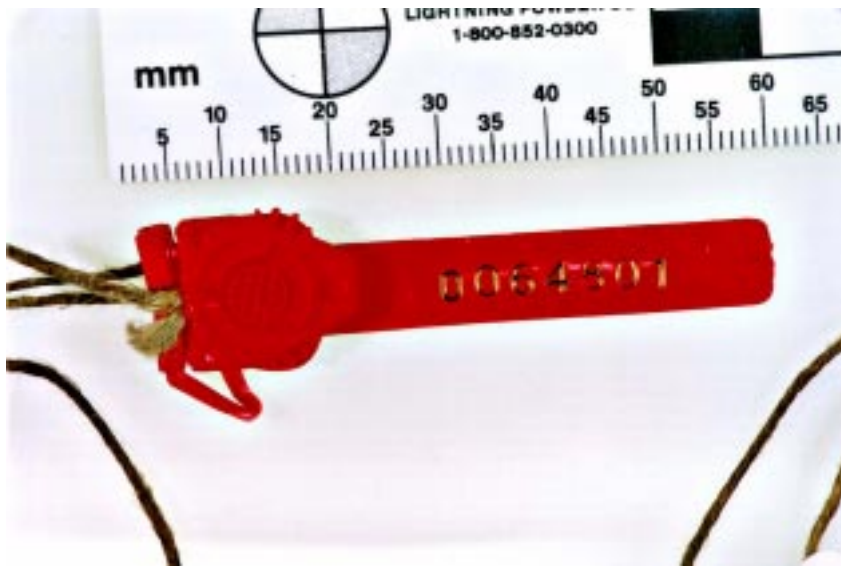
Figure 6
Sea-chest valve seal placed while in Barrow Island

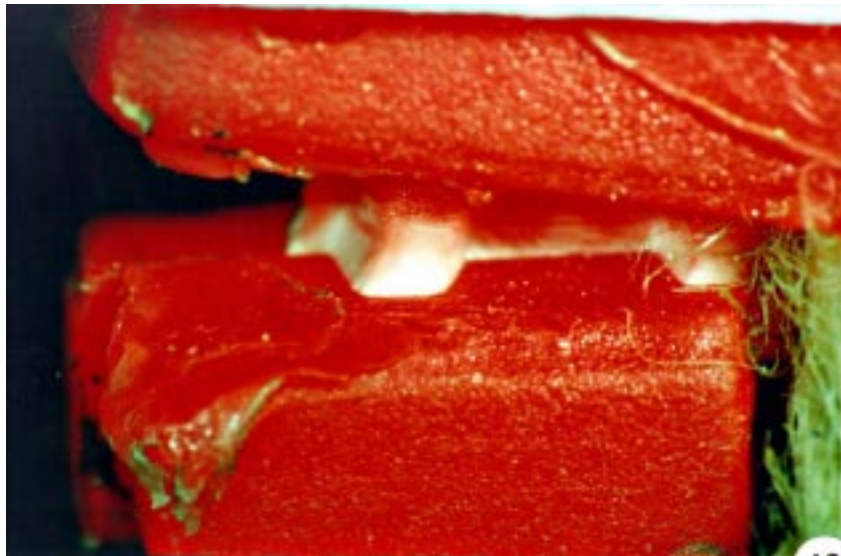
Figure 7
Macro examination of seal no. 0064801 showing tamper damage

- 1) The plastic seals had been tampered with (forced open and reassembled).
- 2) The twine had been cut and rejoined in some way.
- 3) The twine had been broken by being stressed—pulled apart.
