MARINE SAFETY INVESTIGATION  
REPORT 150

Independent investigation into the shift of  
cargo aboard the general cargo vessel

# Sun Breeze

off the West Australian port of Bunbury  
21 August 1999

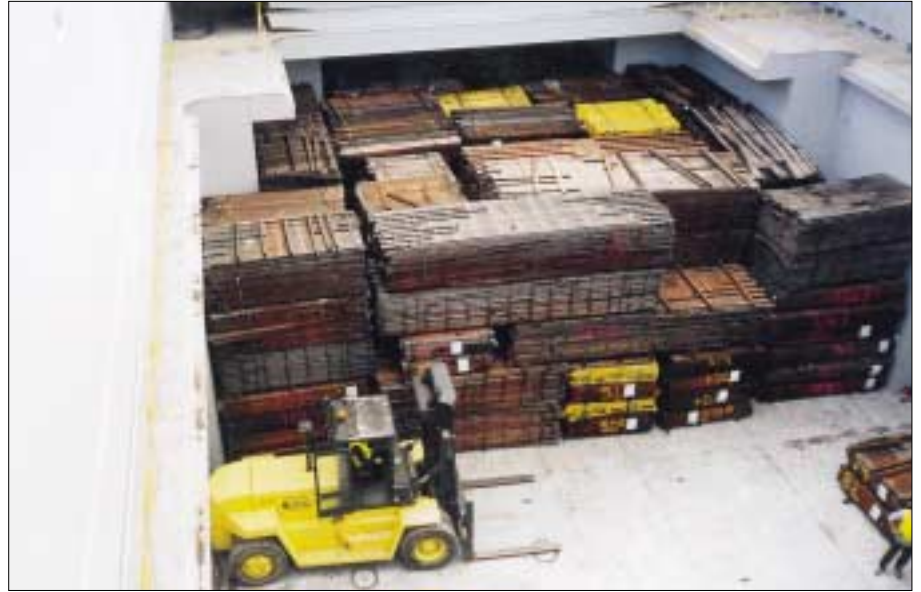
**Figure 3:**  
Initial stow in lower hold  
showing broken stowage

While the lower holds were being loaded, the 3<sup>rd</sup> mate noticed that the stow was not tight. He informed the mate that there was broken stowage and the mate took up the matter with the stevedores. However, the cargo in the lower holds was not chocked or secured to prevent movement in a seaway.

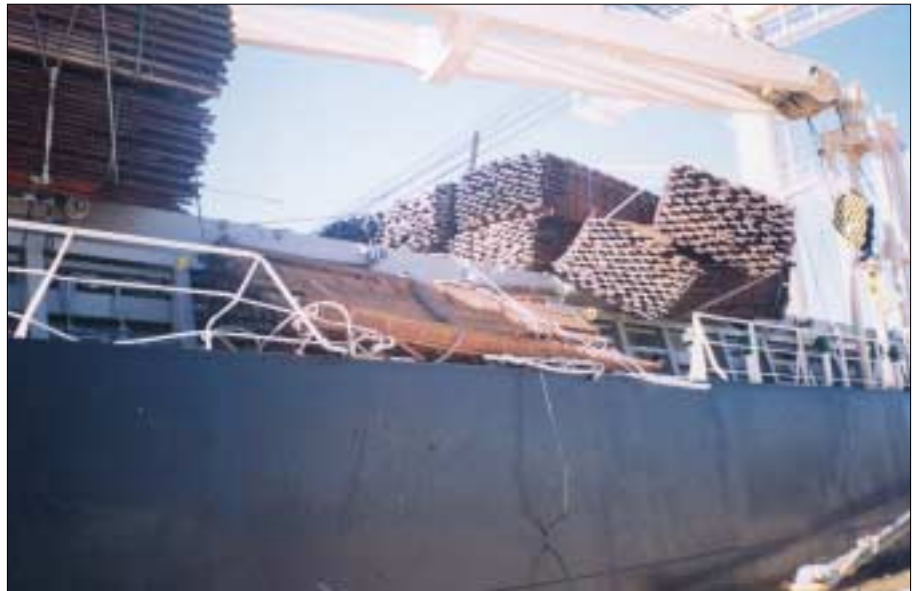
**Figure 4:**  
Deck cargo shown after shifting

The vessel berthed again at Bunbury, where it was found that the timber stacks in the lower holds and tween decks had leaned over to starboard, coming to rest against the ship's side. The cargo on the hatch tops was discharged, after which the hatches were opened. Some packs of timber were opened and the contents stowed in the tween decks to fill existing gaps. The stow in the lower holds was chocked off. When the stow in the tween decks was secure, the hatches were

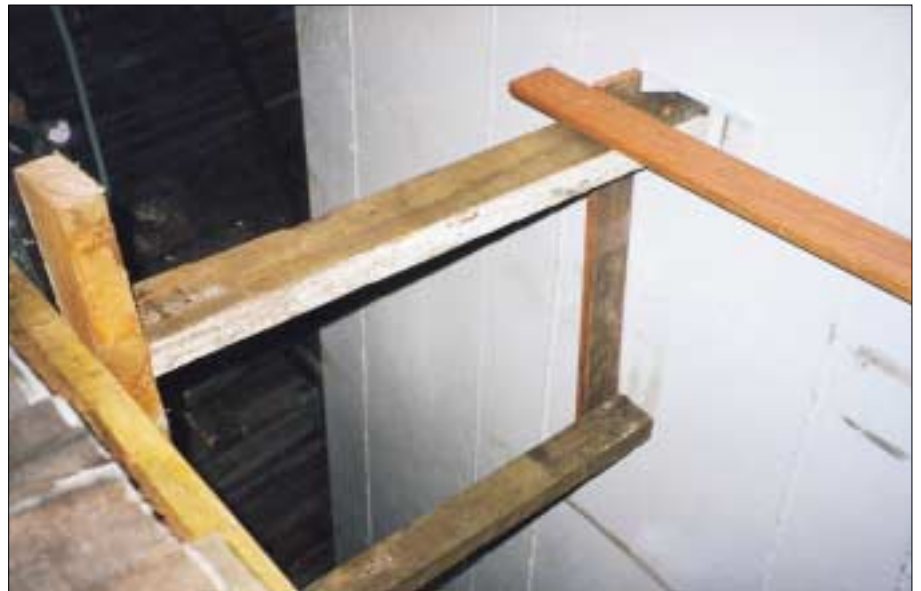
**Figure 5:**  
Lower hold cargo secured after  
incident

After the incident, when the vessel returned to the berth at Bunbury, the cargo was found to have moved through a distance estimated to be about half a metre in the lower holds and about a quarter of a metre in the tween decks.

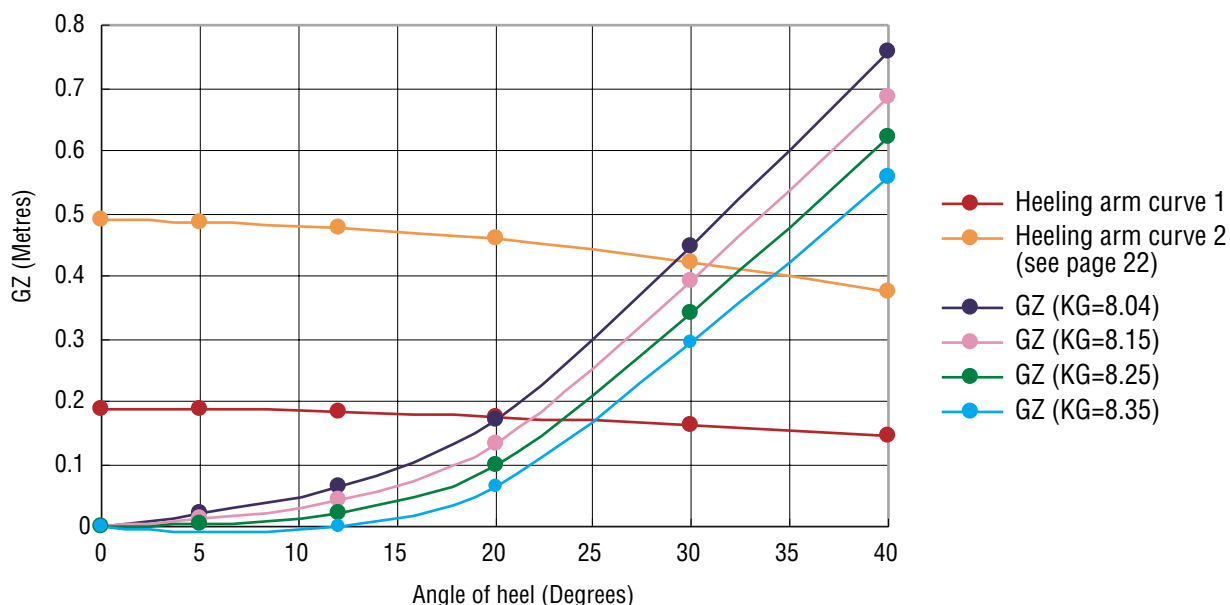
#### GZ and heeling arm curves

The estimated shift of cargo was considered to be reasonably accurate and additional GZ curves were plotted for GM values of 10 cm, nil and -10 cm. The heeling arm curve was found to cut the latter at 25°.

If the vessel had listed to a maximum of 26° as indicated by the inclinometer, the fact that the heeling arm curve cut the GZ curve drawn for a GM of –10 cm at 25°, could indicate that the vessel had negative GM at sailing.

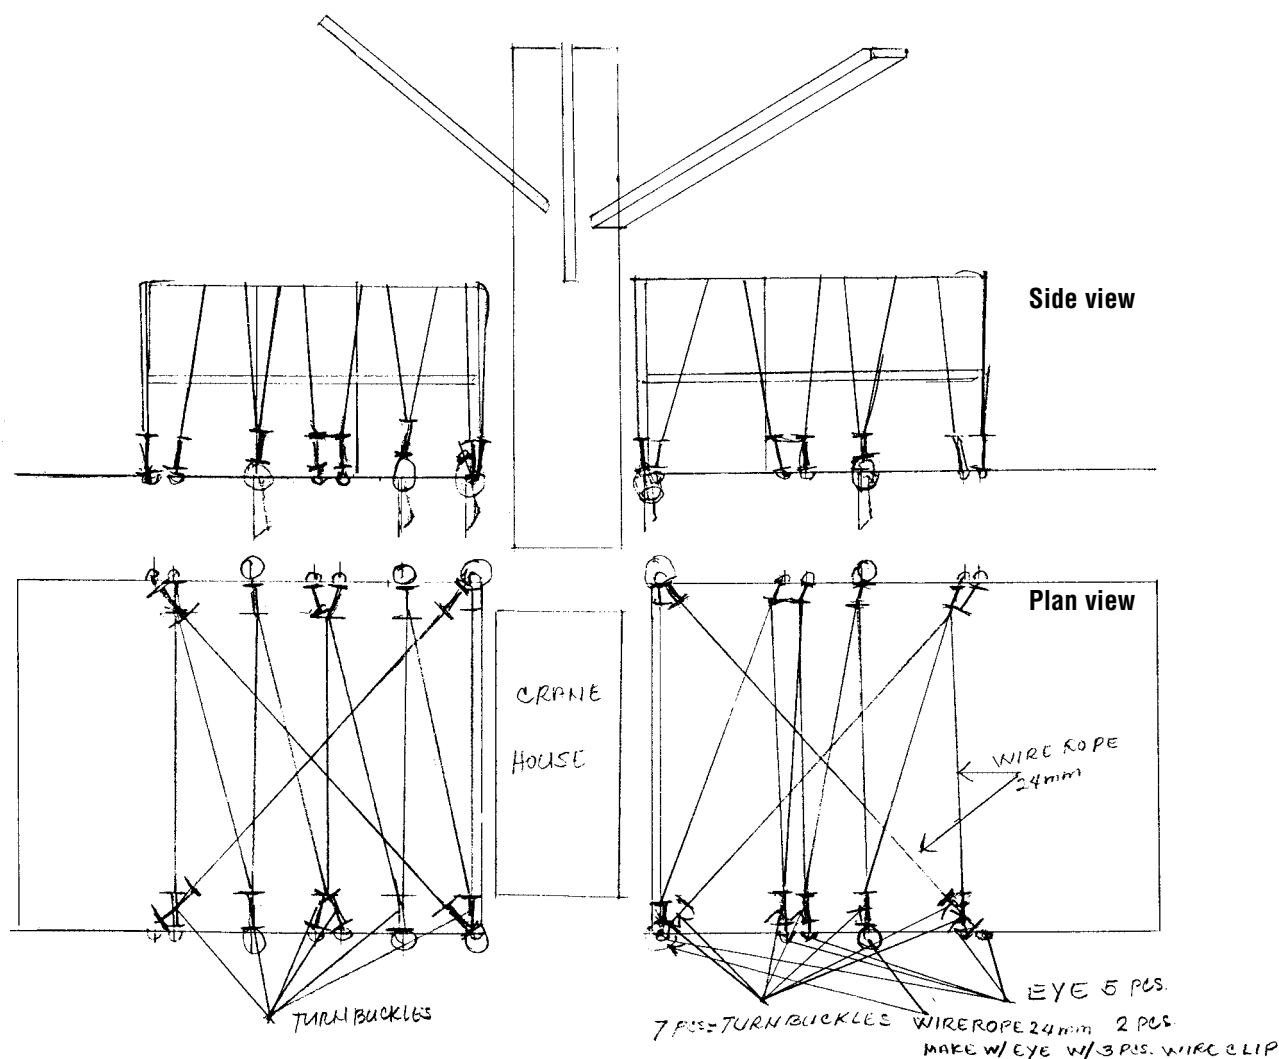
**Figure 7:**  
Mate's sketch of deck cargo lashings

An AMSA surveyor attended the vessel immediately after the incident and noted that some lashings had insufficient clips on them, also that a number of wire clips had U-bolts fitted to the live load segment. He noted, too, that a number of nuts that should have been used to tighten the bolts appeared to have been left slack, resulting in the lashings opening and releasing cargo overboard.

The Code of Safe Practice for Ships carrying Timber Deck Cargoes recommends that where wire rope clips are used to join wire ropes,

- the number and size of clips should be in proportion to the diameter of the wire rope and should not be less than four at 15 cm intervals

- the saddle portion of the clip should be applied to the live load segment and the U- bolt to the dead or shortened end segment
- rope clips should be tightened so they visibly penetrate into the wire and be re-tightened after the lashing has been stressed.

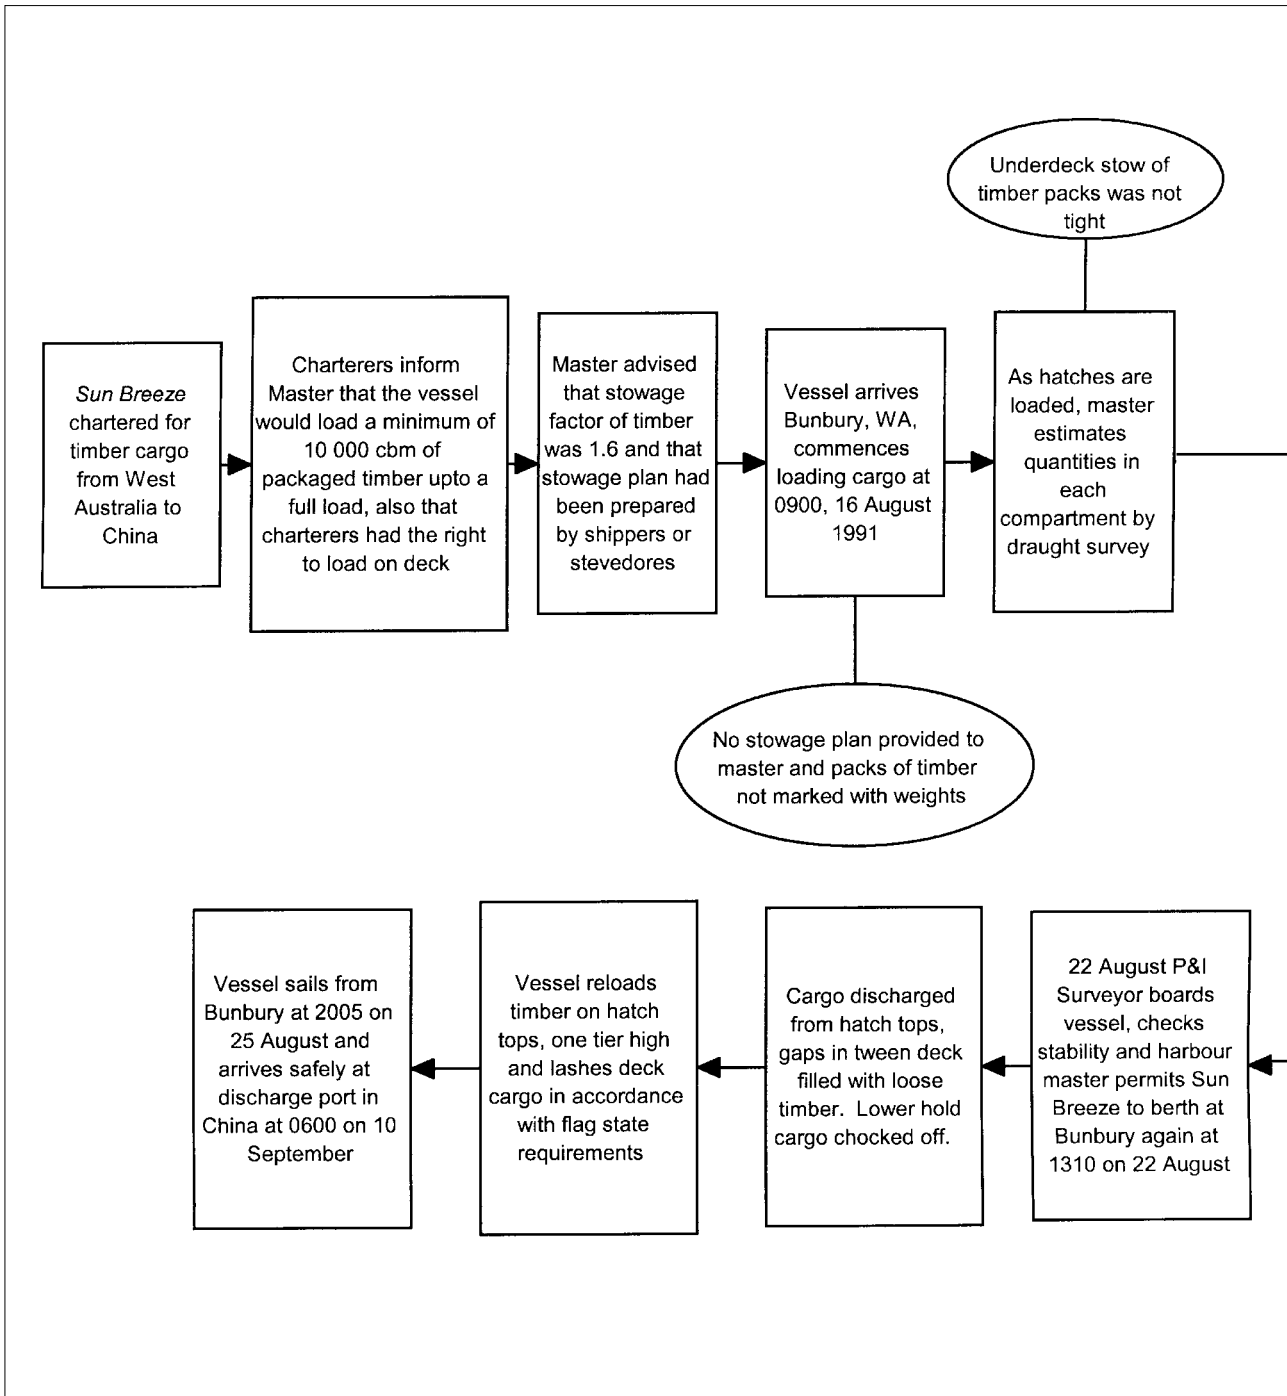
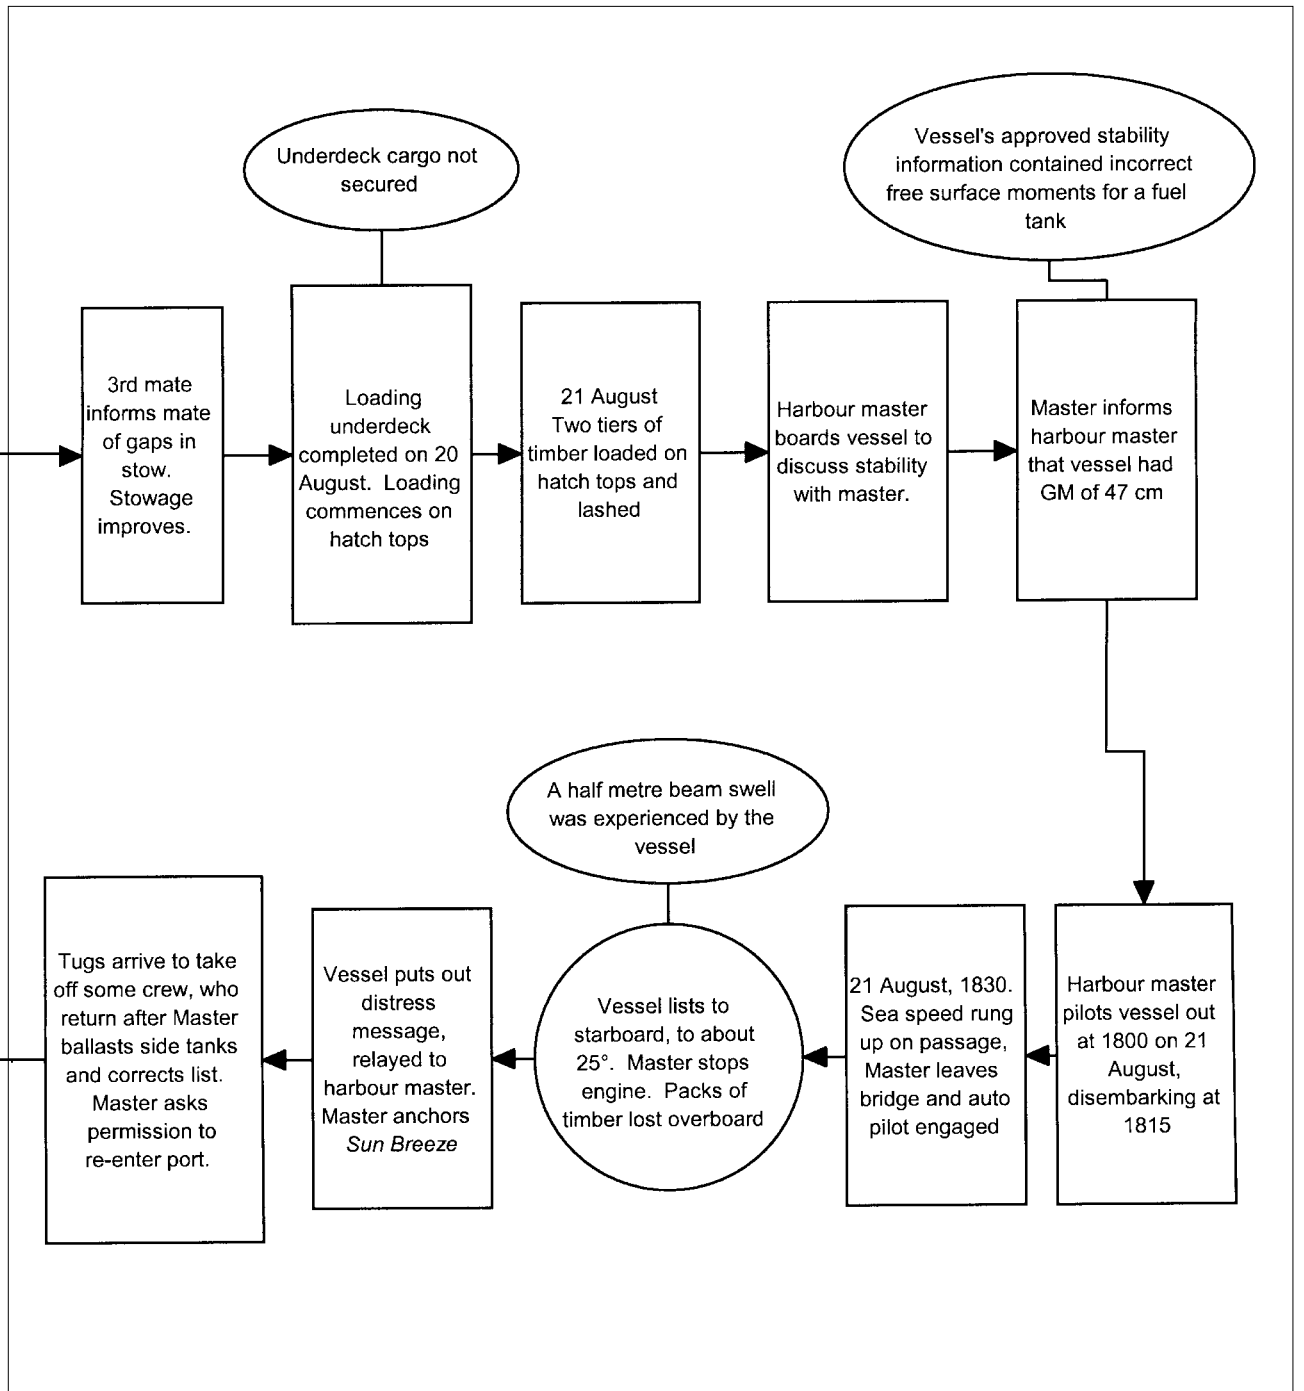
**Figure 8:**  
**Sun Breeze: Events and causal factors chart**

1. The vessel sailed with negative GM, resulting in an angle of loll<sup>v</sup> which caused the shift of cargo.
2. The vessel was tender at sailing and rolled under the influence of the swell, possibly also heeling under the influence of the rudder. The unsecured cargo in the

The cargo in the holds was not secured. There is no dispute about this. There was a level of broken stowage underdeck, but the degree of broken stowage cannot be determined. The shift of cargo of 0.5 m in the lower holds and 0.25 m in the tween decks would account for a list in excess of 15°. The shift of deck cargo would also have contributed to the list.
