MARINE SAFETY INVESTIGATION
REPORT 151

Independent investigation into the collision involving
the Liberian woodchip carrier,

Craig The Pioneer

May Bell II

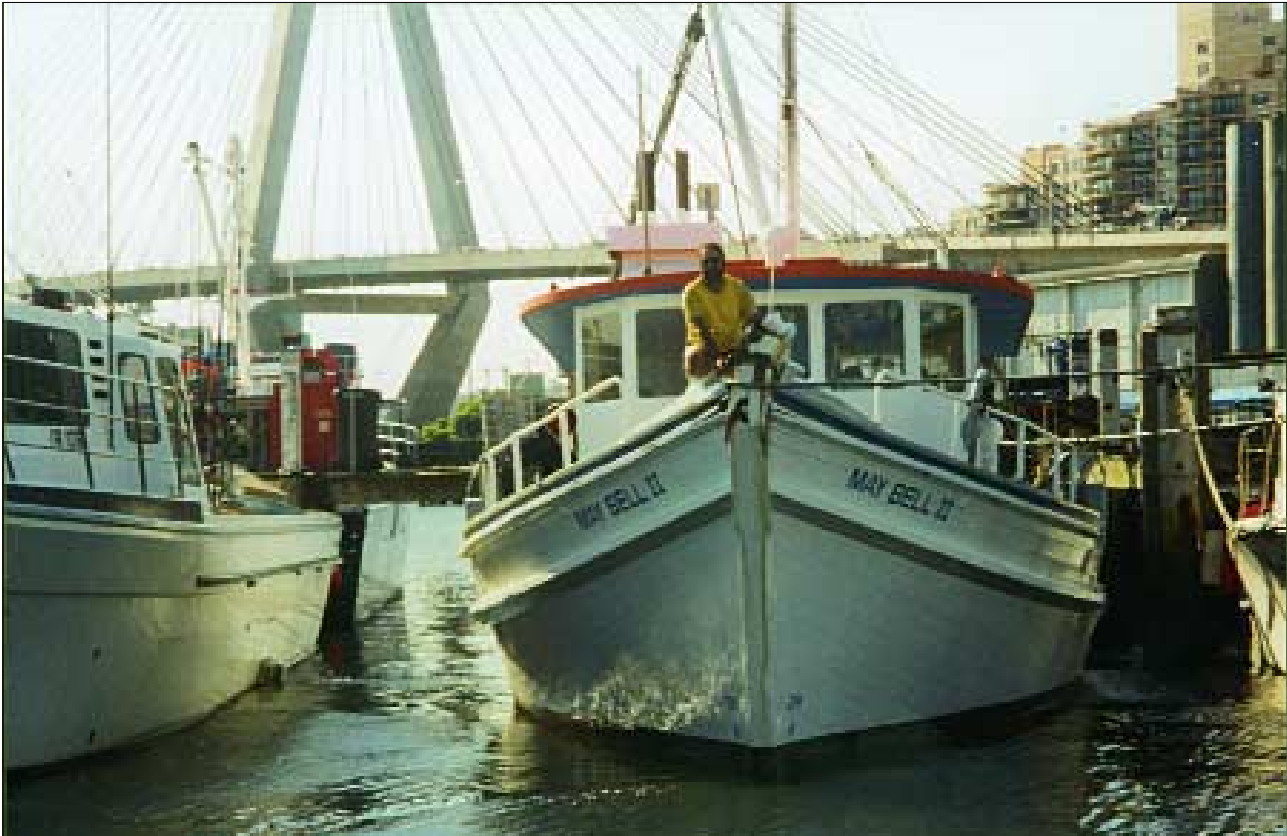
FIGURE 2
May Bell II at the Timber Wharf in Sydney

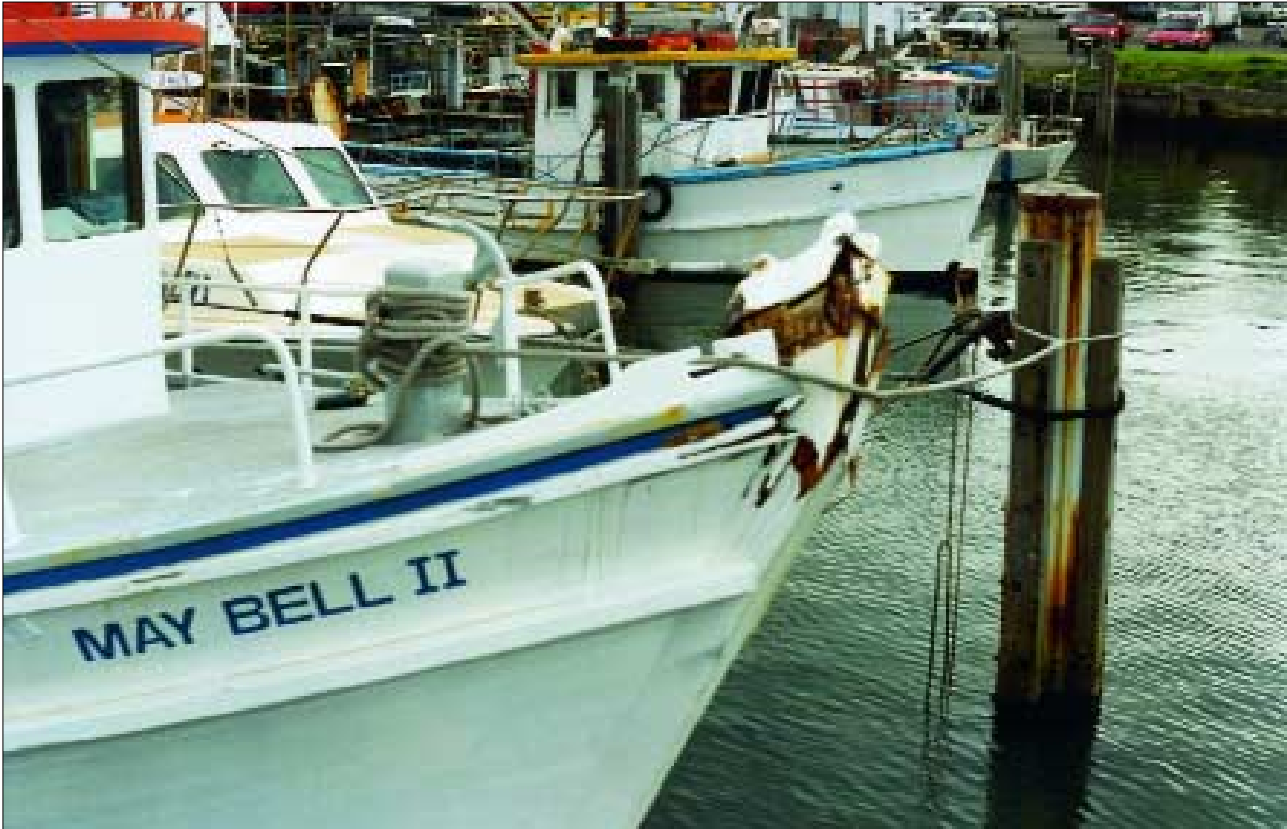
FIGURE 3
May Bell II, bow damage

After the collision, the skipper and deckhand checked the trawler for damage. The top of the stem post was broken and bent to starboard. There was a hole, about 20 cm in diameter, just below the main deck, visible from the deck forward and also from the interior of the boat. There was, however, no ingress of water. A steel plate at the top of the stem post, about 20 cm high and 10 cm across, had foreign paint, apparently from the ship, deposited on it.

The collision caused paint from the ship to be deposited on a steel plate on the stempost of the trawler.

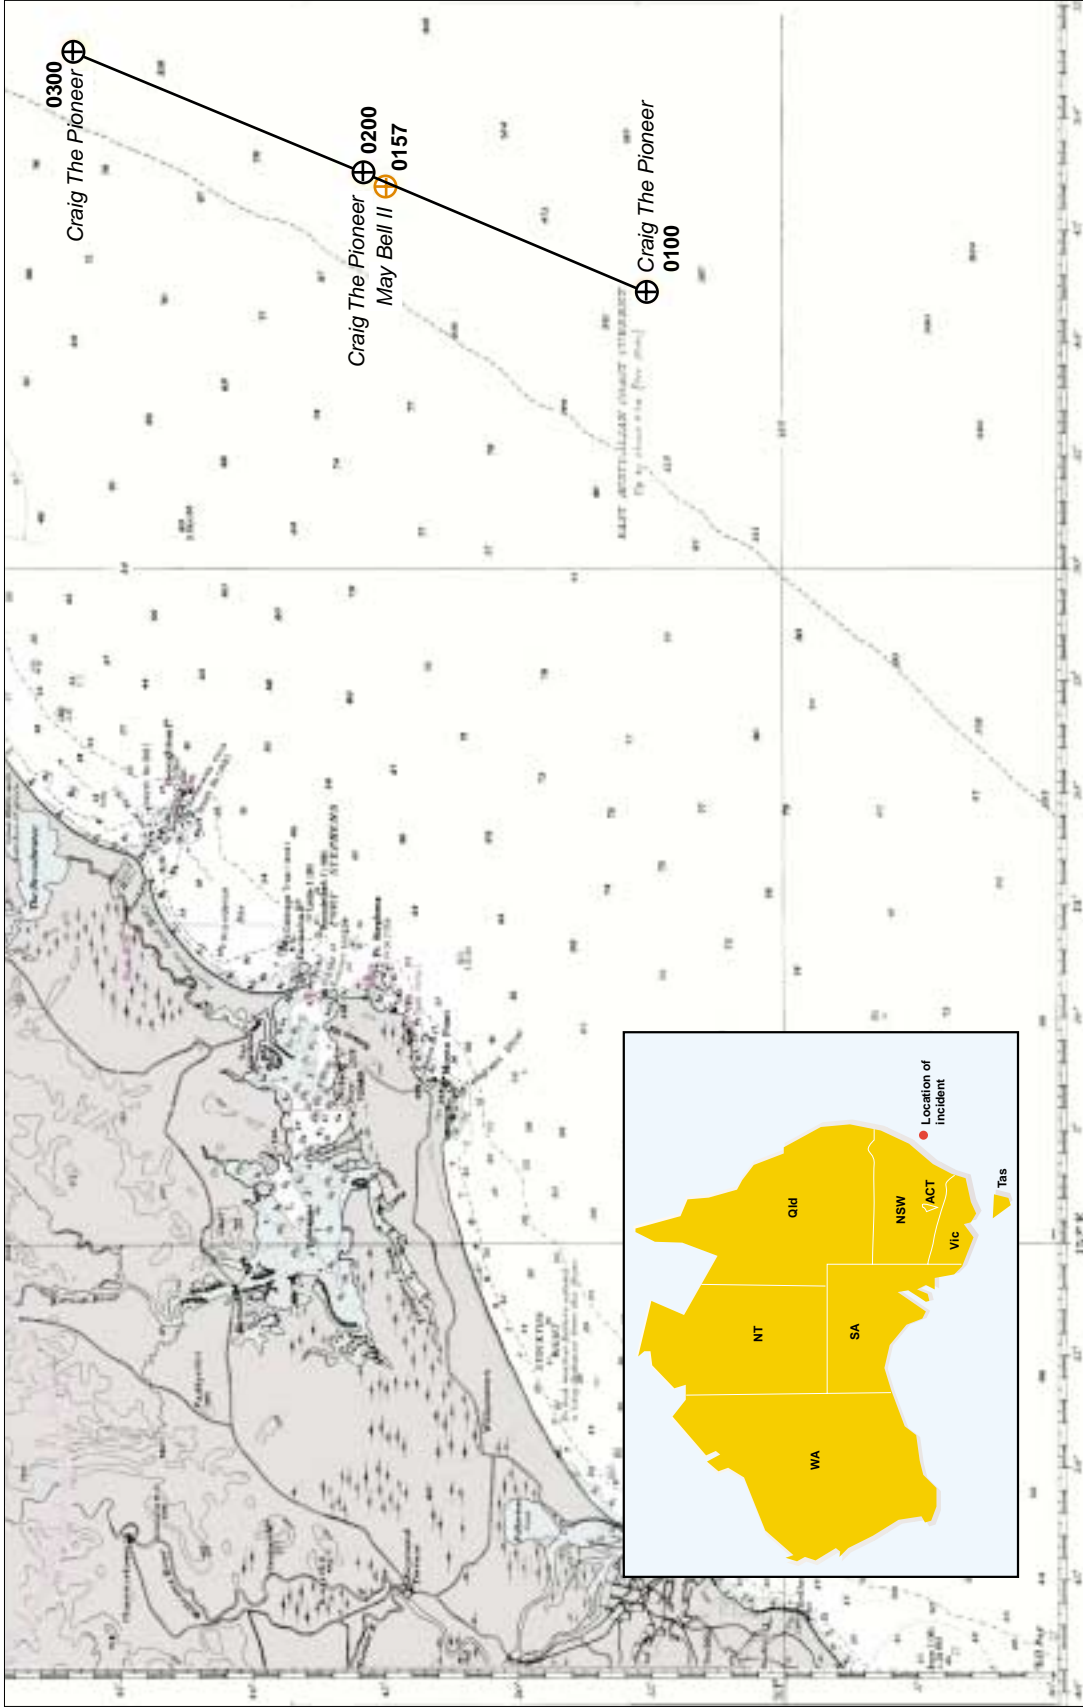
FIGURE 4
Chart of the area with position of fishing boat and track of ship on 9 October, (AEST)

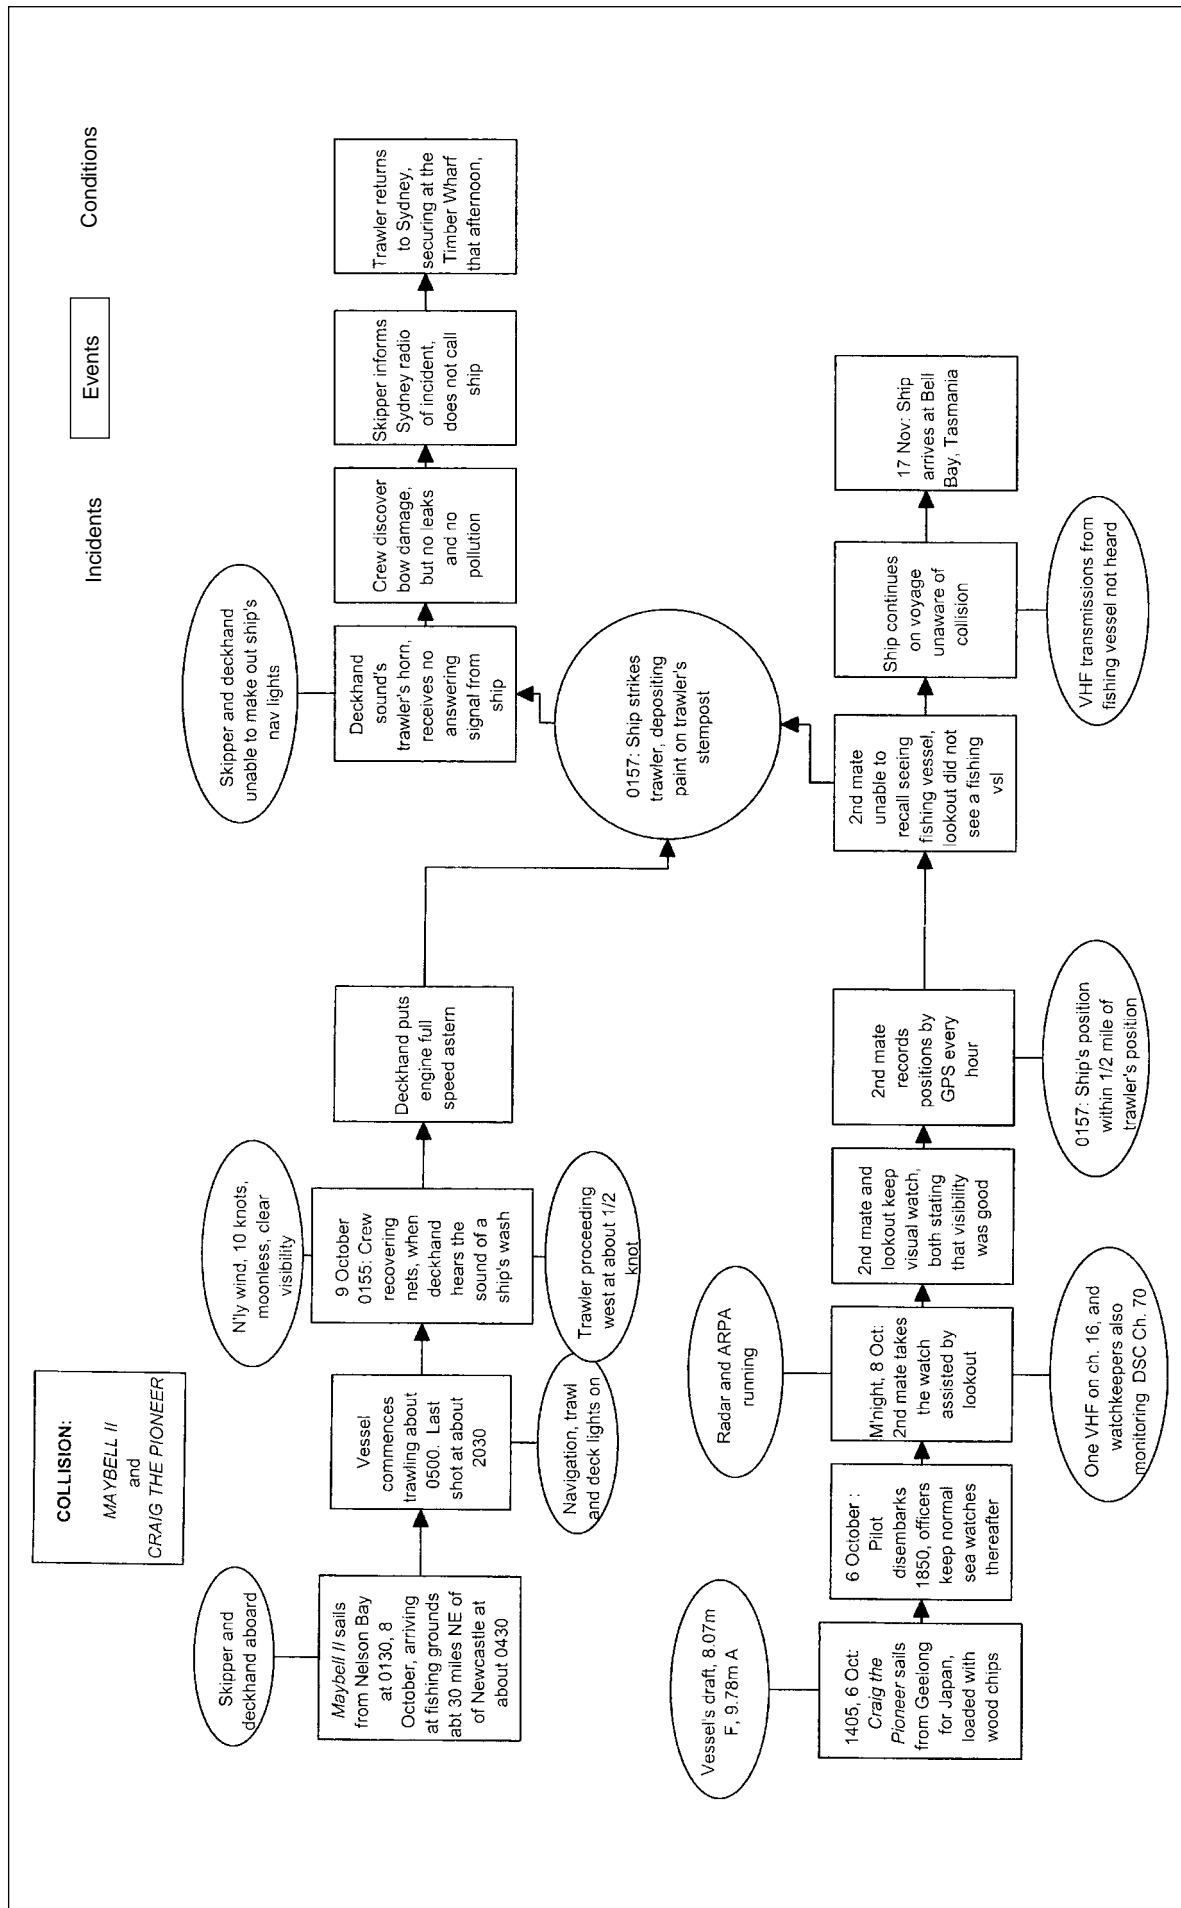
FIGURE 5
Events and causal factors chart

It is also considered that the fitting of a radar reflector or similar device to the fishing vessel to enhance its radar returns would have increased the likelihood of it being detected by a ship.
