MARINE SAFETY INVESTIGATION  
REPORT 154

Independent investigation into the collision  
between the Panama flag motor tanker

# **Barents Sea**

# **Sea Wasp**

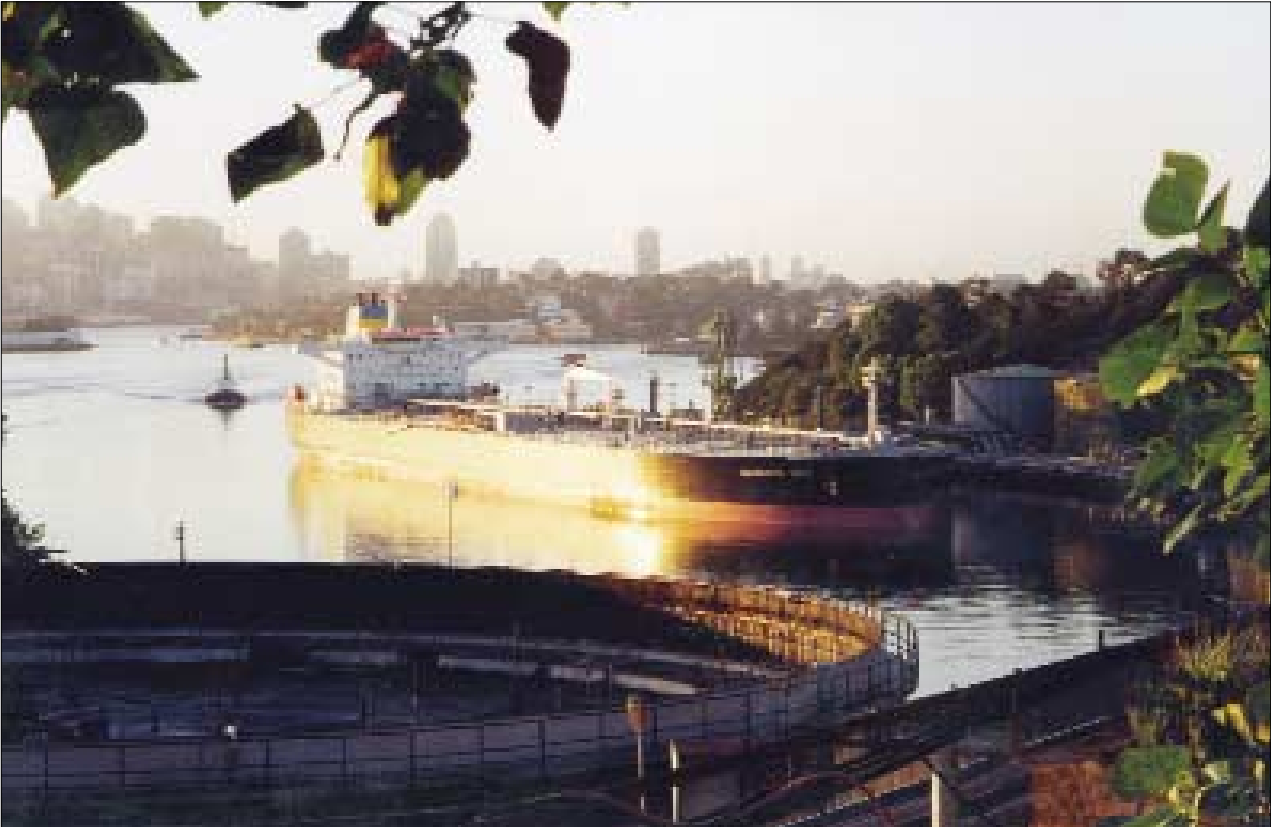
**Figure 1:**  
*Barents Sea (Gore Bay)*

A surveyor from the Australian Maritime Safety Authority (AMSA) inspected *Barents Sea*'s hull adjacent to the waterline on the ship's starboard side forward. He reported that there were no obvious score marks or paint damage to indicate a possible point of impact. A sample of the ship's hull paint and 'boot topping' was taken during the inspection for later analysis.

The AMSA surveyor's investigations revealed that there was no obvious marks or paint damage on the hull of *Barents Sea*. Trust you agree, that had there been any contact with the *Barents Sea*, there should have been some scratch marks or paint damage on the hull of *Barents Sea*. There weren't any.

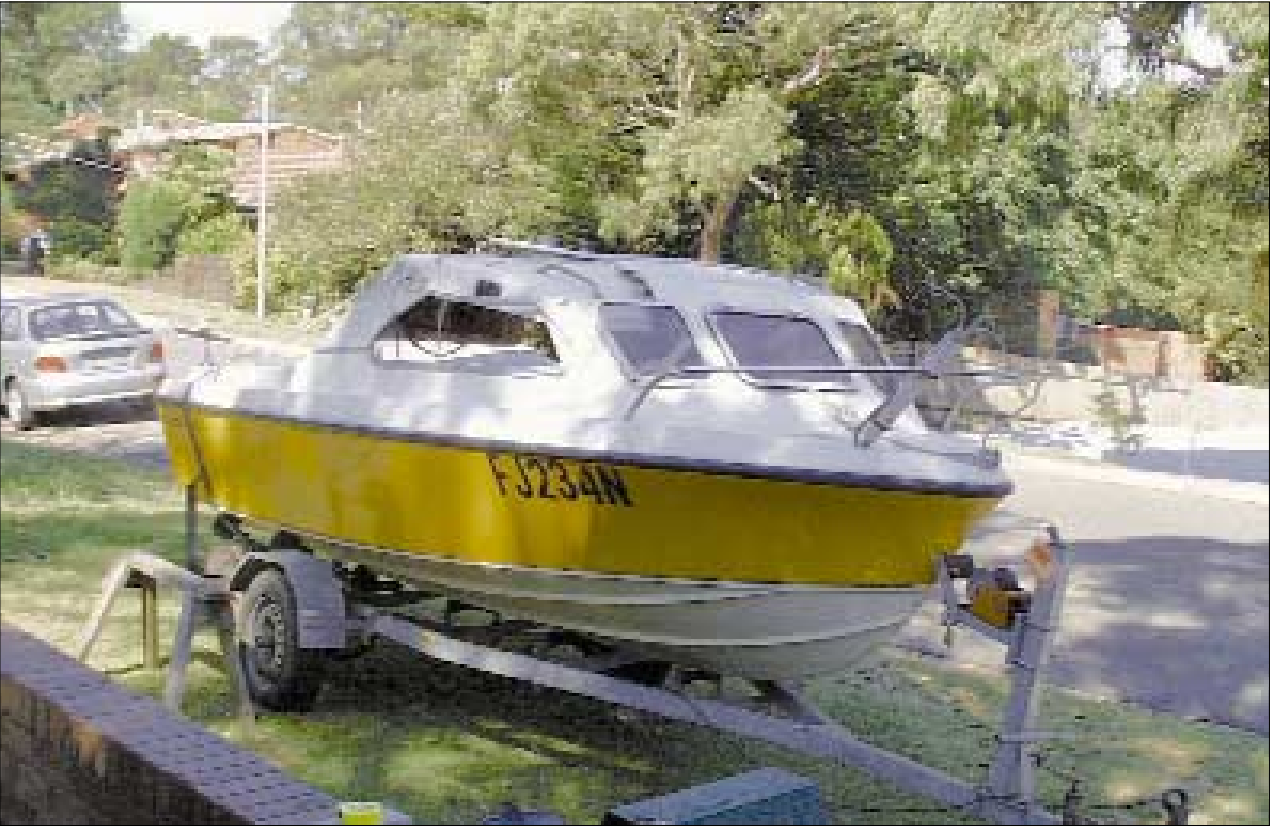
**Figure 2:**  
*Sea Wasp* showing damage to cabin and windscreen

At 0935, the ship's starboard bow struck *Sea Wasp* causing structural damage to the starboard side of the boat's cabin, and damage to the windscreen and depth sounder.

The coxswain and his friend inspected *Sea Wasp* and found that the boat had sustained structural damage to the upper cabin on the starboard side, and that the windscreen and depth sounder, had also been damaged in the collision. The boat had also taken about 40–50 litres of water into the cockpit. The two men were unsure if the boat had been damaged below the waterline as the cockpit floor forms a sealed compartment with the bottom of the boat and is not directly accessible for inspection. The men were also concerned that the motor had sustained damage as it had stopped in the collision.

Investigators attended the homes of the coxswain and his fishing friend on 10 February. *Sea Wasp* was inspected at the home of the coxswain and presented as a well maintained and well equipped standard design half-cabin runabout. Damage was noted to the starboard side of the cabin, the windscreen mounted on top of the cabin, and the depth sounder mounted behind the windscreen on the top of the cabin. The boat's cabin showed some areas on which some dark material had been deposited and a sample was obtained for analysis. Copies of statements taken by Sydney Water Police were obtained, and the coxswain and his friend were interviewed by the investigators.

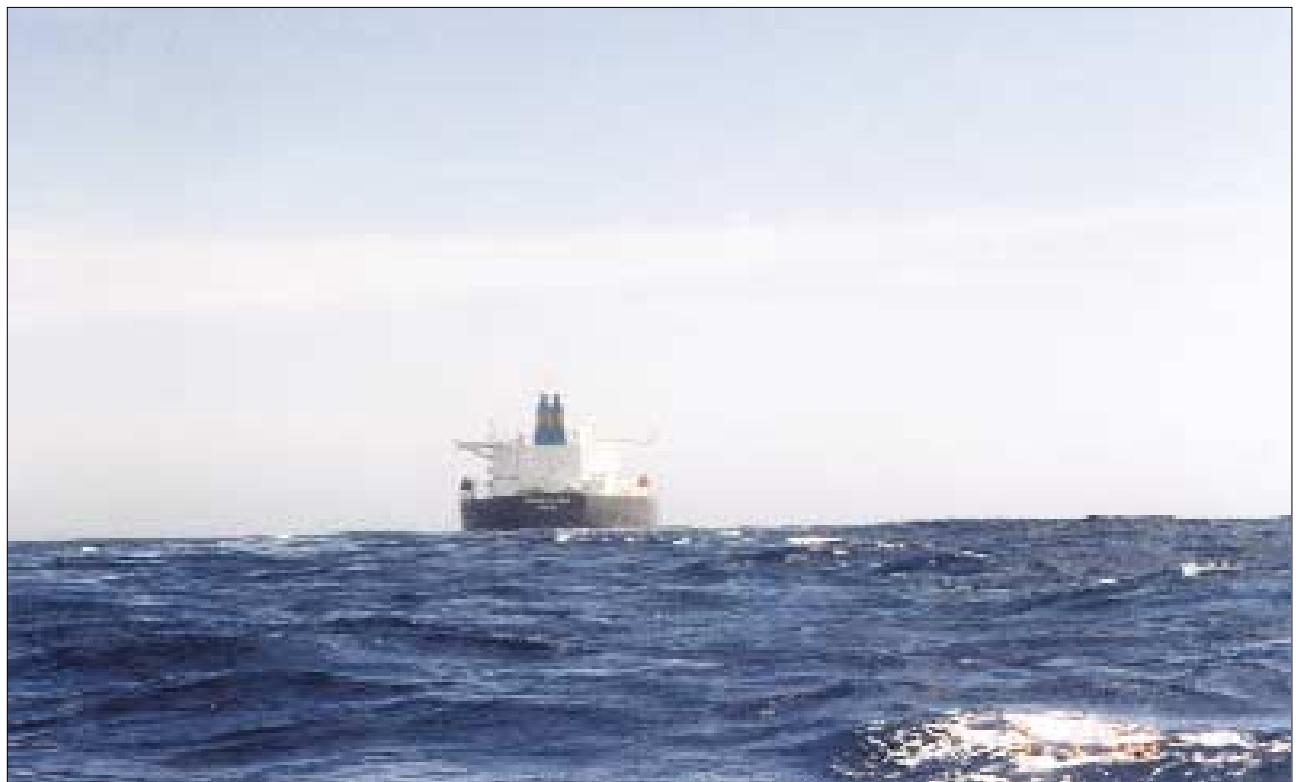
**Figure 3:**  
Coxswain’s photograph of *Barents Sea*.

After re-boarding *Sea Wasp*, the coxswain called 000 on his friend’s mobile telephone to report the incident and request assistance. The 000 call was logged at 0937:40 seconds. During his opening statement to the 000 operator, the coxswain identified himself, stated *Sea Wasp*’s general position and named the ship involved in the collision as *Barents Sea*. The operator took his details and transferred the call through to Sydney Water Police. The coxswain’s friend stayed on the telephone while the coxswain took some photographs of the receding ship as it continued north to Sydney heads (fig.3). The coxswain then set off an orange smoke

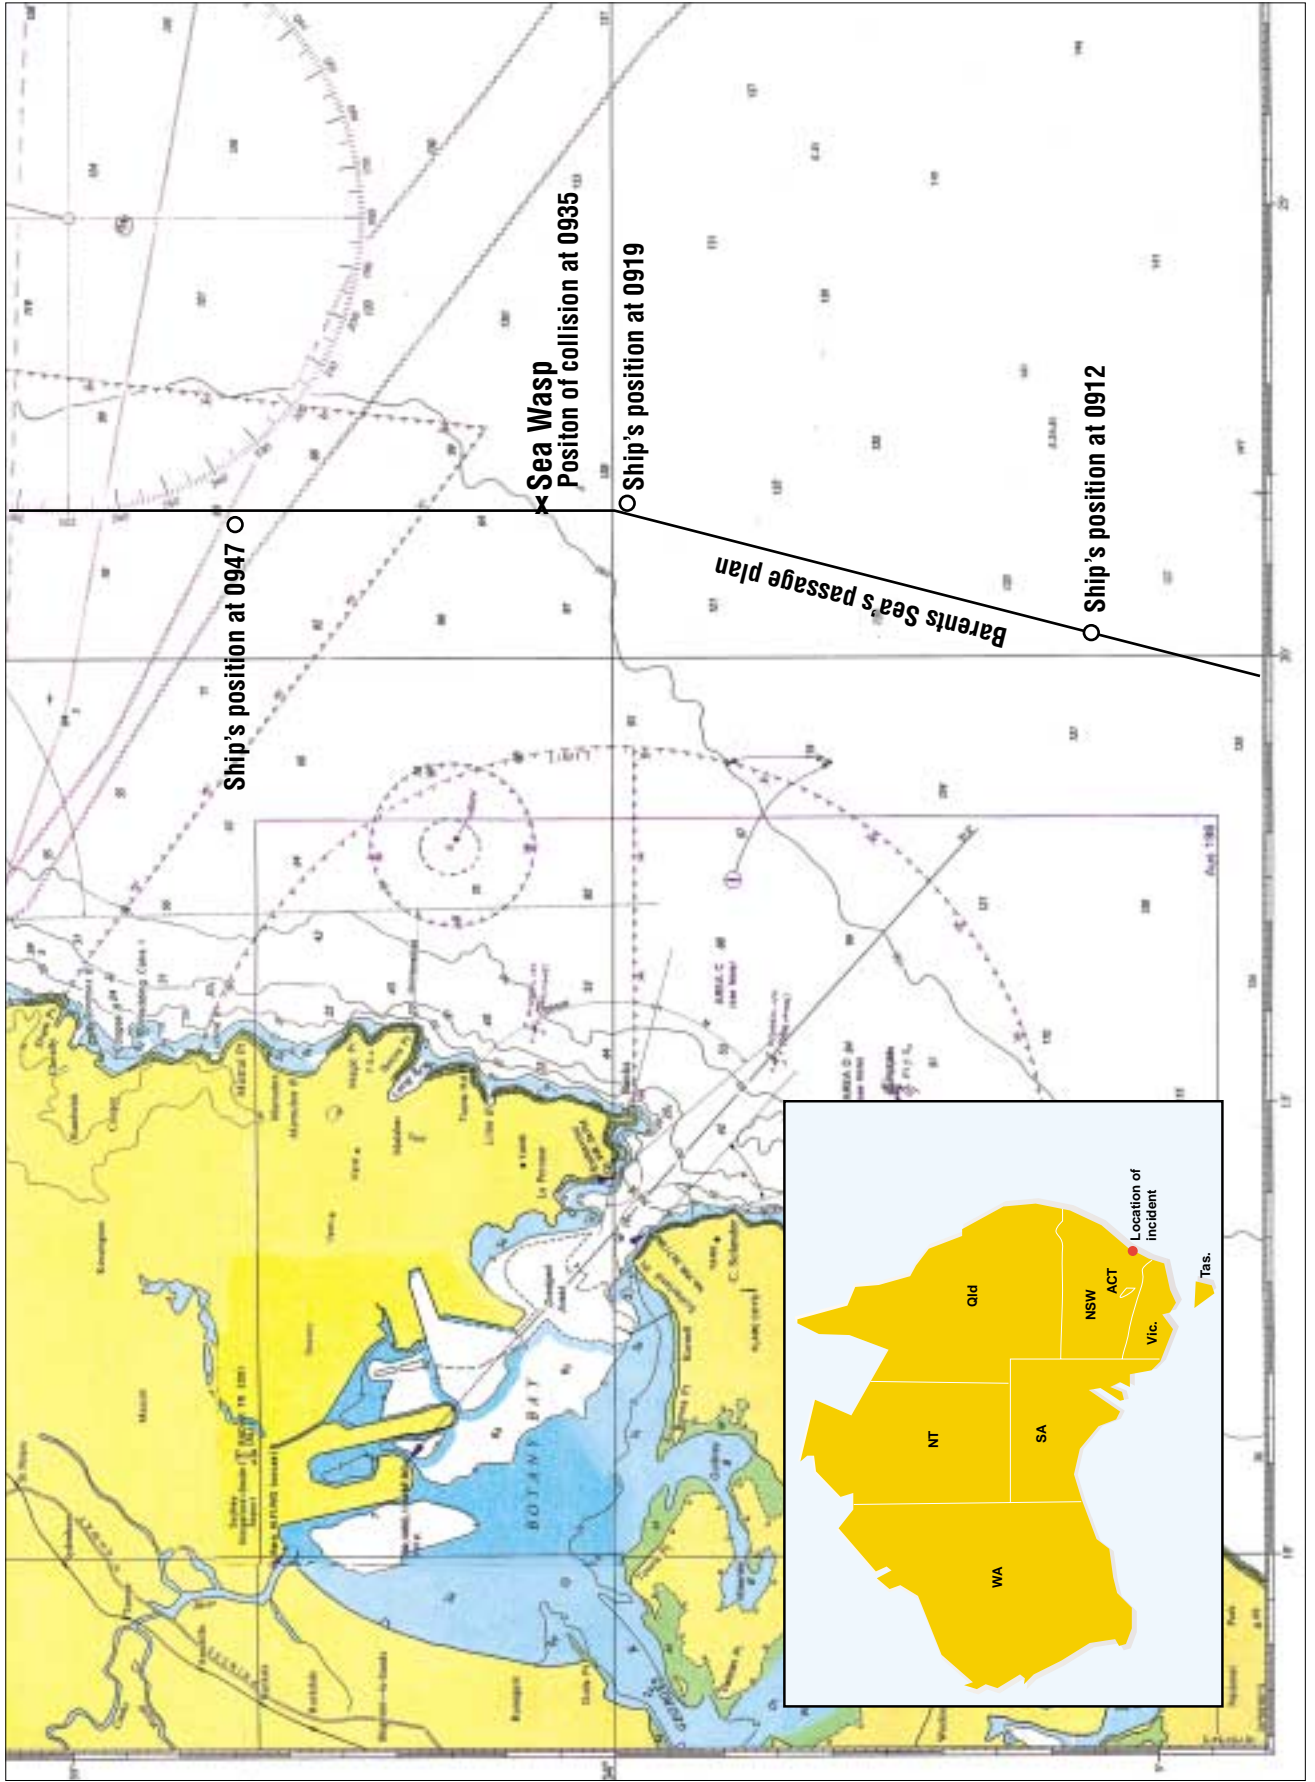
Figure 4:  
Chart of *Barents Sea's* passage plan and position of collision

At 0929, *Barents Sea* altered course, in a position east of Botany Bay, from 015° to 000°. This was the final course alteration approaching the pilot boarding ground off Sydney heads some 10 miles to the north.

At 0929 *Barents Sea* made a planned course alteration from 015° to 000°. The course alteration was executed by switching the steering over to 'hand'. The ship was brought around to the new course and then the automatic pilot was re-engaged. This was the last planned course alteration prior to arriving at the pilot boarding ground off Sydney Heads.

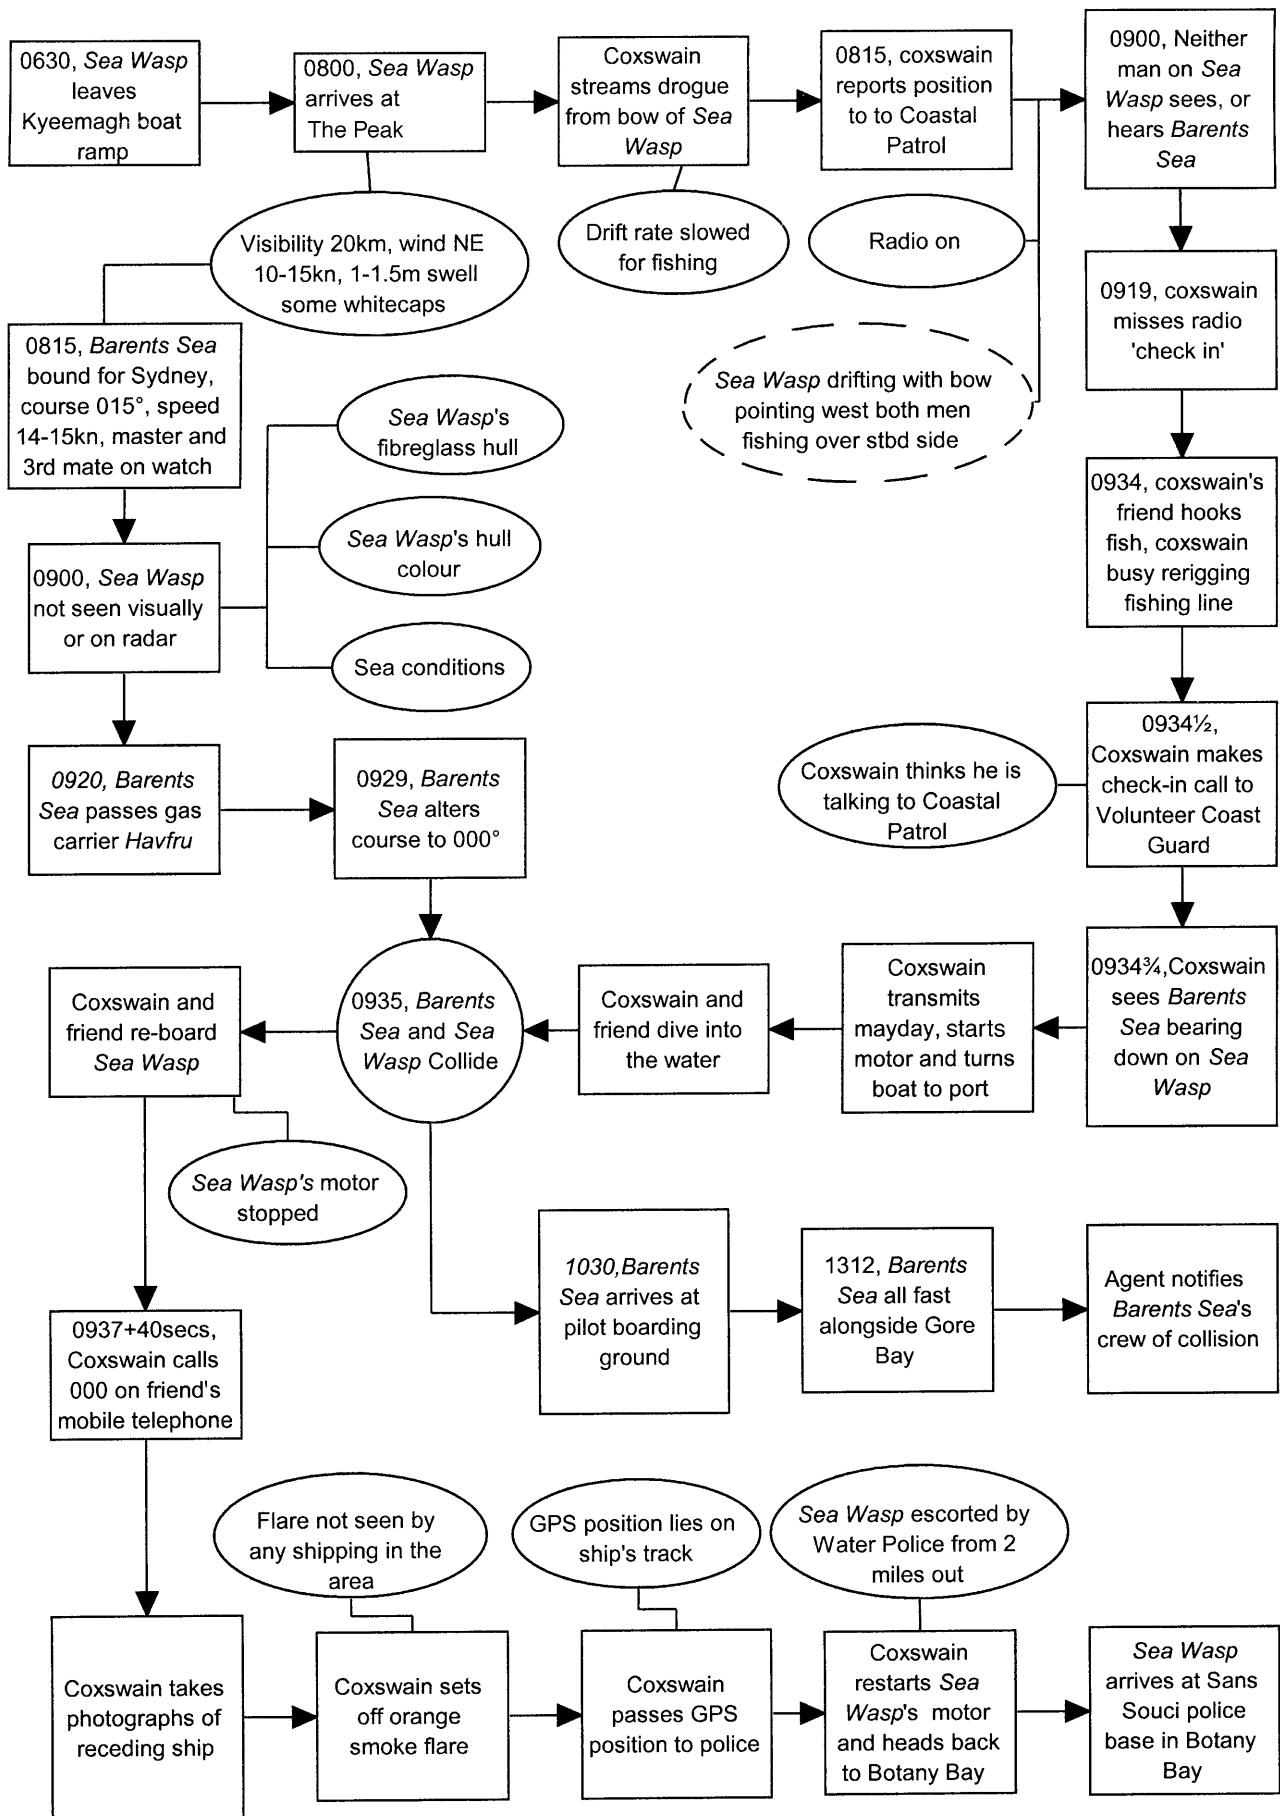
**Figure 5:**  
**Barents Sea/Sea Wasp collision events and causal factors chart**

4. In the prevailing weather conditions, *Sea Wasp's* white topsides would have made its visual detection more difficult.
5. The ability of the men aboard *Sea Wasp* to maintain an effective look-out was hindered listening to the radio.

6. The sea anchor streaming from *Sea Wasp's* bow limited the manoeuvrability of the boat and the coxswain's ability to take evasive action immediately prior to the collision.
