**MARINE SAFETY INVESTIGATION
REPORT 159**

Independent investigation into the collision between the
Panama flag bulk carrier

Star Sea Bridge
and the Australian fishing vessel
Sue M

east of Evans Head, NSW
on 21 June 2000

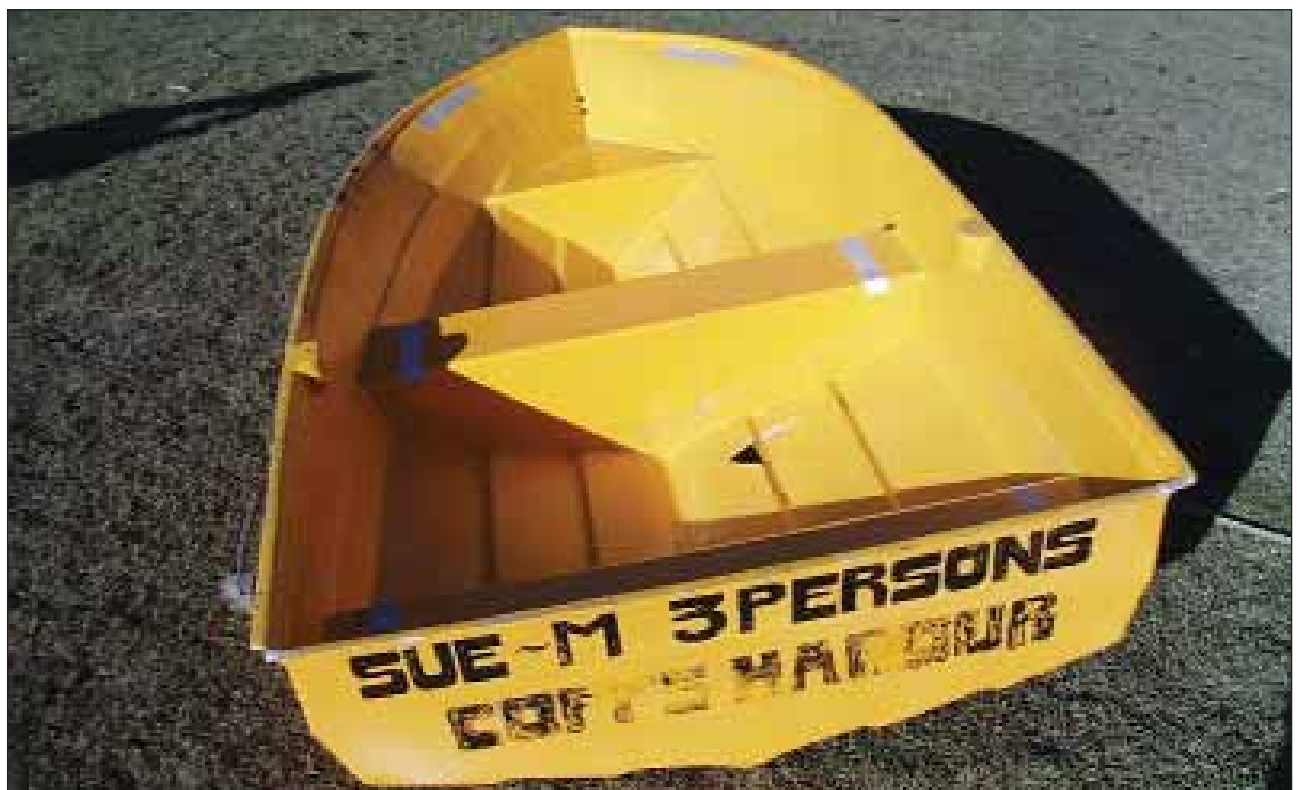
FIGURE 4:
Damaged dinghy used by deckhand of *Sue M* to stay afloat

Sue M was equipped with a manually launched dinghy, which was required to be equipped with two oars, a painter, a bucket or bailer and means to enable persons to cling to the boat if upturned. The dinghy was secured to the wheelhouse top. It is probable that the deckhand would not have survived had the dinghy not fortuitously broken away when *Sue M* sank. In breaking away the dinghy was holed, but remained afloat on its in-built buoyancy. The oars and bailer, if stowed with the dinghy, were probably lost as it came to the surface inverted.

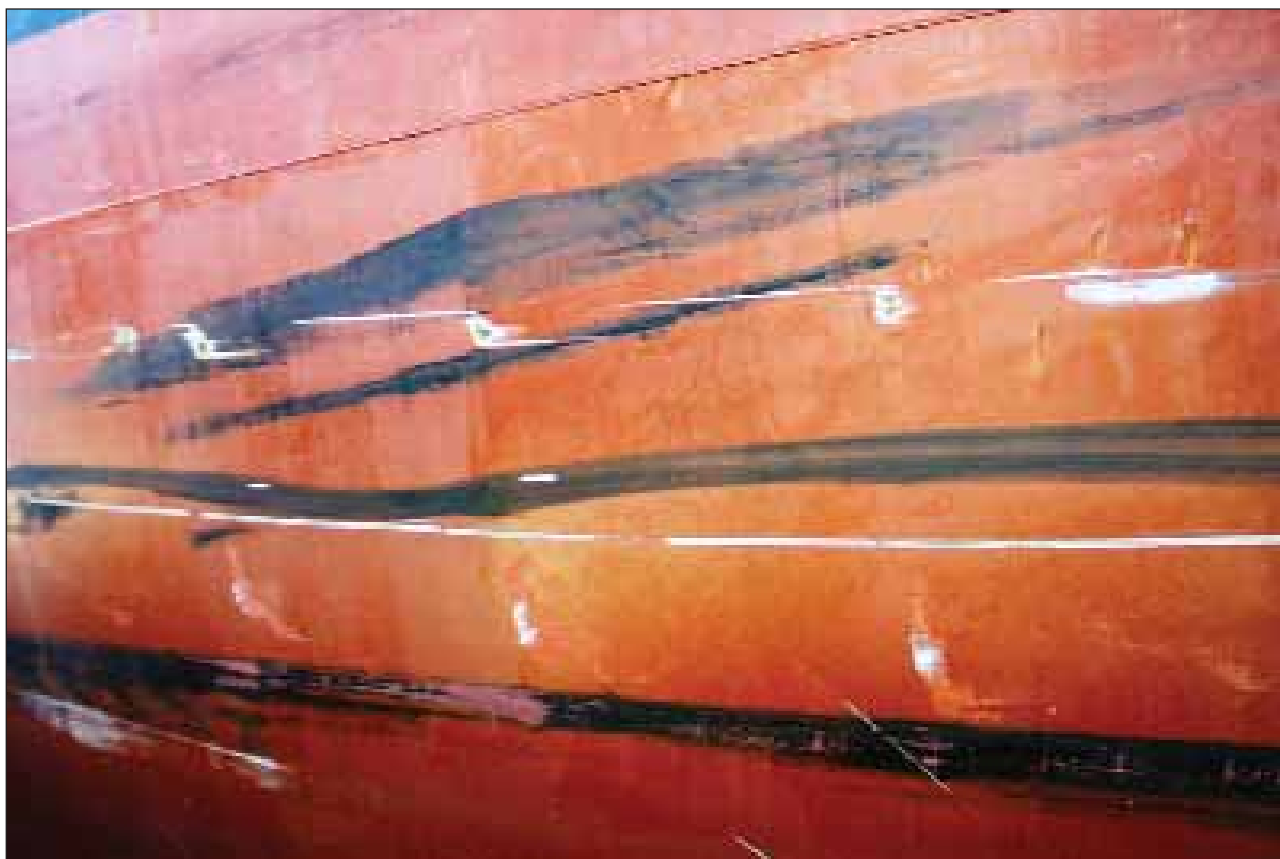
FIGURE 6:
Paint scrapes on hull of *Star Sea Bridge*

The second mate could not make out what the white light was, but it was closing. He wondered how it could be getting nearer even though the ship was turning to port. According to his evidence, he sounded the ship's whistle and ordered the lookout to steer 'hard-a-port'. At this point, the white light appeared to close rapidly and, moments later, it made contact with the starboard side of *Star Sea Bridge*, adjacent to No. 3 hold.

- 2.2 The microscopical examination of the samples taken from the damaged surface on the starboard side of the ship “Star Sea Bridge” revealed the presence of black and white particles. It was apparent that the ship had been in collision with a black and white painted object. These particles of apparent paint were isolated for further testing by infra-red and x-ray fluorescence spectrometry.

- 3.2 Strong similarities were observed in the infra-red spectra of the Pascol black paint and the questioned black particles recovered from the ship (Item 6 and others). Differences in the infra-red spectra, while present, were subtle and may well be due to environmental effects such as ultra-violet degradation.
- 3.3 White material with a granular matrix was observed adhering to the black paint from the tape lifts. This had the microscopical appearance and properties of an undercoat. It was compared against the International Interlac 172 white undercoat, AFP exhibit 0003982. The comparison of their infra-red spectra did not reveal any significant differences. Similarly, the x-ray fluorescence spectra revealed a similar elemental composition.

- 4.1 The comparison of black paints revealed sufficient similarities to conclude that the black paint from the damaged area of the ship could have come from the can of Pascol paint (AFP exhibit 0003898), or another paint of similar formulation.

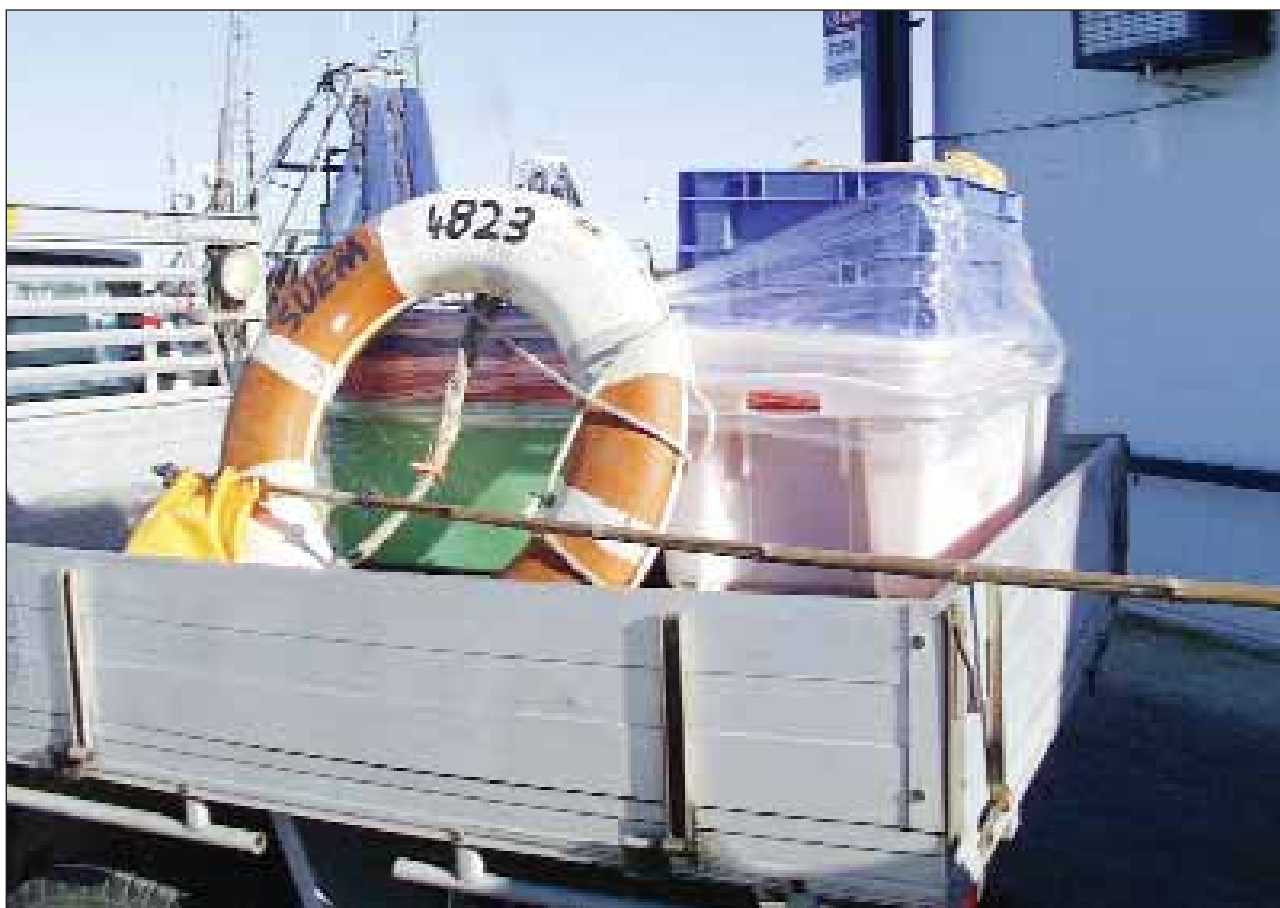
FIGURE 8:
Debris recovered from *Sue M*

Numerous items of debris, located in the search area, were identified as belonging to the lost vessel. An oil slick was also observed. Datum buoys were dropped to check the drift. The search was suspended at last light pending further intelligence from the NSW Water Police. It was considered that, if the missing man had survived, he would have been in the water for 54 hours by the next morning, with a negligible chance of survival.

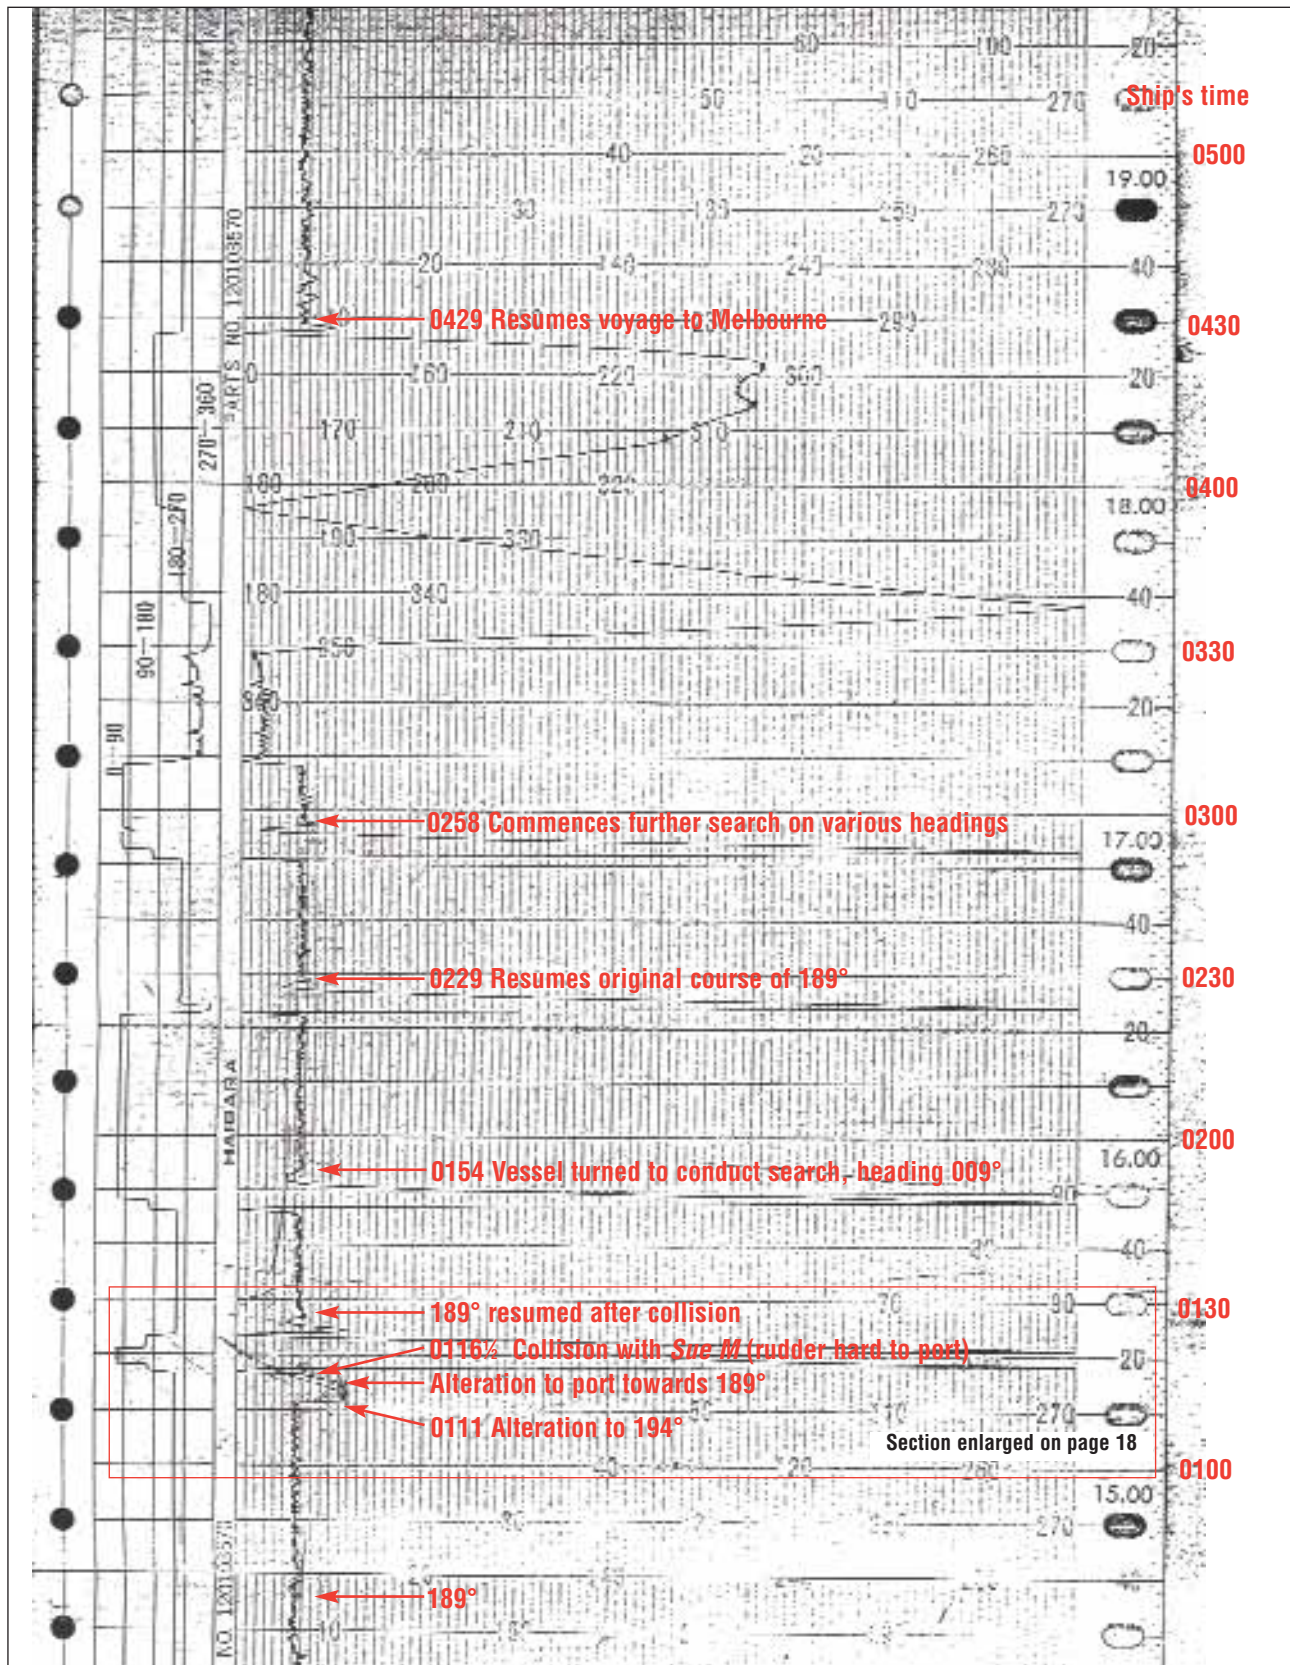
FIGURE 10:
Star Sea Bridge: Course recorder trace (2½° low on actual course)

From midnight until 0110 ship's time, the course recorder trace was steady. At 0110, the second mate of *Star Sea Bridge* switched the steering from autopilot to manual, ordering an alteration of course of 5° to starboard to clear *Ever Able*. The course recorder showed that this alteration of course was made at about 0111.

The trace shows that the new heading, 194°, was maintained for about three minutes before the course was altered gradually towards the original course of 189°. Just before returning to 189°, the trace started to change rapidly to port. This is likely to have occurred when the second mate ordered the rudder hard-over to port to avoid *Sue M*.

Judging by the trace, full port rudder would appear to have been applied at about 0116 and maintained thus for about four minutes, to avoid the collision. The ship reached a heading of 050°, before turning to starboard towards the original course of 189° at which point the master arrived on the bridge. At 0127, the vessel resumed a course of 189°.

The trace then indicates that the bulk carrier turned to port, to a heading of 009° at about 0154, which heading it maintained for about half an hour, before resuming its original course of 189° at 0229. This is consistent with the master’s statement that he had turned the vessel about to conduct a search. Between 0154 and 0229, the crew of the bulk carrier searched for the object with which they had collided, but found nothing.

the second mate observed a white light close to the bulk carrier's starboard side, he ordered full port rudder to avert a collision. From the slope of the trace of the course recorder, it appears that the rudder was put hard to port at about 0116. The collision was reported to have occurred just after this and the best estimate of the time at which it occurred would be 0116½.

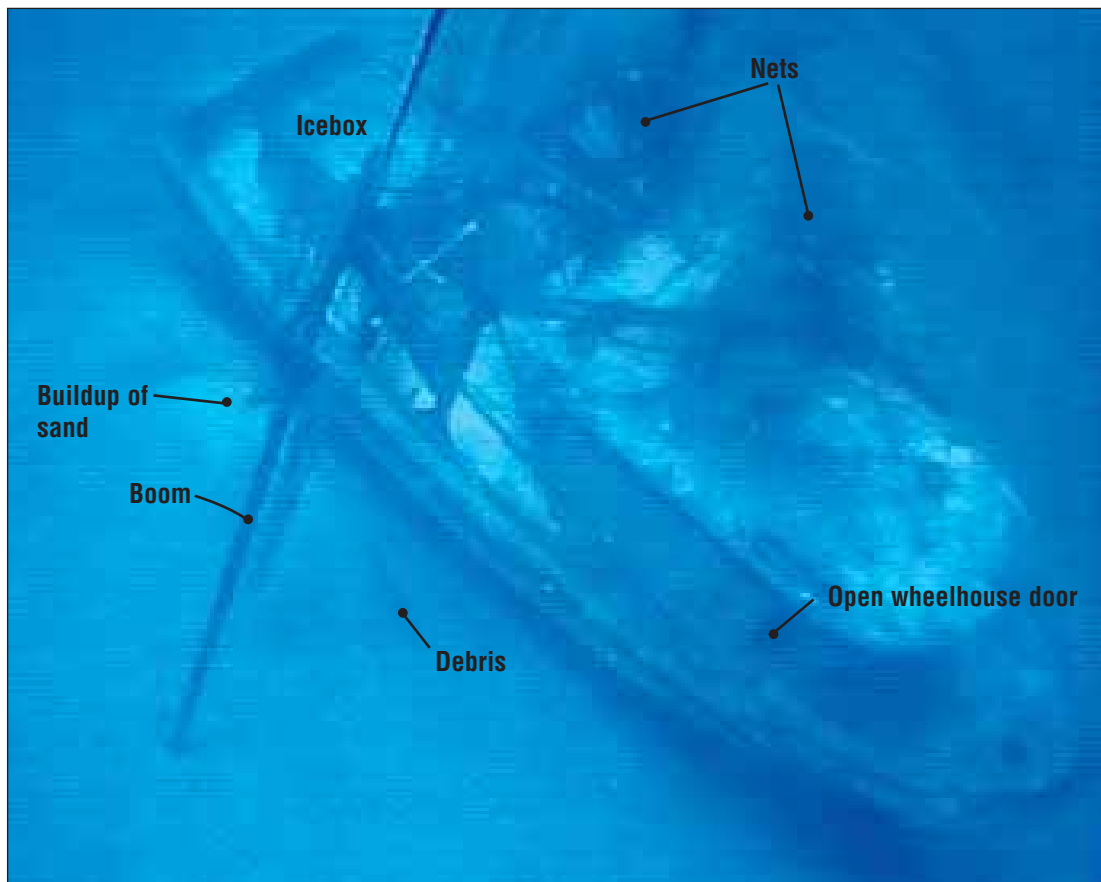
FIGURE 12:
Frame taken from a video recording of the wreck of *Sue M*

On 22 June, after conducting a search for the missing fishing vessel, the skipper of *Starfish* had located and buoyed the wreck of *Sue M* in about 64 metres of water at 29° 11' 10.8" S, 153° 37' 58.8" E.

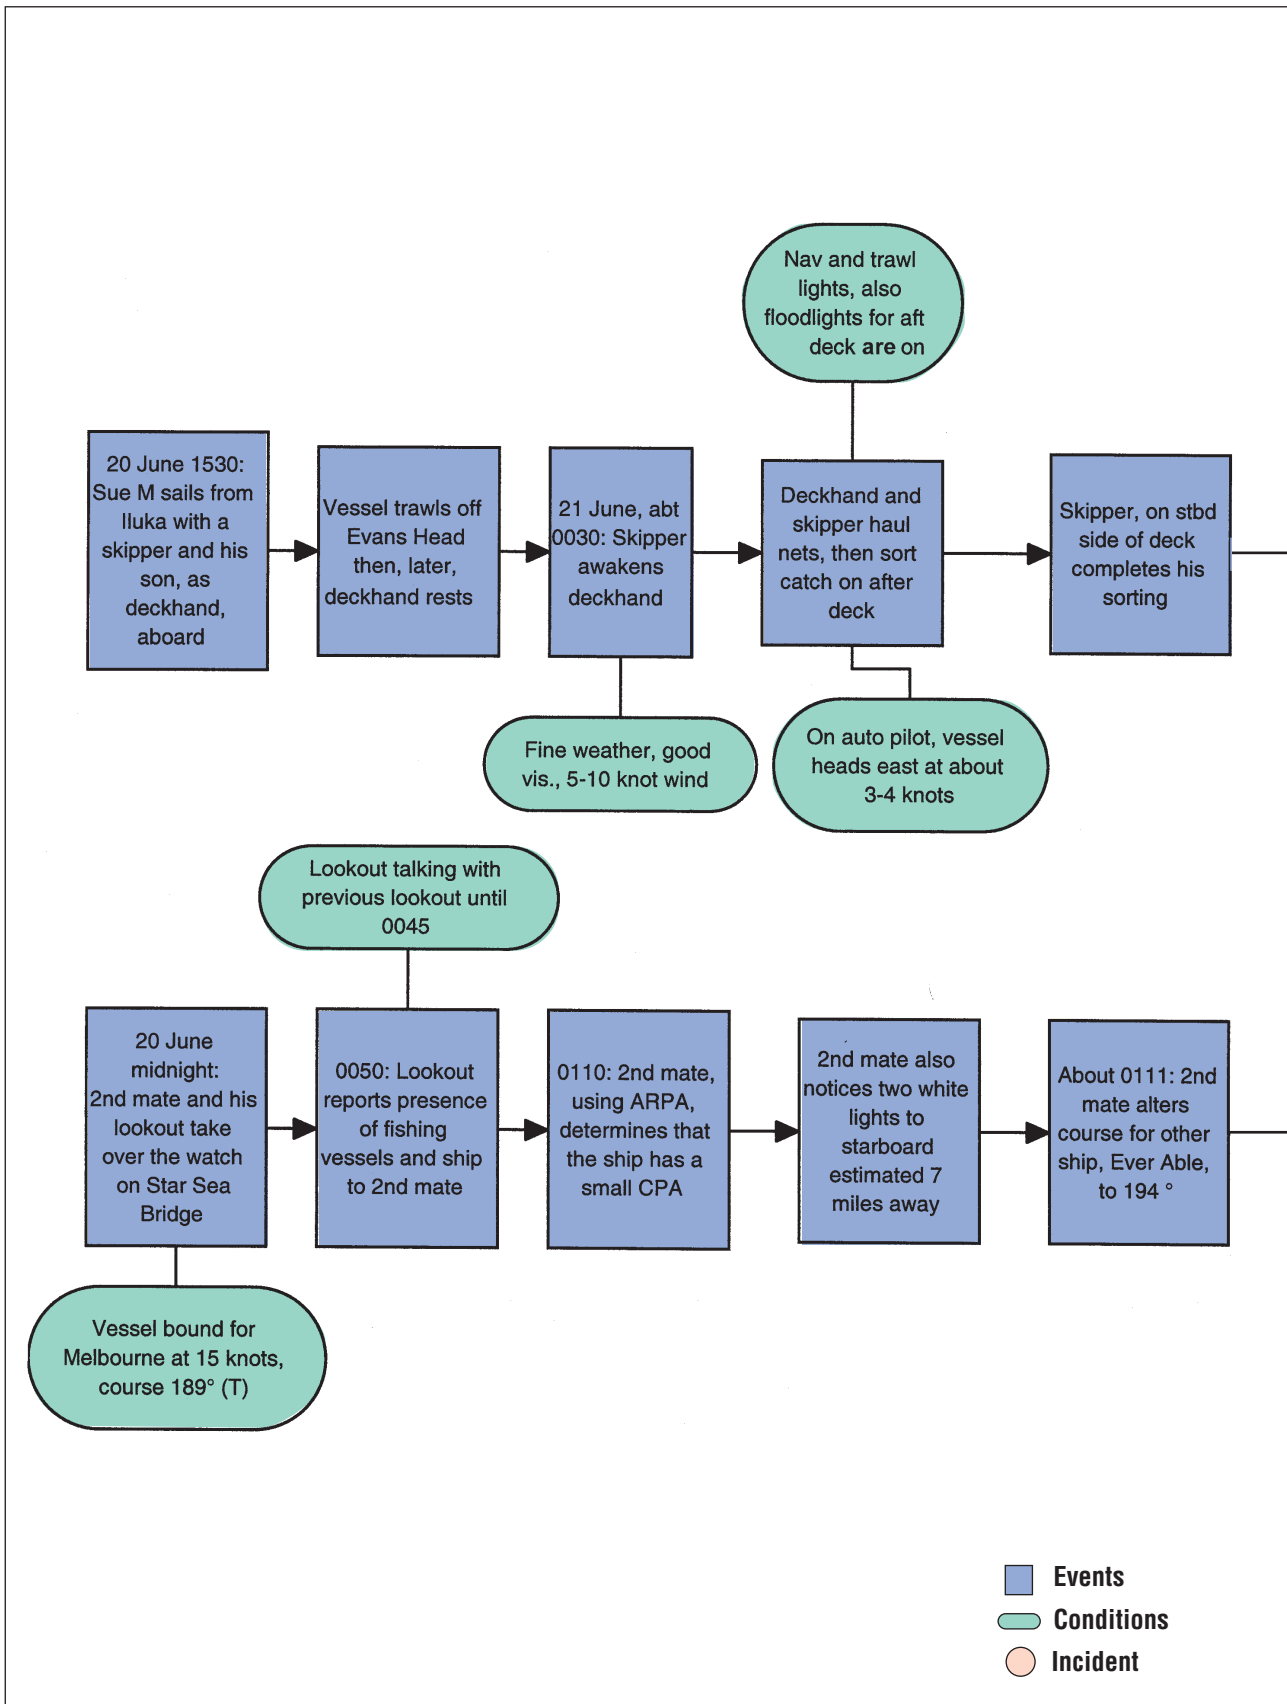
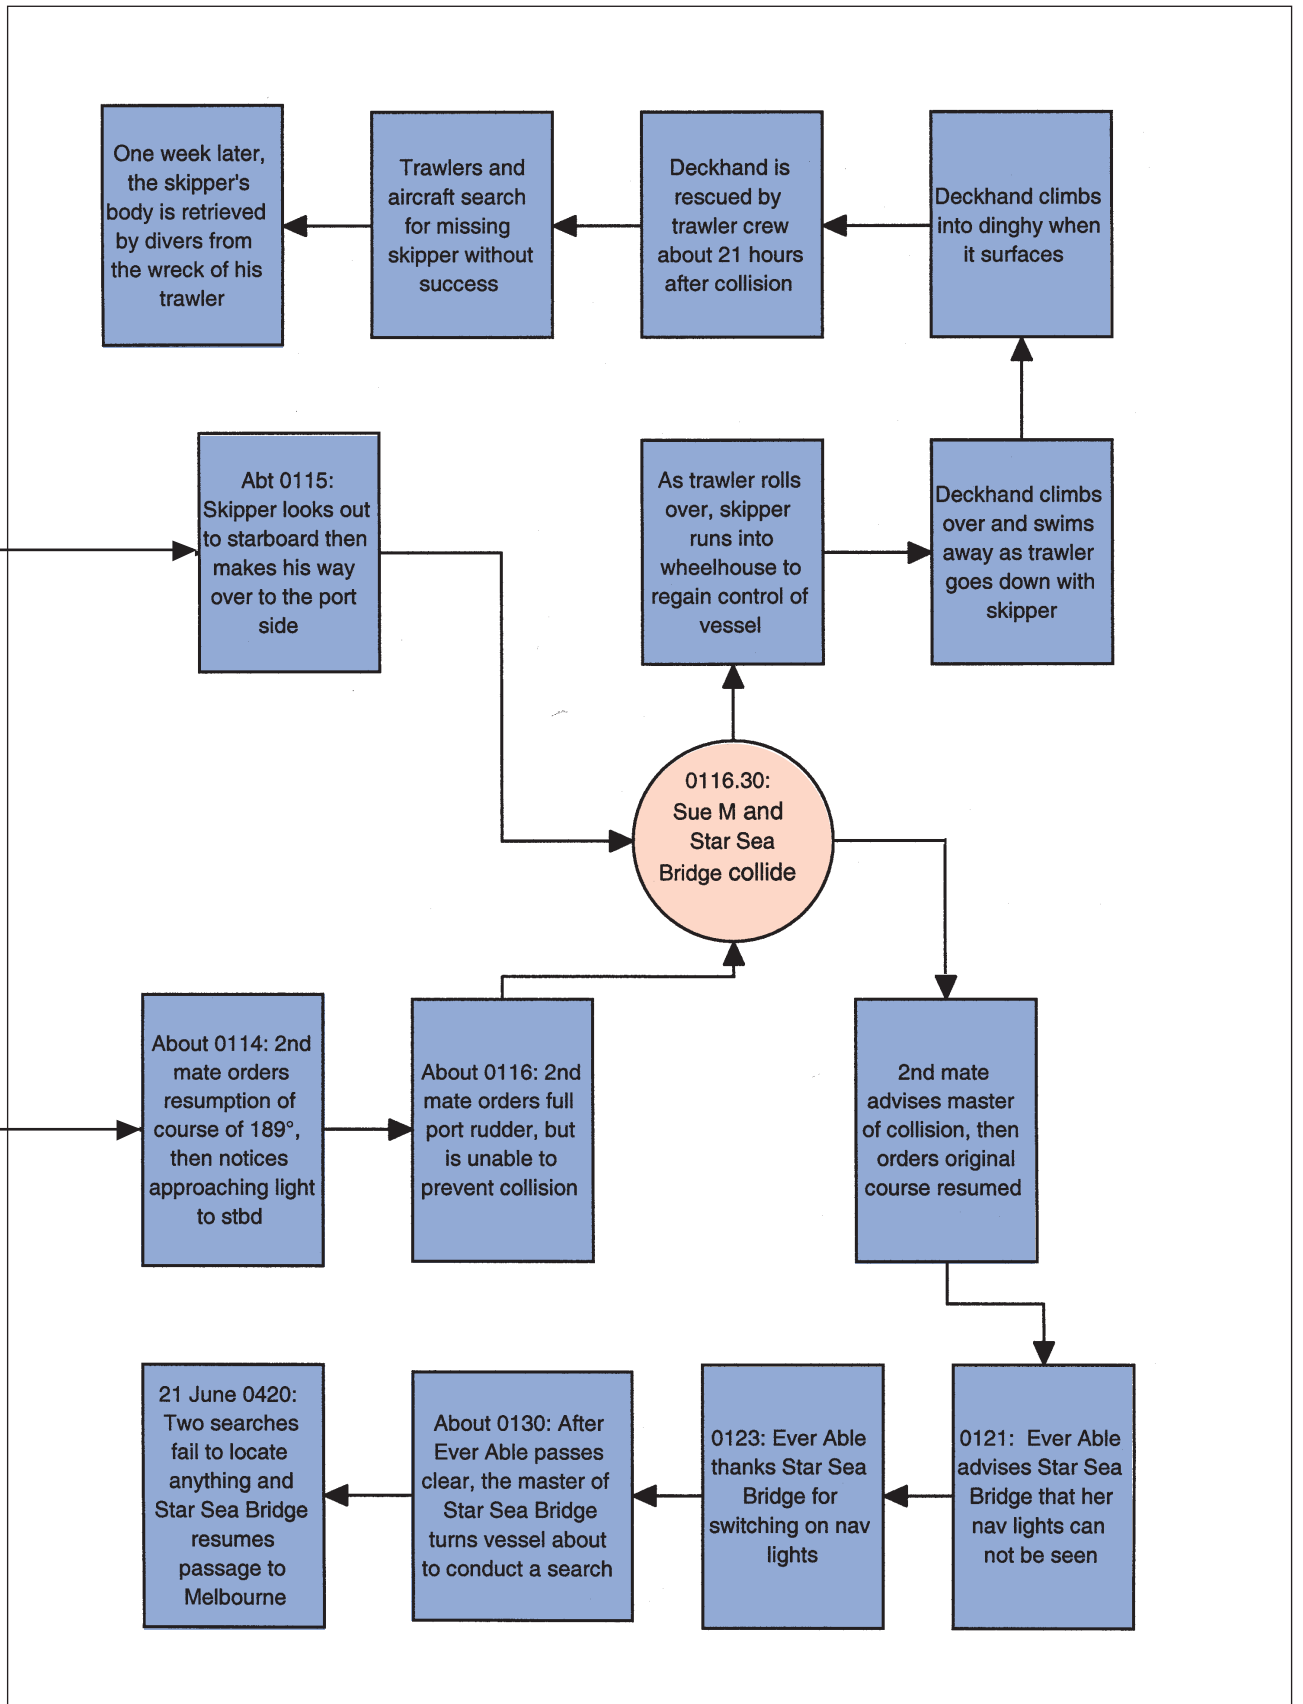
FIGURE 13:
Star Sea Bridge and Sue M: Events and causal factors chart

4. Both the skipper and the deckhand on the fishing vessel had been busy sorting their catch and had not been keeping a proper lookout.
5. The skipper and deckhand on *Sue M* were working under bright deck lights. Under these conditions, they would not have been able to visually detect approaching vessels, least of all one not displaying navigation lights.

In addition, based on the issue of night vision when working under bright lights, the Inspector considers that it is unlikely that the failure of *Star Sea Bridge* to exhibit its navigation lights before the collision was a causal factor in the collision itself.

The risk to the deckhand of *Sue M* not surviving a sinking at sea was increased significantly by the stowage of the EPIRB and lifejackets within the wheelhouse and the absence of readily available distress signals on deck.
