MARINE SAFETY INVESTIGATION

REPORT 167

Independent investigation into the grounding  
of the Indian flag bulk carrier

# Devprayag

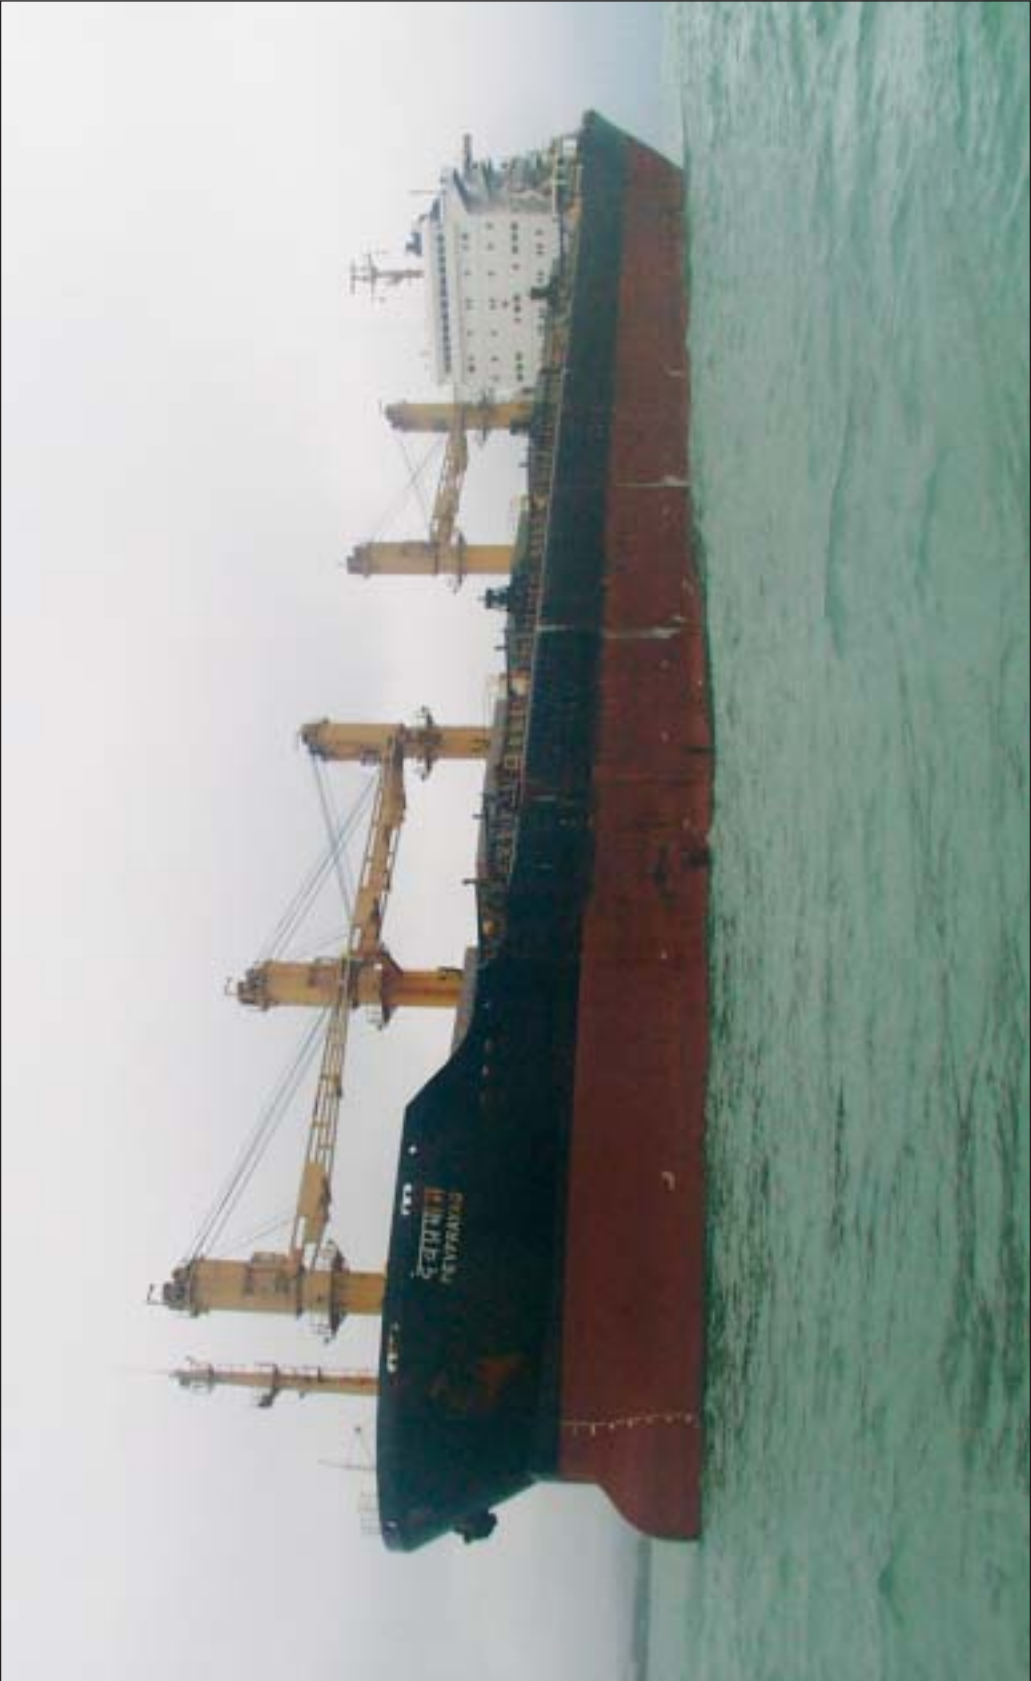
**FIGURE 1:**  
*Devprayag* aground at Portland

While the anchor was being weighed, the ship was set northwest towards Minerva Reef, along the Portland foreshore and, at about 2320, it grounded on the reef.

Nobody was hurt as a result of the grounding and no oil or other pollutant escaped from the ship. The ship was checked for damage. All tanks in the engine room, all ballast tanks, bilges and void spaces were sounded and the hull was found to be sound.

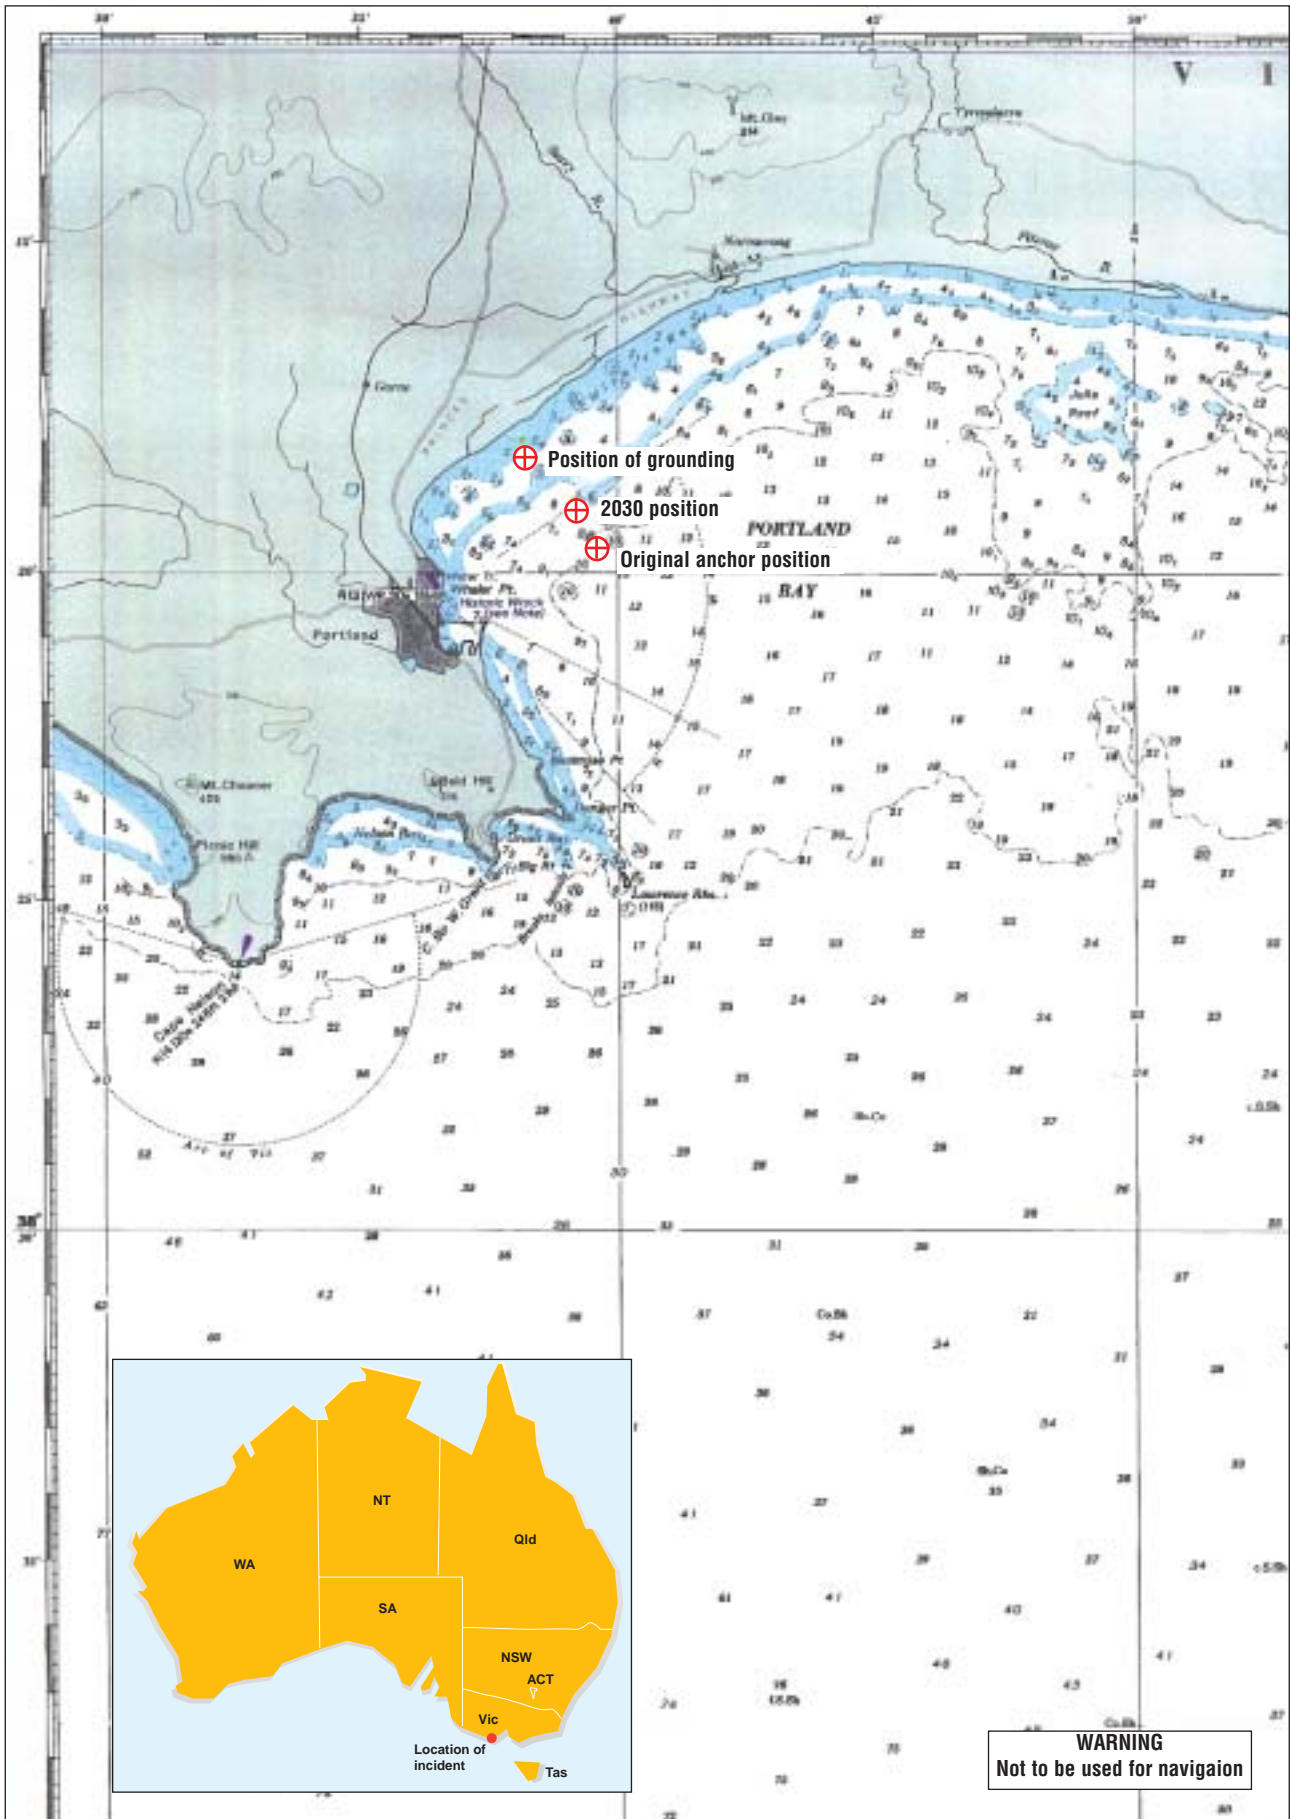
**FIGURE 2:**  
Portion of Chart Aus 786 (as used by the vessel) showing positions of *Devprayag*

At 1950, *Devprayag* anchored off Portland, about 0.5 miles south of the 6 fathom contour, 2.02 miles from the main breakwater, which was bearing 231° (T). This position was about 1.5 miles south-southeast of Minerva Reef. The master, expecting strong winds, used the port anchor and 7 shackles (192m) of cable in about 16 metres of water.

the day before. The bearing and distance of the main breakwater was now 216° (T), 2.3 miles. The distance from the nearest land was 1.4 miles. The vessel maintained this position for some time.

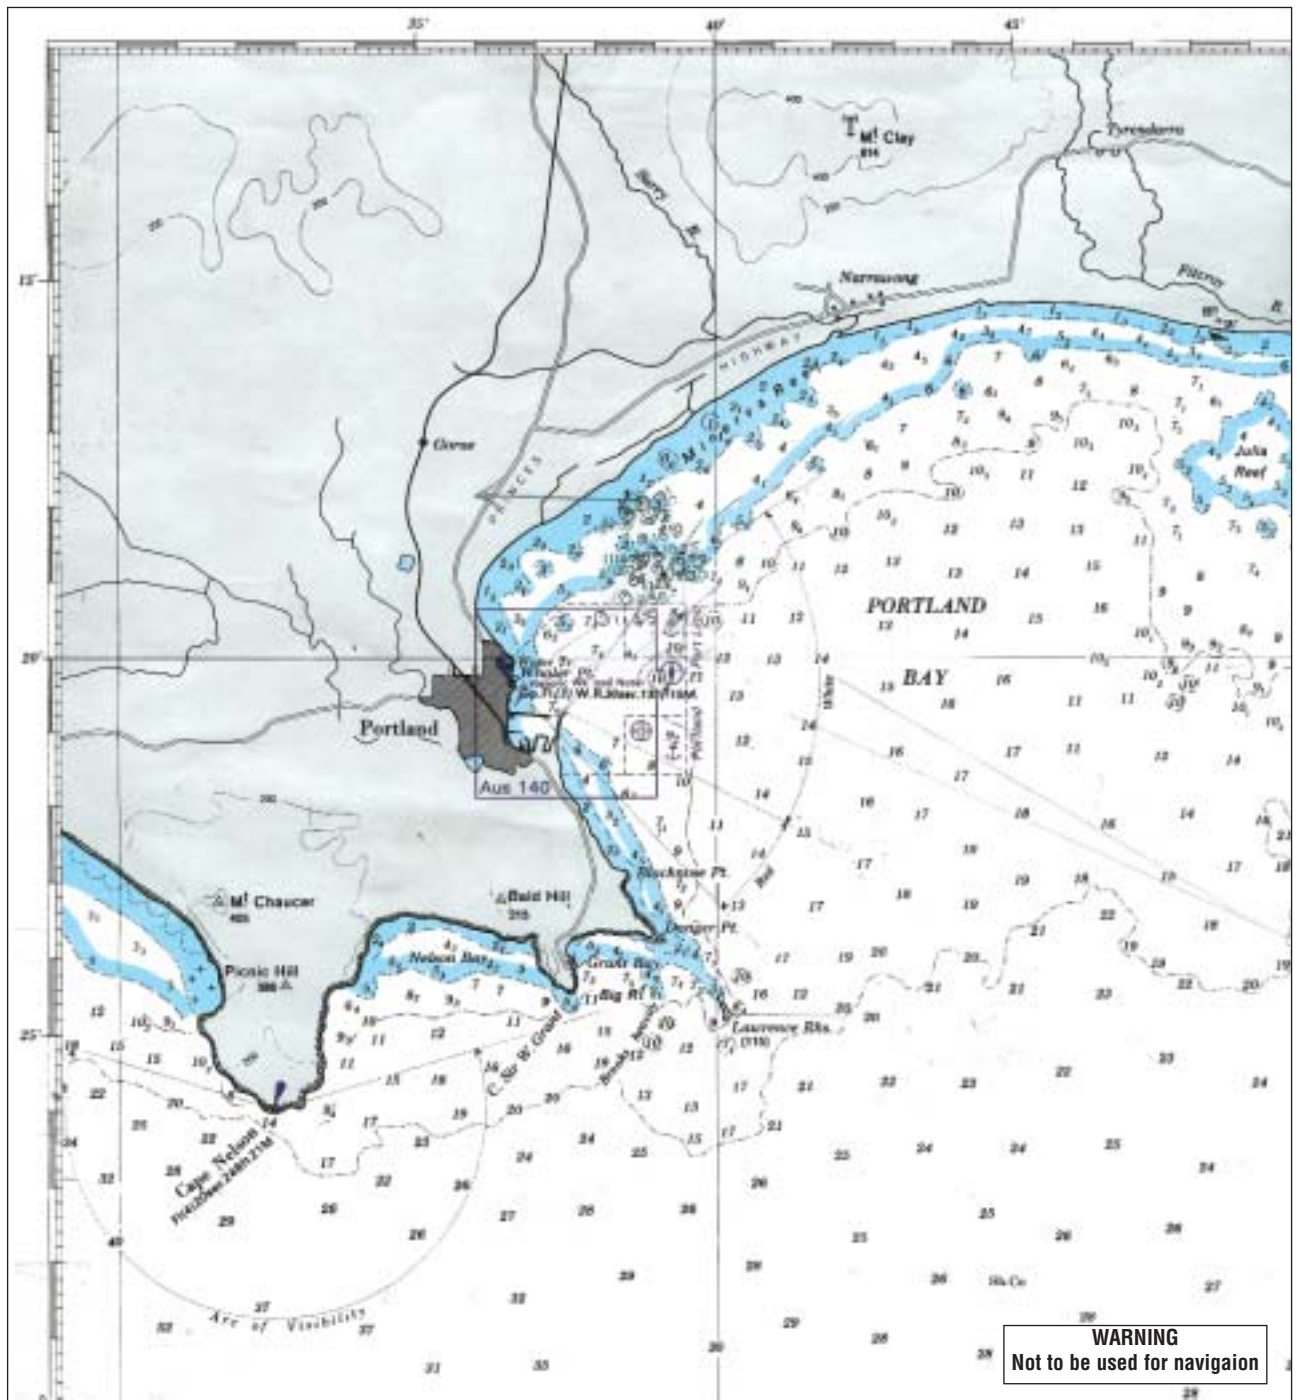
**FIGURE 3:**  
*Devprayag's* chart with anchor and other positions prior to grounding erased and overprinted when vessel refloated

Positions plotted on the navigation chart by the cadet and the second mates, as the ship dragged and grounded, had all been erased before the investigation commenced, the master stating that he 'might have been responsible' for the erasures. This made it difficult to verify, from the chart, those positions or the direction in which the ship had dragged during the incident.

At best, the overwriting in the log and the chart erasures show unprofessional watch-keeping practices. At worst, there was a deliberate attempt to obstruct the investigation.

8. The small scale chart in use might have caused the mate and the cadet to underestimate the significance of the distance that the vessel had dragged at about 1815.

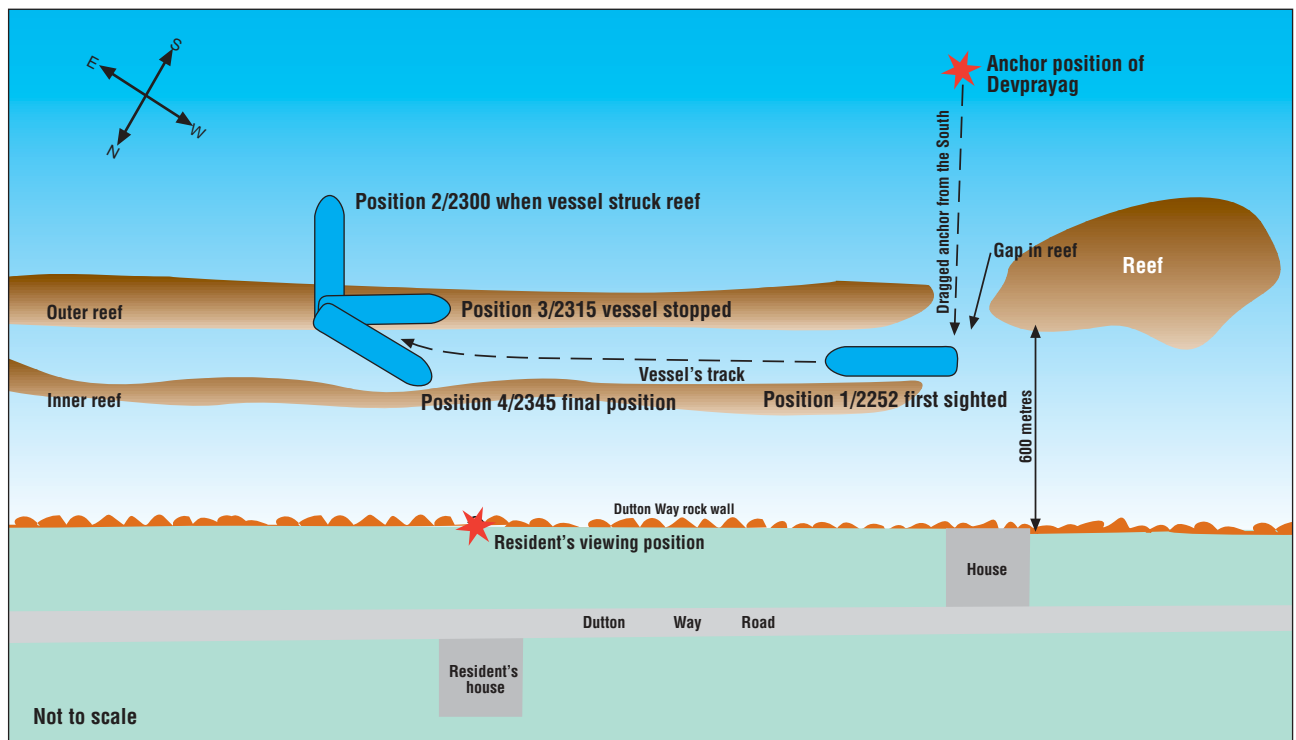
**FIGURE 4:**  
Sketch of incident supplied by local resident

A local resident, himself a seafarer, who had witnessed the incident from the shore, provided the ATSB with a diagram of the track followed by the ship, from his perspective, in the hour before the grounding.

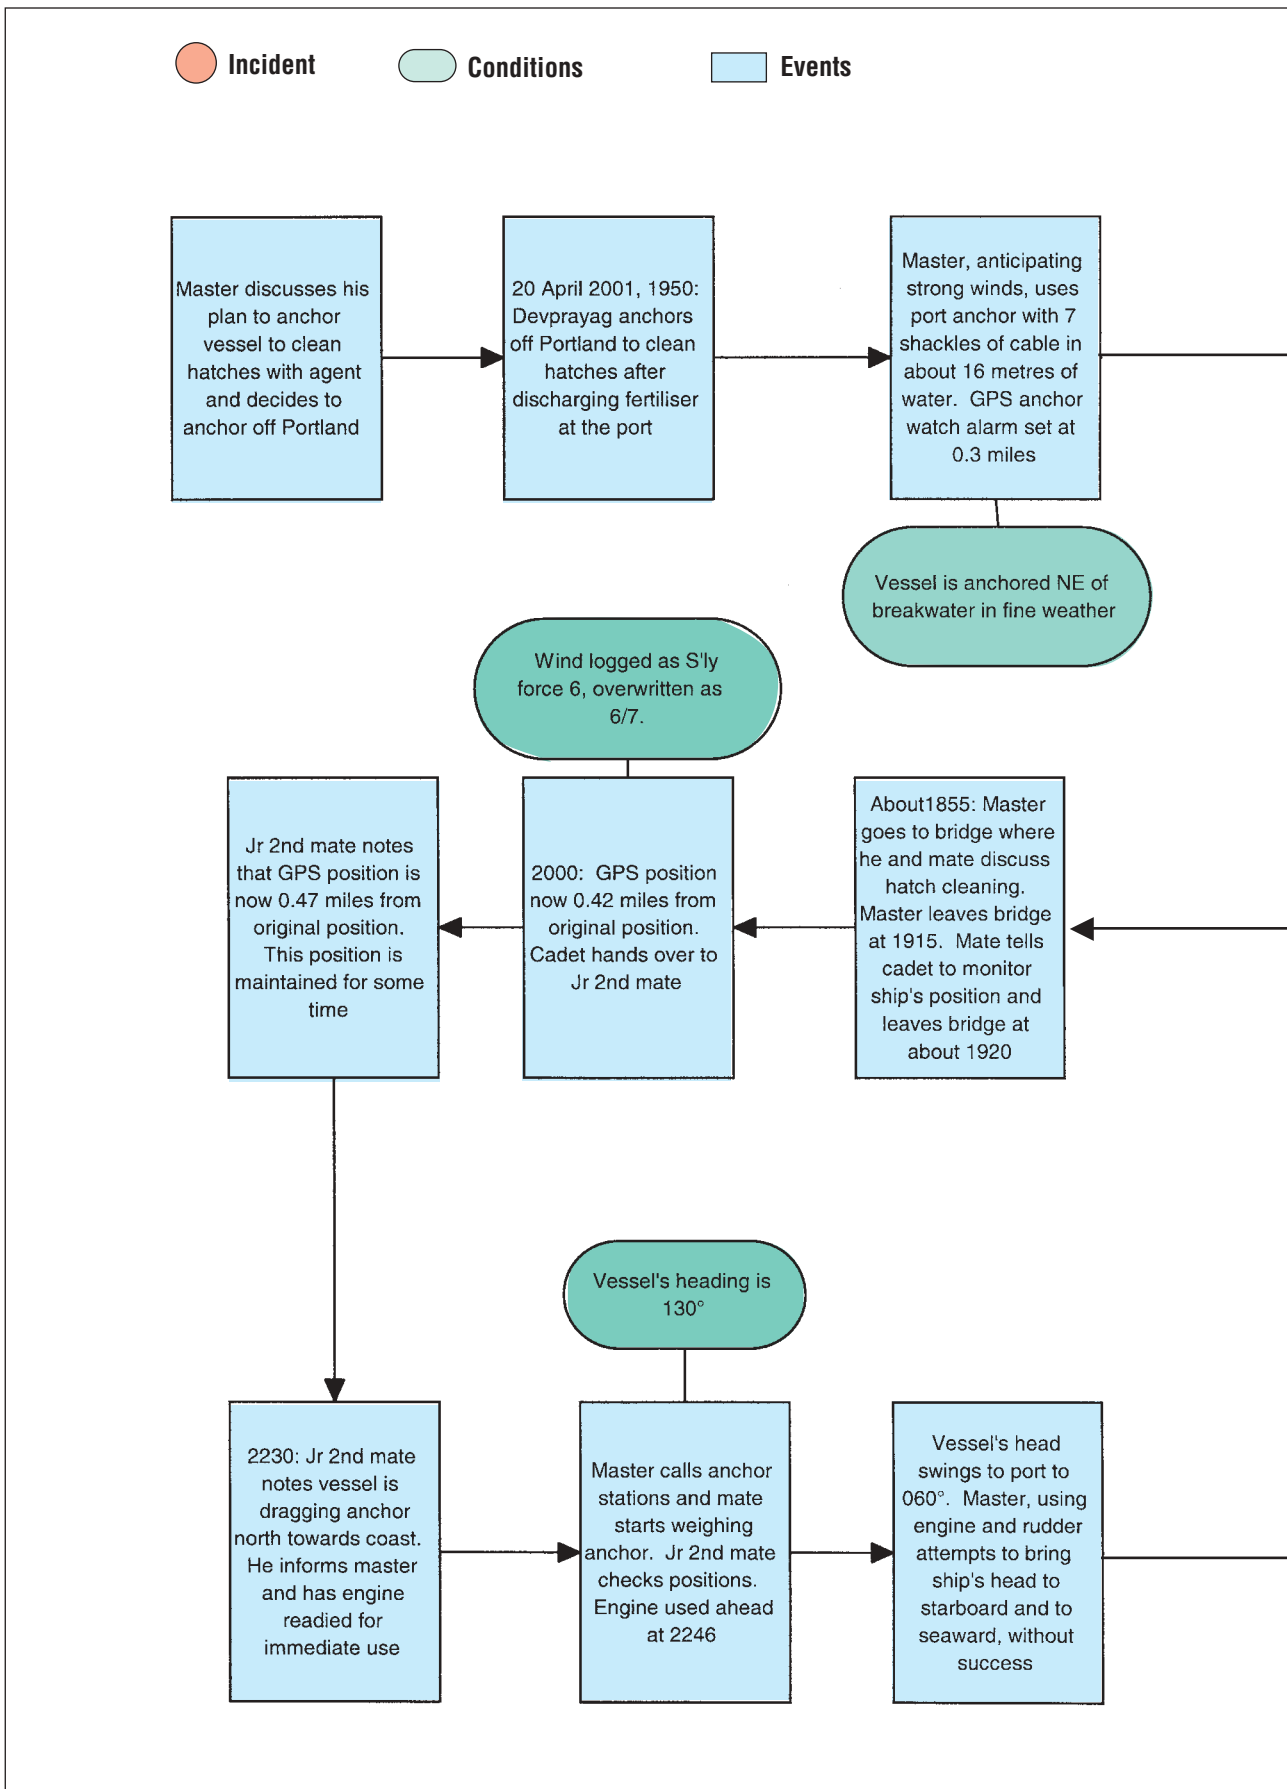
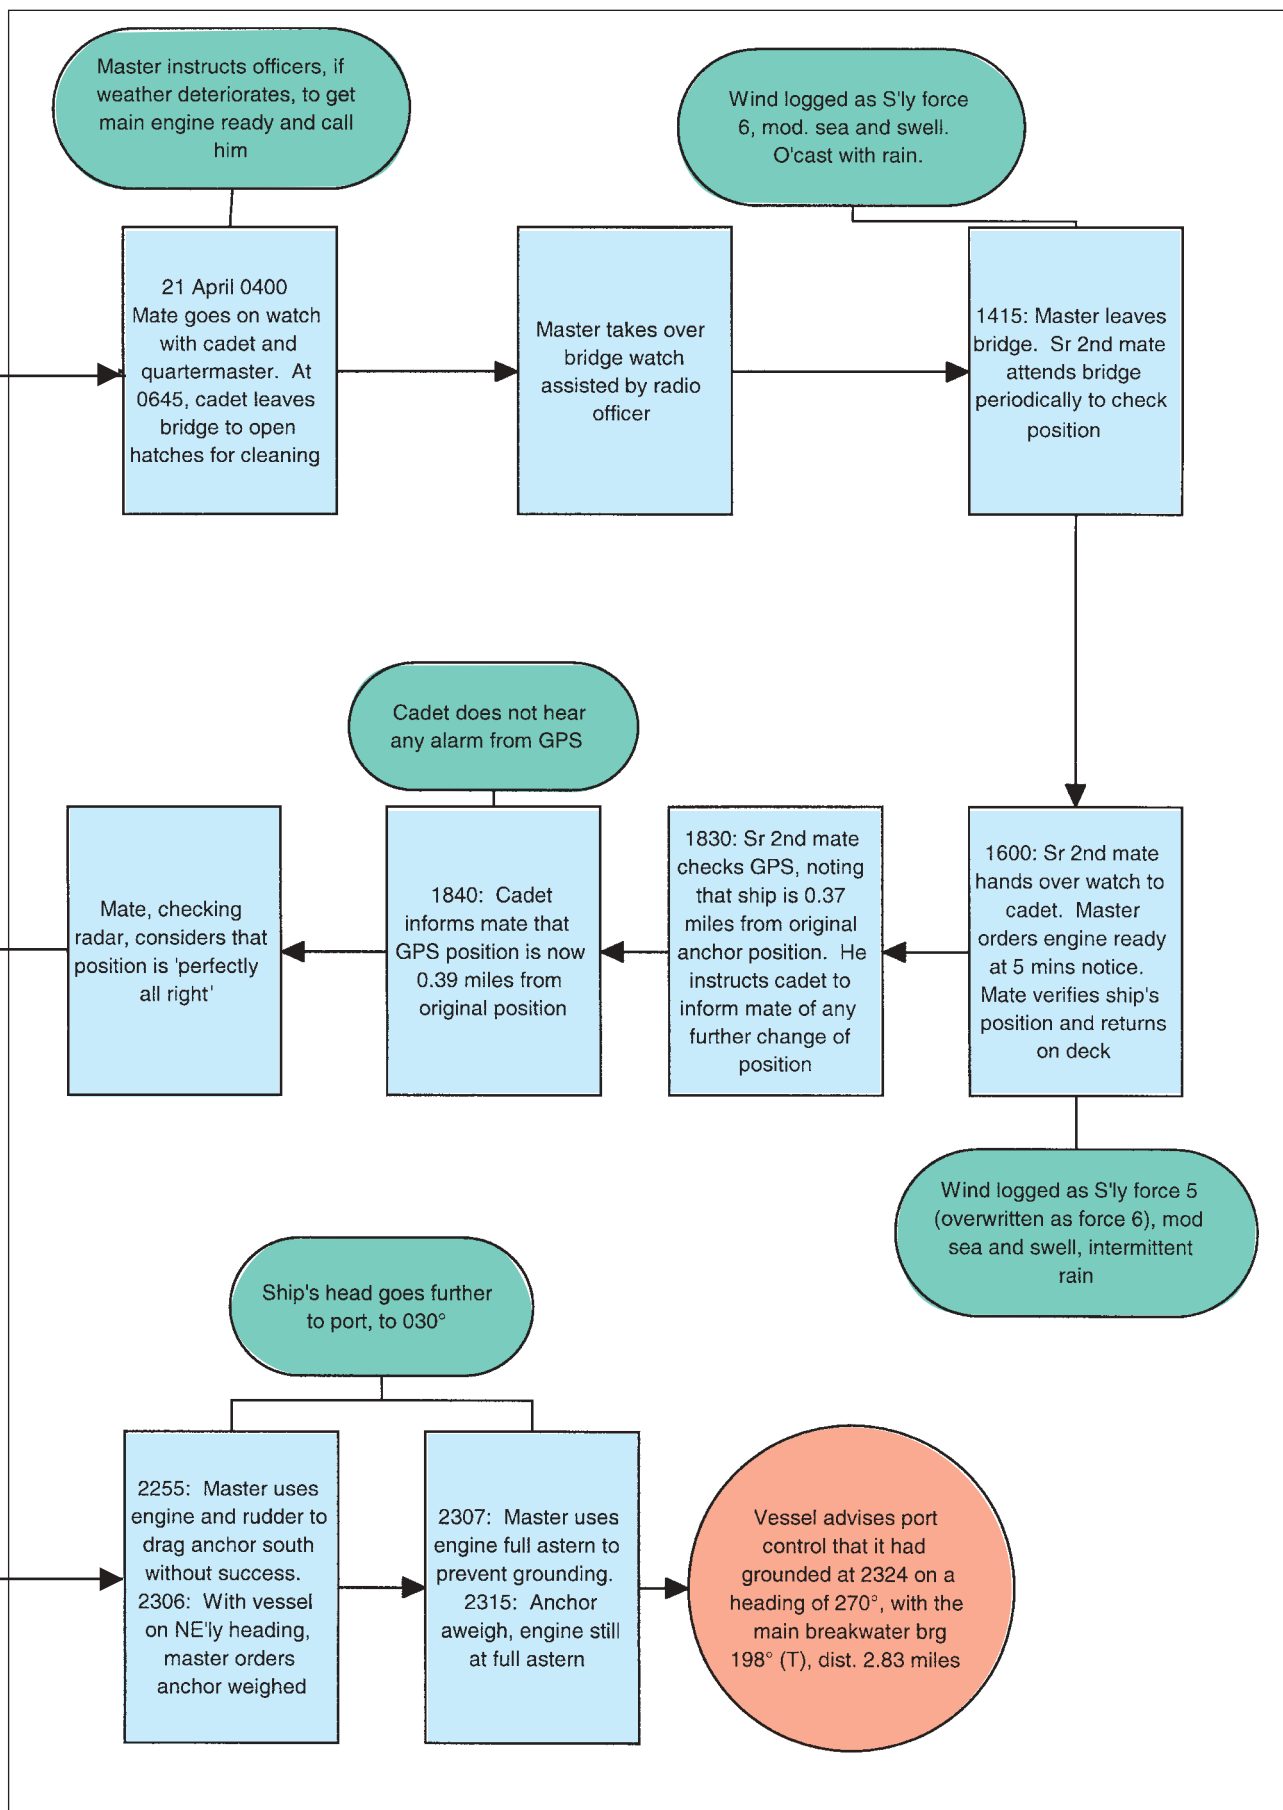
**FIGURE 5:**  
**Devprayag: Events and causal factors chart**

1. The master had anchored on a lee shore and permitted the vessel to remain at the exposed anchorage in deteriorating weather conditions.
2. The master had not noted the warning in the Sailing Directions that the anchorage at Portland was not recommended in strong E and SE weather.

3. Insufficient notice was taken of the gale warning for the area.
4. Advice in the company's safety manual, to consider picking up the anchor in good time to clear the anchorage when threatened by heavy weather or storm conditions, was not heeded.

The Inspector recommends that mariners note the importance of using Sailing Directions when planning passages, when entering or leaving a port or anchoring in or near a port.

The Inspector also recommends that mariners be fully aware of weather conditions and the fact that inclement weather can alter a relatively safe anchorage into one that is unsafe.
