MARINE SAFETY INVESTIGATION

REPORT 168

Independent investigation into the contact by
the Russian flag container ship

with the navigational beacon 'E5'
in Moreton Bay, Queensland on 21 April 2001

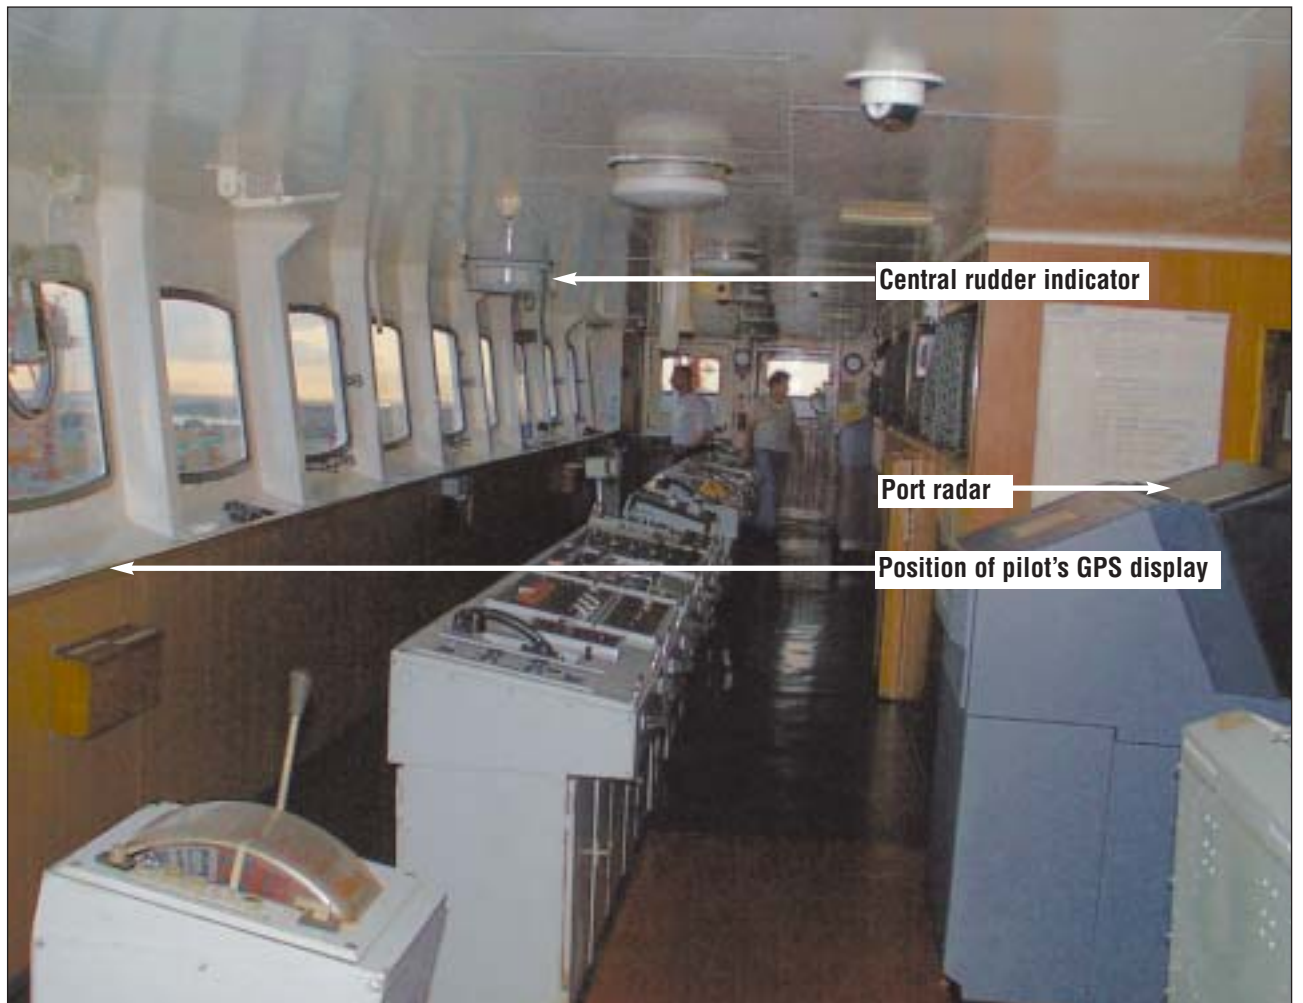
FIGURE 2:
Wheelhouse from port side

At interview the pilot stated that he could not see the rudder indicator until he had moved from his position to about 5 m to port of the centre line. This rudder angle indicator was of a type that is mounted on the deckhead. It is of circular construction showing the rudder angle on the port and starboard sides of the wheelhouse and also to a person, such as the helmsman, standing on or near the centre line.

Even when dimmed, the rudder angle appeared easy to see on the rudder angle indicator.

For the pilot, this was exacerbated by the fact that the only gyro repeater in the wheelhouse, other than those on the radar displays, was on the steering column. When the ship was turning, the pilot could not monitor the turn at his preferred conning position. He relied on the helmsman to relay the ship's heading.

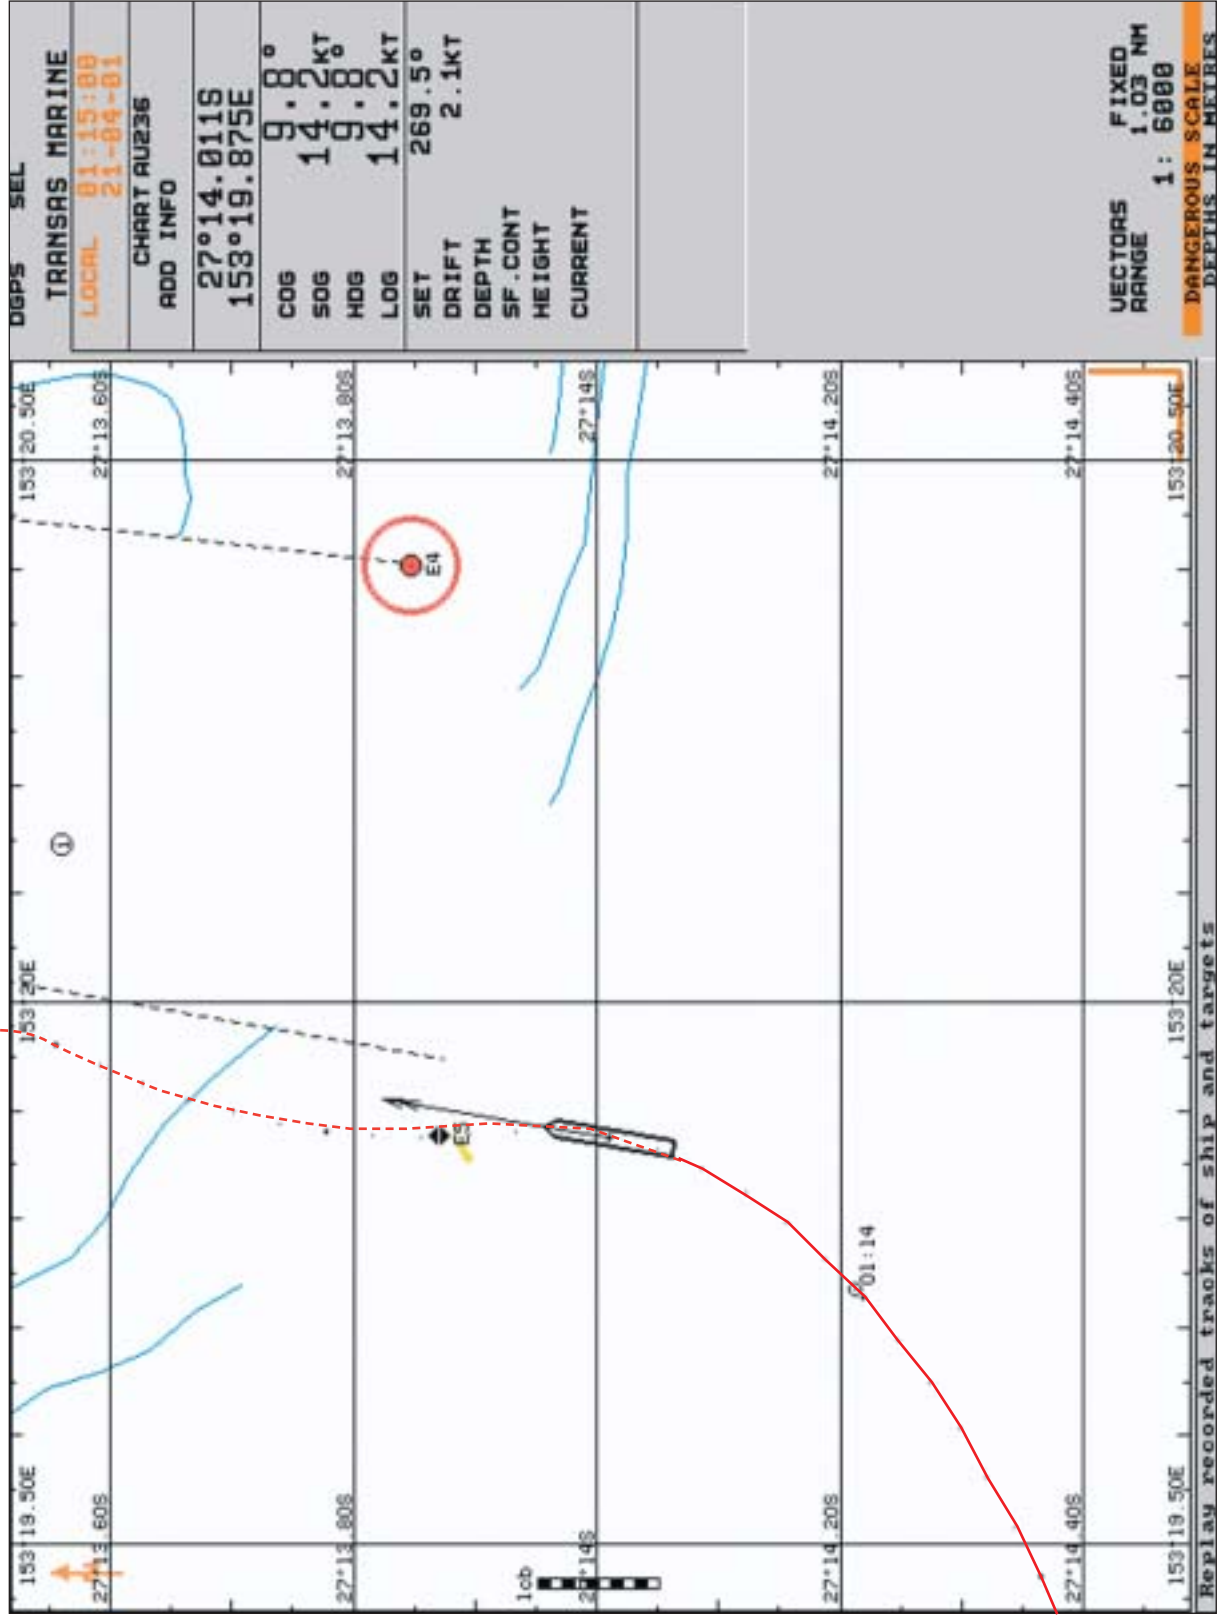
FIGURE 3:
 Replay recorded track of *Maksim Mikhaylov*

Based on the timing taken from the pilot's electronic chart, initial contact was made between beacon E5 and the break of the forecastle at 0115:30 at a speed of 14.5 knots on a heading of 038° (from the course recorder trace). The ECS does not record ship's heading information but it showed a course made good at this time of 000°. The ship

The electronic chart record shows that the ship was consistently 370 m to the north of the pilot's planned track. This was not due to any set; there was little tidal effect during the passage across Moreton Bay. The pilot stated that he was aware that he was to the north of his proposed charted track but, given the shipping situation (no traffic in the area), the calm weather and clear night, he was not concerned.

pilot's ECS plot. At 0114, with beacon E5 bearing 021.2° on the port bow at 0.37 miles, the ship started to alter course to enter the East Channel. The ship had effectively followed the pilot's planned track even though the ship was offset to the north. The pilot did not initiate the alteration of course with beacon E5 at 5° on the port bow, as recalled by the ship's personnel. The evidence available supports the pilot's account in relation to the initial alteration position.

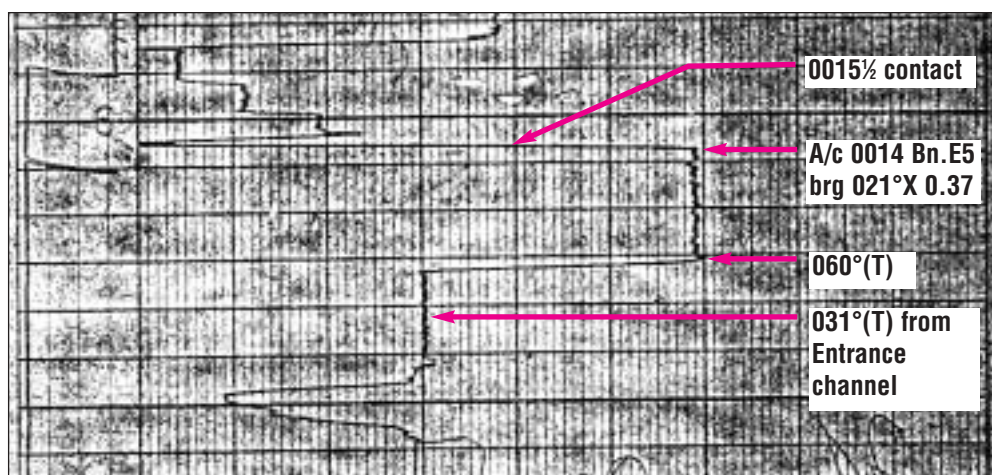
FIGURE 4:
Course recorder trace *Maksim Mikhaylov*

In an attempt to reconcile the differing accounts of the ship's staff and the pilot in relation to the rudder orders, the course recorder trace from 0114 to 0120 was enlarged and examined. There is agreement that the initial order was for 5° port rudder.

The course recorder indicates that the ship altered its heading through 60 degrees in 2½ minutes, reaching a heading of 000°(T) at 0116:30. (The course recorder shows a very brief excursion into the 270°–360° quadrant.) The ship's heading then returned to a heading of about 025°(T) at 0118, before steadying on a course of 020° at 0119:30.

The rate of turn was calculated from the slope angle of the recorder trace. The results are approximate, as there is inevitably some pen vibration. There appear to be four distinct components to the curve:

- for the first minute (0114 to 0115) the rate of turn was 21°/min;
- for the next minute (0115 to 0116) the rate of turn increased to 33°/min;
- for the next 30 seconds (0116 to 0116:30) the rate slowed to about 10°/min;
- then returning to a heading of 025°(T) at a rate of 15°/min.

From analysis of the slope of the course recorder trace there is no indication that the ship significantly slowed its rate of change of heading over the first two minutes of the turn into the East Channel. This suggests that there was no early intervention with counter rudder to support the ship's account. However, given the limitations of the course recorder trace, the analysis cannot be taken as positive support for the pilot's account.

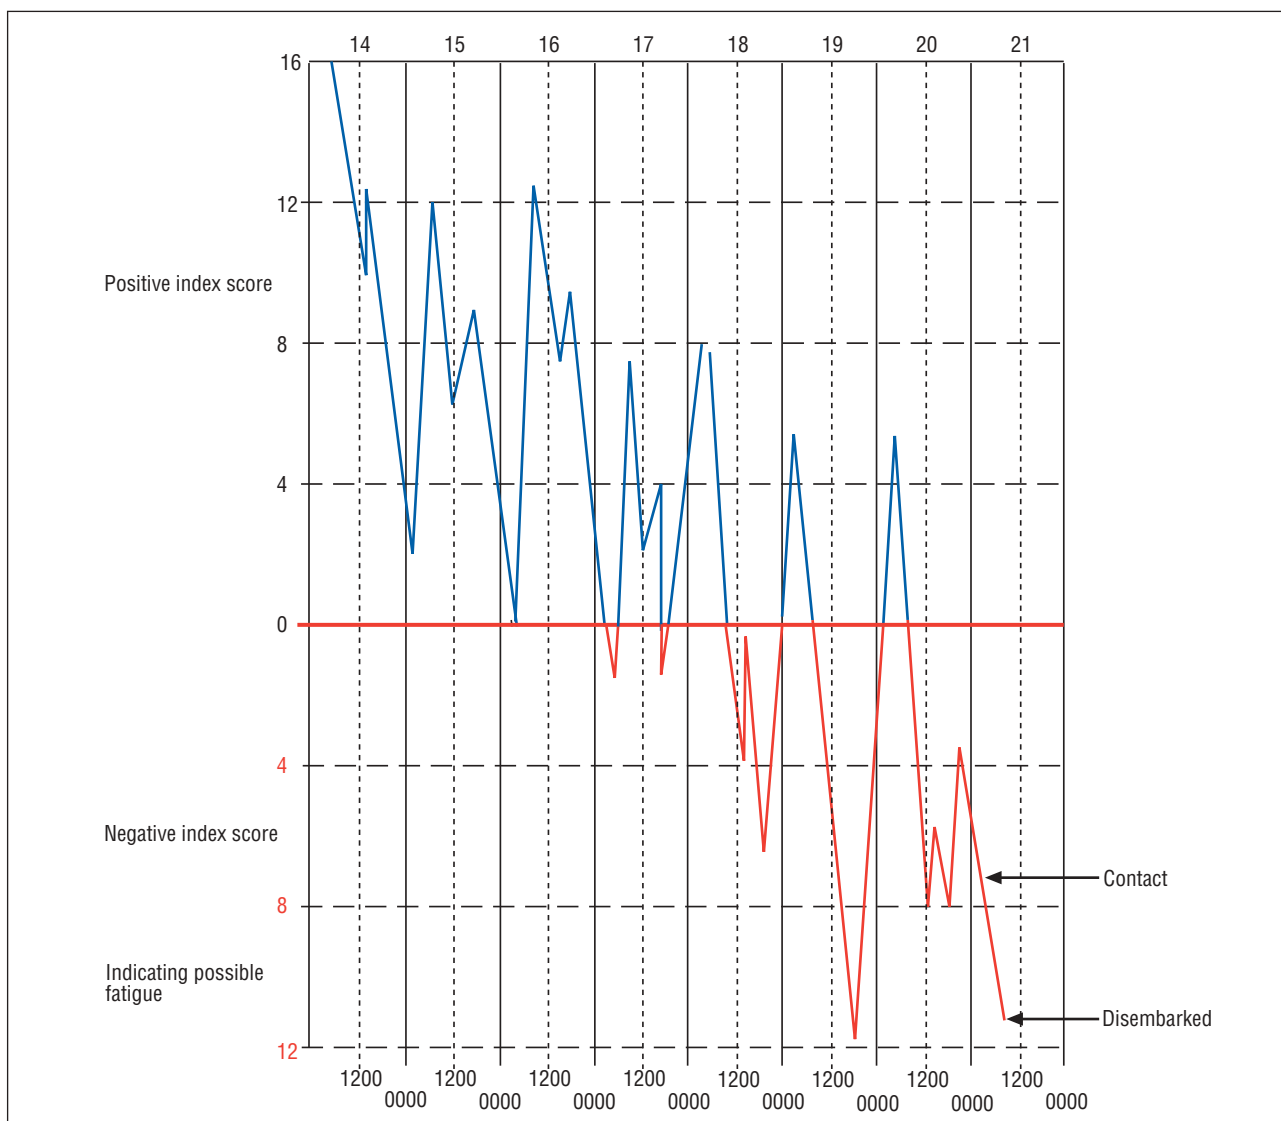
**FIGURE 5:
Pilot's work hours showing sleep credit/deficit analysis**

To assess the pilot's possible exposure to fatigue the simple test of 'sleep credit/deficit' was applied to the pilot's work hours. The system credits sleep hours with a credit of two points for every hour of sleep and one point debit for every hour awake. The system makes no allowance for physical or mental effort or for circadian rhythms. A negative score only indicates that the work hours warrant greater examination.

The pilot had returned from a period of leave, starting the ten day roster on 12 April. Examination of the roster hours show that on the morning of 14 April the pilot started the day with a full credit of 16 points.

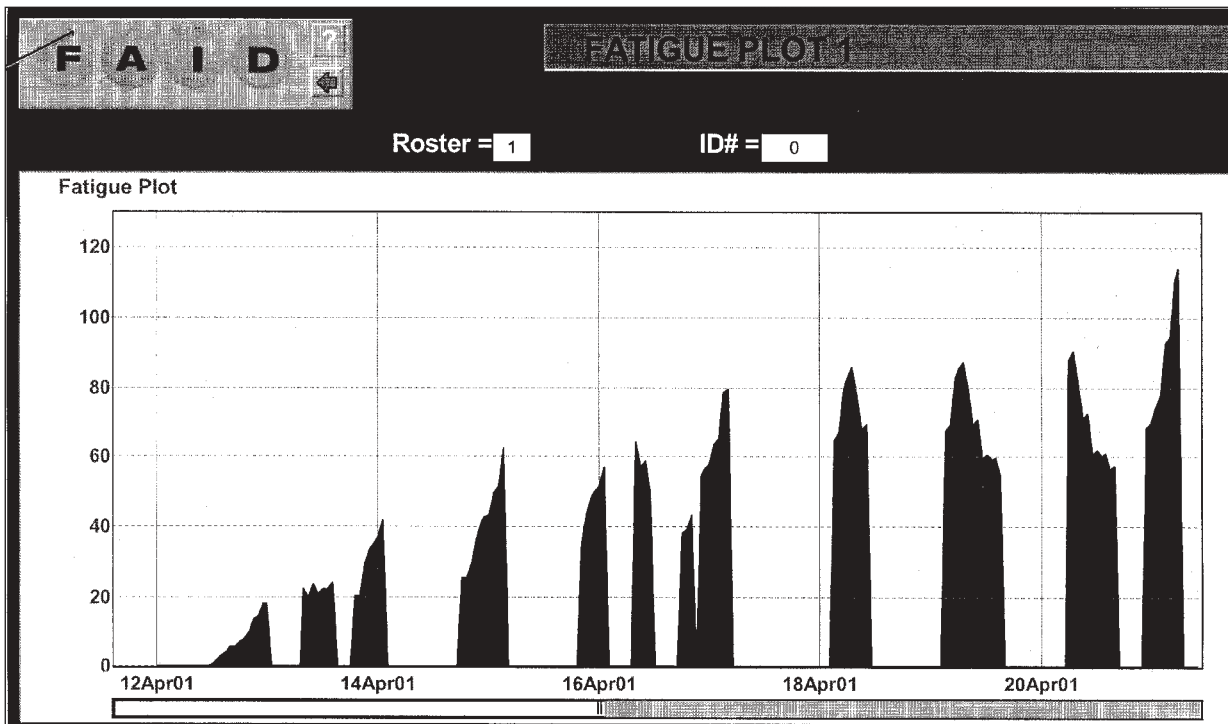
FIGURE 6:
Output graph from FAID 330E program

The pilot company's computer program generated a fatigue index score of 75 at 0115 on 21 April. This was nearly the same score as generated by the FAID 330E fatigue program, based on the conservative, 'low' duty hour estimates. Using the total hours awake, the

FAID 330E fatigue program gave a fatigue index score of 120 at 0115. This reflects a degree of subjectivity in assessing the input hours.

While the pilot was operating within the pilot company's guidelines, having analysed the pilot's routine over the preceding days and assessed the pilot's actions leading up to the contact with beacon E5, the Inspector is satisfied that some level of fatigue contributed to the incident.
