Navigation Act 1912
Navigation (Marine Casualty) Regulations
investigation into the serious injury to a crew member
on board the Bahamas flag bulk carrier
CSL Pacific
at sea, south of Portland Victoria
on 18 February 2002

Report No 175

January 2003

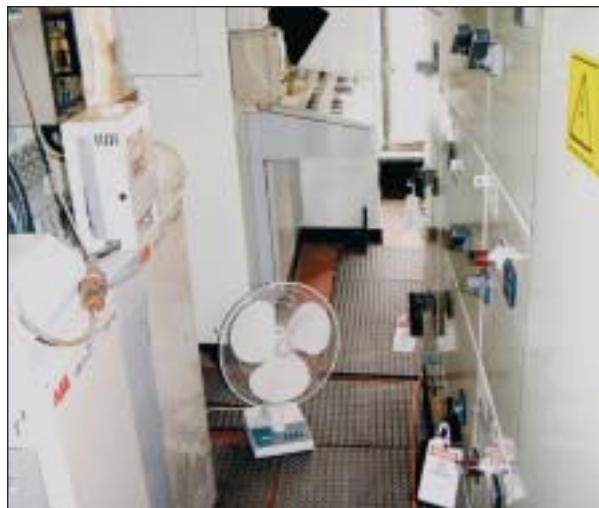
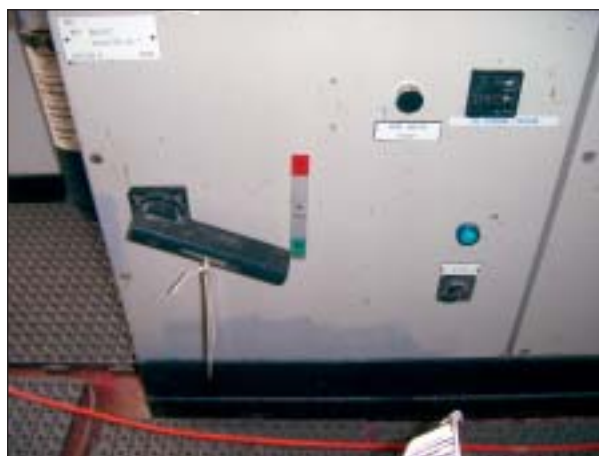
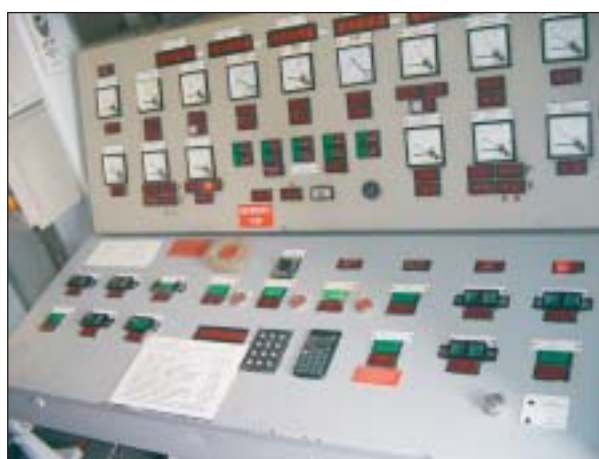
FIGURE 2:

Inside number 1 cargo control room showing bucket elevator circuit breaker and the control panel

Prior to starting work on number one bucket elevator, the deck mechanic went to number one control room to check that the circuit breaker for the main electric motor on number one bucket elevator was open. He found that the circuit breaker was open but he did not place a danger tag on the circuit breaker, nor did he lock the breaker tripping lever in the 'off' position.

There was no danger tag on the breaker and he had momentarily forgotten about the work at the top of the bucket elevator.

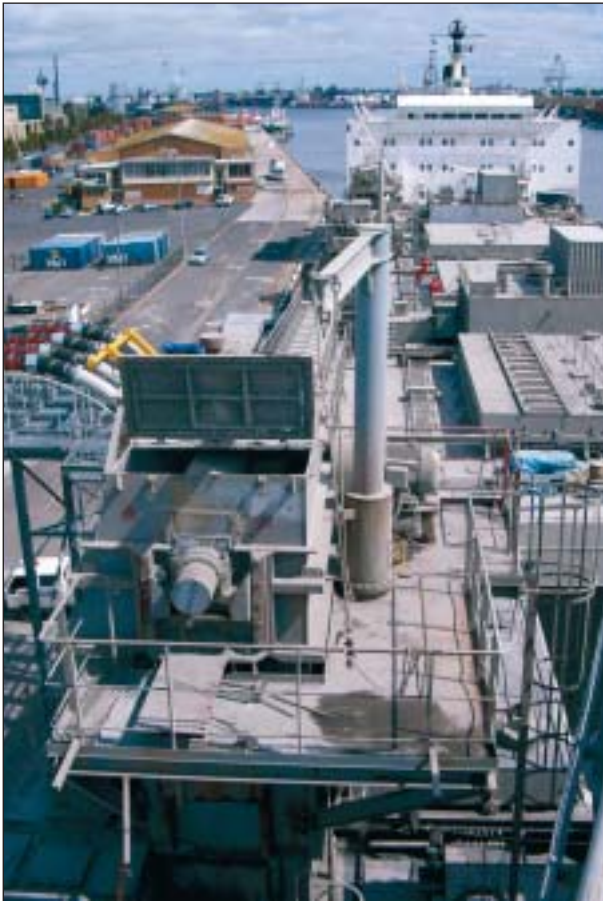
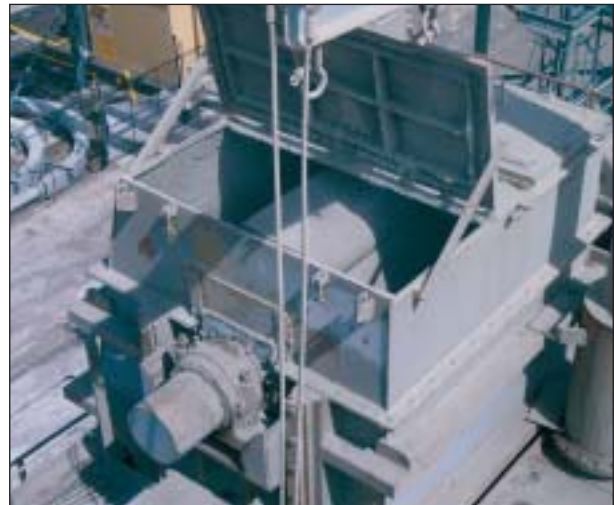
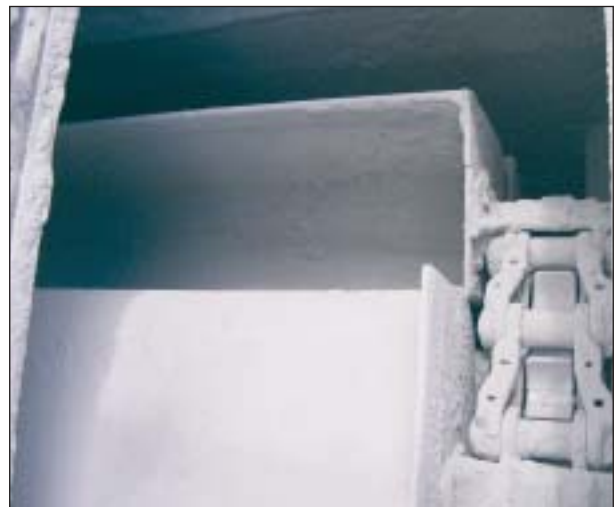
FIGURE 4:
Two views of the top of number one bucket elevator,
and one view inside

At this time the fitter working inside number one bucket elevator was lying with his torso inside the bucket and was welding with one foot resting on one of the drive chains. The other deck fitter was standing on top of the housing outside the bucket elevator and the deck mechanic was in the engine room workshop.

When number one bucket elevator moved, the deck fitter inside the housing was rotated over the top of the elevator inside the bucket he had been welding, and was then thrown out. He was left hanging by the hands on one of the buckets and the adjacent drive chain crying out in pain. His right hip had been dislocated, his pelvis and a vertebrae had been fractured, two ribs were broken and he sustained some ligament damage in the groin area.
