MARINE SAFETY INVESTIGATION  
No. 176

Independent investigation into the grounding of the  
Panama registered bulk carrier

# La Pampa

at Gladstone, Queensland  
27 March 2002

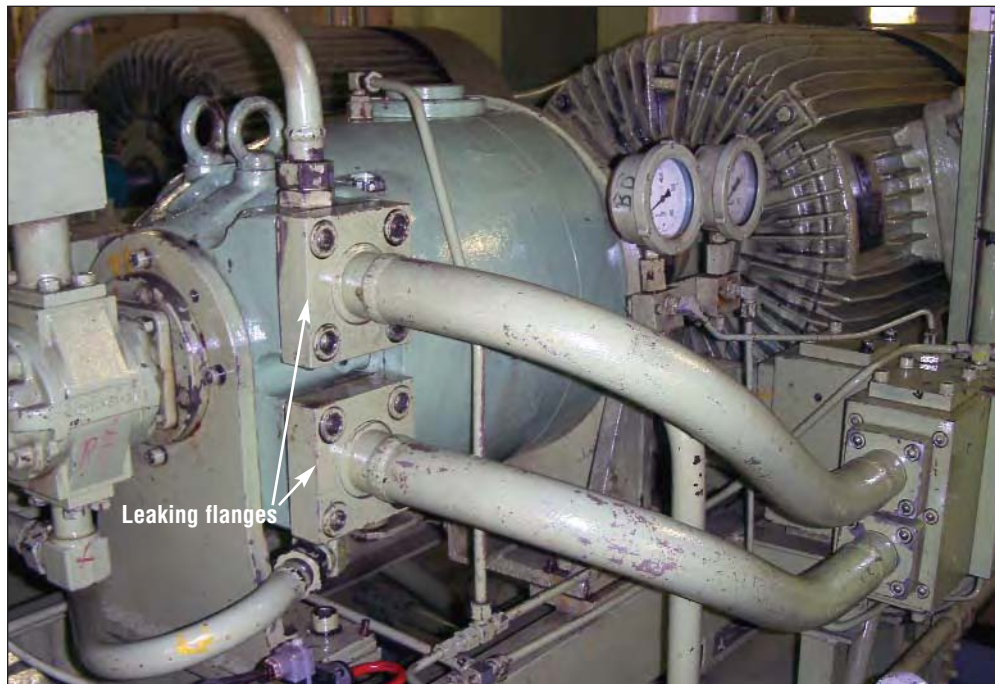
**FIGURE 2:**  
**No.1 main steering pump and motor**

In the steering flat, the chief engineer found that the suction and discharge flanges of number one main steering pump were leaking, with oil spraying out over a distance of some metres (see figure 2). He telephoned the mate on the bridge and asked him to stop number one pump. Around this time the low-level alarm on the steering gear header tank sounded.

When the chief engineer went to the steering flat at 0710, he found that number one steering pump was leaking oil from both flanges (its suction and discharge ports). It would appear that the seals on the pump flanges had failed as a result of over-pressurisation. The service report states that the pressure valve assembly (which includes the pump relief valves), after the self cut-off valve, was not operating correctly after the incident due to some debris lodged in the balance line in the self cut-off valve. Had this valve failed at the time of the incident, the pump would have been isolated from its relief valves and this is one possible explanation for the over-pressurisation which caused the seals to fail at the pump ports.

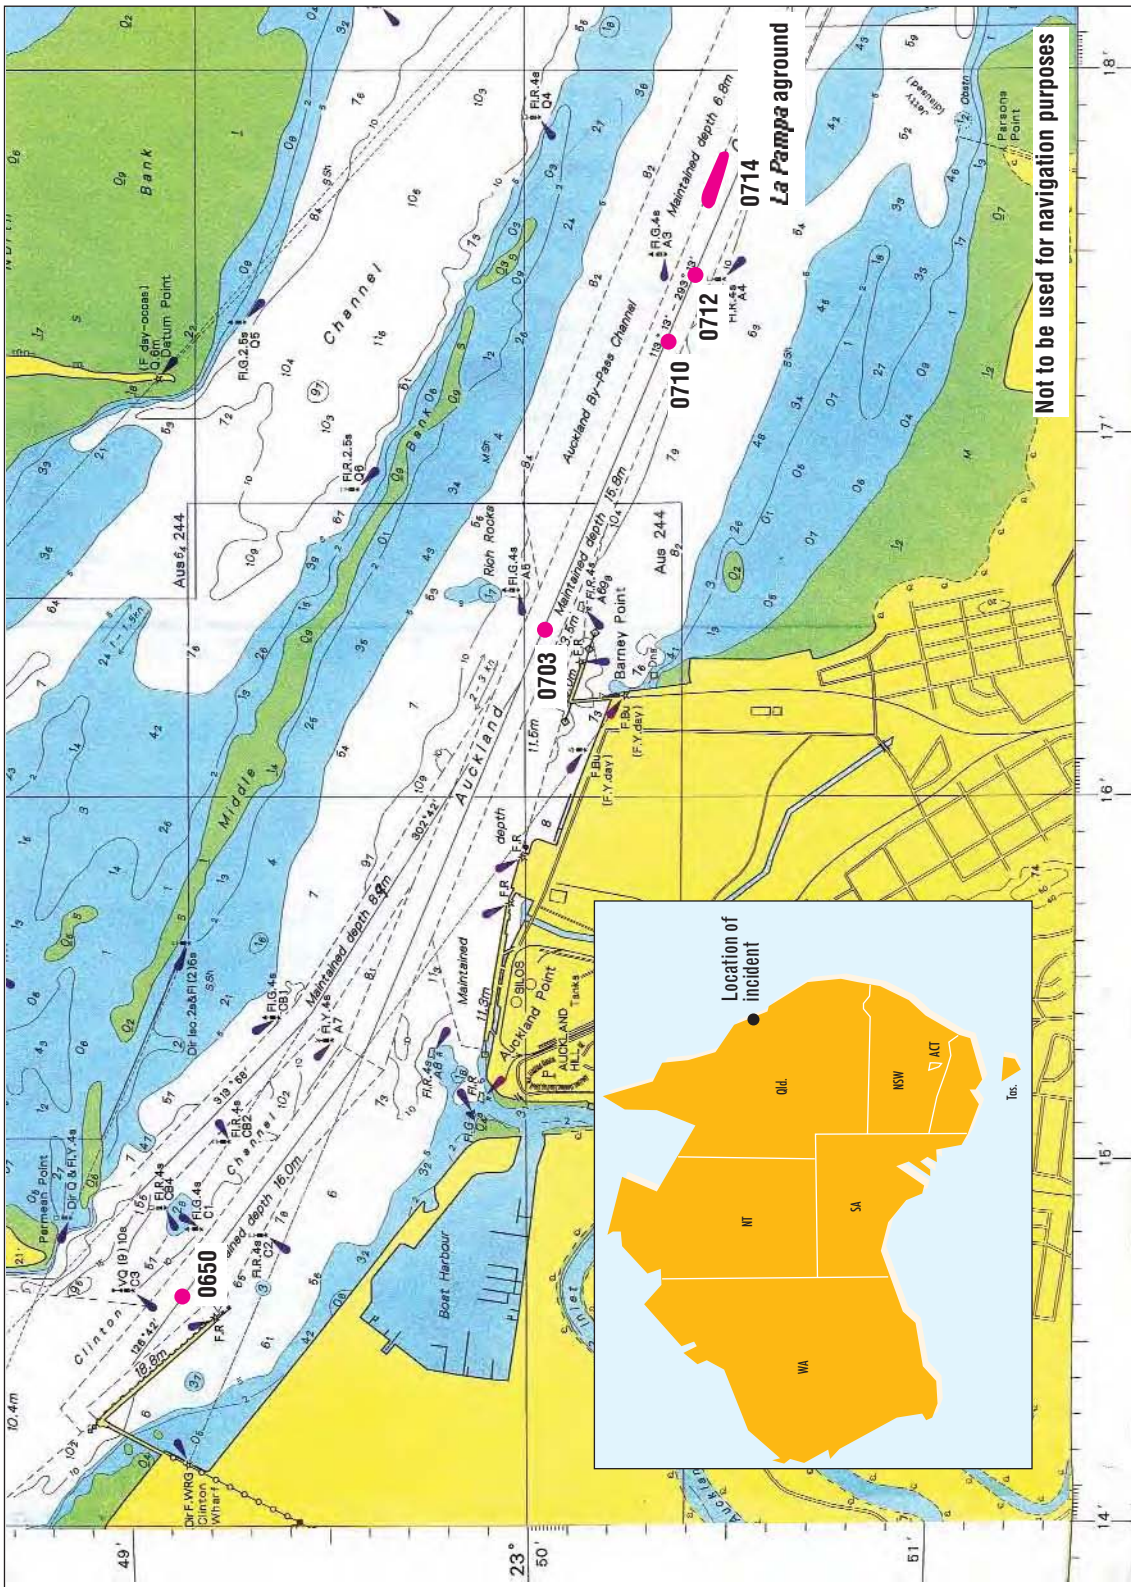
**FIGURE 3:**  
**Portion of chart Aus 245 showing *La Pampa's* track outward to position of grounding**

The vessel developed a swing to port and, at 0714, at a speed of about 5 knots, it made contact with the bottom on the northern side of the channel, grounding on a heading of about 105°, about a cable (185 metres) east of beacons A3 and A4 (see figure 3).

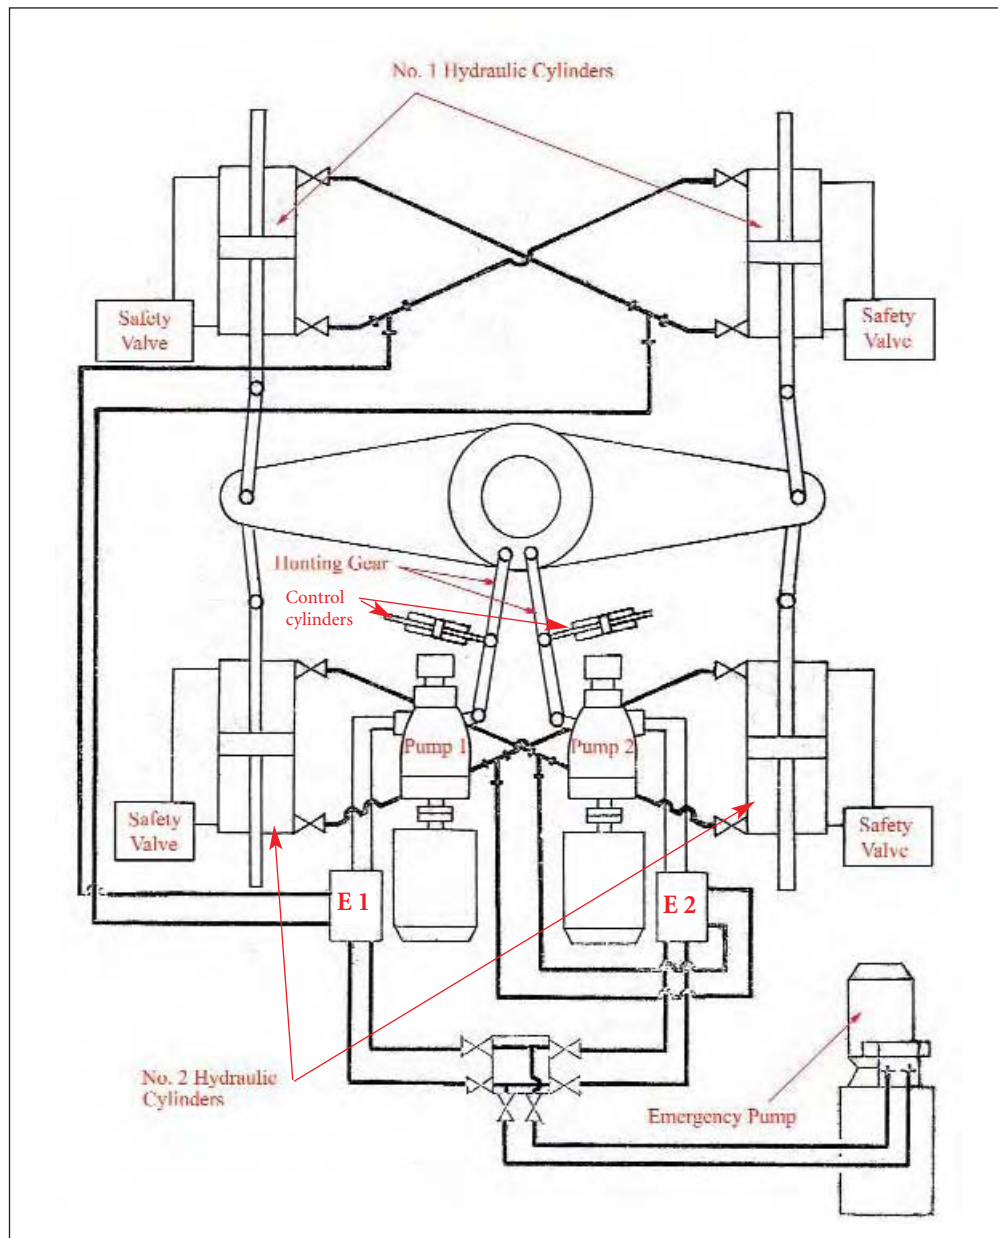
**FIGURE 6:**  
*La Pampa steering gear schematic*

*La Pampa's* steering gear is a four-ram system, which utilises two main variable displacement pumps (swashplate) and a fixed displacement emergency pump. The four rams are double acting and arranged with two port and two starboard rams which are attached to the forward and after sides of the rudder tiller (see figure 6). The main pumps and associated control valves are mounted over the number two rams on the starboard side.

The system is designed so that a single main pump is normally used to operate the steering gear, with complete redundancy of both the main and control system hydraulics provided by the second pump. Both pumps may be used when the ship is navigating in confined waters where a faster response to helm orders is desirable. Variable displacement pumps deliver oil at varying flow rates in both directions, that is the ports on the pump may be either suction or discharge depending on the position of the pump control rod. When the control rod is in the neutral position, there is no flow of oil to or from the pump.

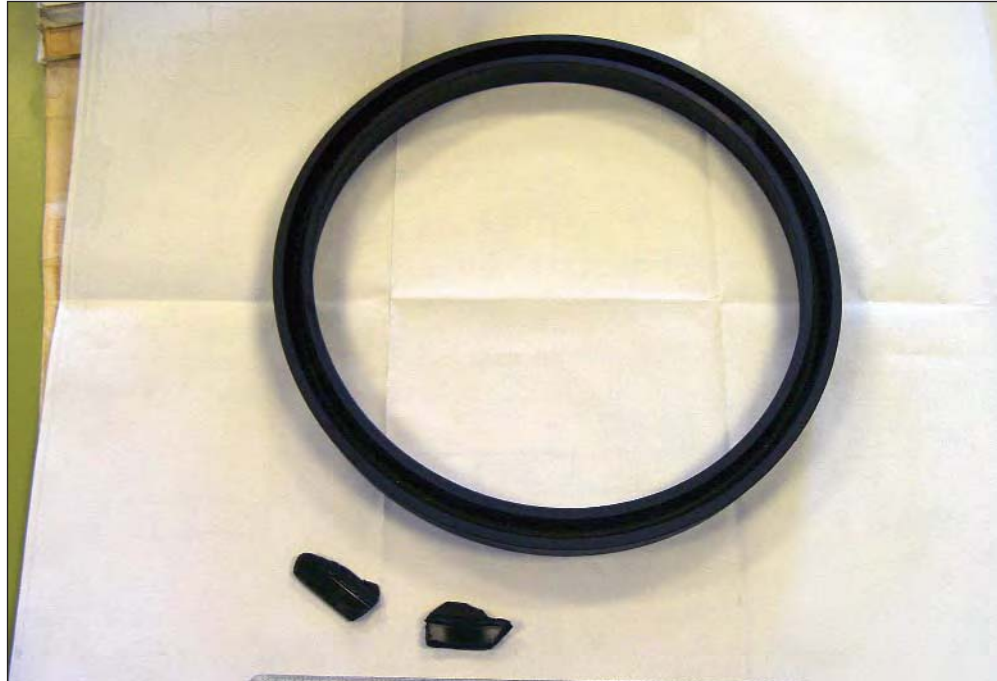
**FIGURE 7:**  
Piston seal and debris

one side of the piston to the other thereby connecting the pressure side of the system to the drain side. With the cross connection valve E2 open, the whole system was effectively crippled. From the damage to the seals and seal backing rings, it is not possible to determine exactly when the seal failure occurred. However, once the seals started to break down and pick-up on the inside of the cylinder bore, disintegration would have been rapid. It is also probable that the debris, resulting from failure of the seals in one ram, flowed to the other cylinder and caused the seal failure there.

Later the chief engineer stated that he had found rubber debris jamming the E2 cross-connection valve (see figure 7). He knew it was likely that the rubber debris was from ram seals but he could not ascertain which ram or rams were faulty. It is not clear whether the cross-connection valves (E1 and E2) were both open during the subsequent operation of the system when further steering failures occurred. In any case, if the system was still split, number two pump, which was being run, would have been supplying the defective number two rams (see figure 8). If the system was cross-connected, flow across the defective number two ram piston seals meant that pressure could not be built up to drive the sound number one rams. The only way that emergency steering could have been effected at this point was by isolating number two rams and using either number two pump or the emergency pump to drive the cross-connected number one rams.

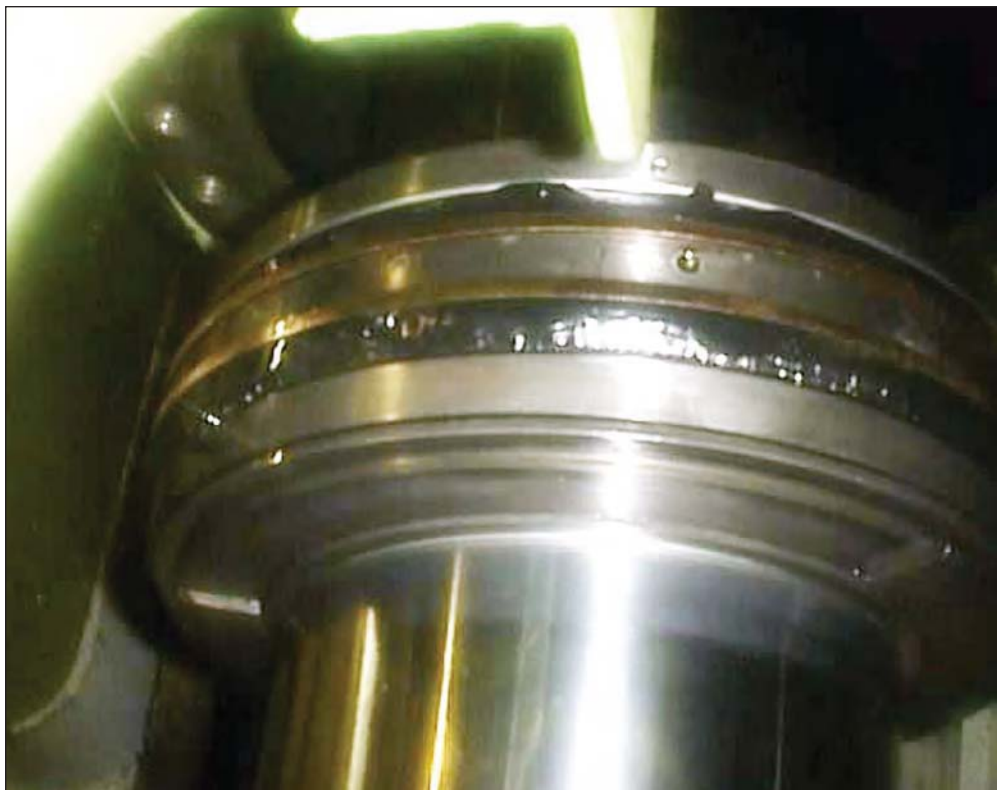
**FIGURE 8:**  
Starboard ram piston showing damaged seal rings

The two no. 2 starboard rams, located beneath the swashplate pumps, were found to have severely damaged rubber seals, in numerous segments. The surfaces on the remnants of the seals were smoothed.

Heavier scoring of no. 2 starboard chrome rams than in evidence on no. 1 port rams, without any evidence of any oil leakage.

No. 2 starboard aft outboard seal retaining ring was found distorted and was renewed.
