MARINE SAFETY INVESTIGATION
REPORT 182

Independent investigation into the grounding of the
Greek registered ship

Doric Chariot

at Piper Reef, North Queensland
on 29 July 2002

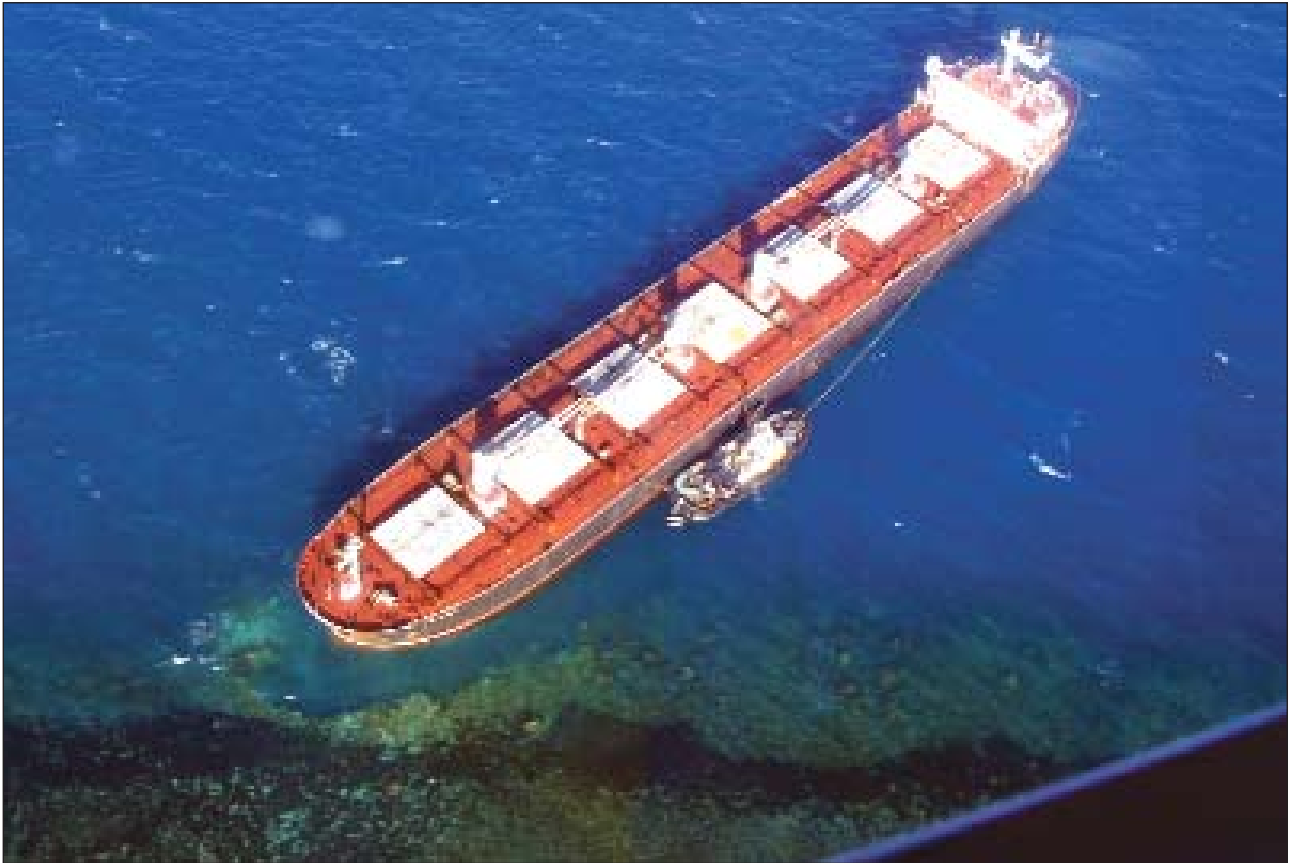
FIGURE 1:
Doric Chariot aground on Piper Reef

Doric Chariot grounded at about 0335, 0.52 miles south from Piper Reef light beacon on a heading of 343°(G), in position 12° 15.593'S 143° 15.038' E by the ship's GPS. The high water at Piper Reef was at 0001 at a predicted height of 2.3 m and the next low water was at 0741. The tide at Piper Reef had been ebbing for about 3½ hours.

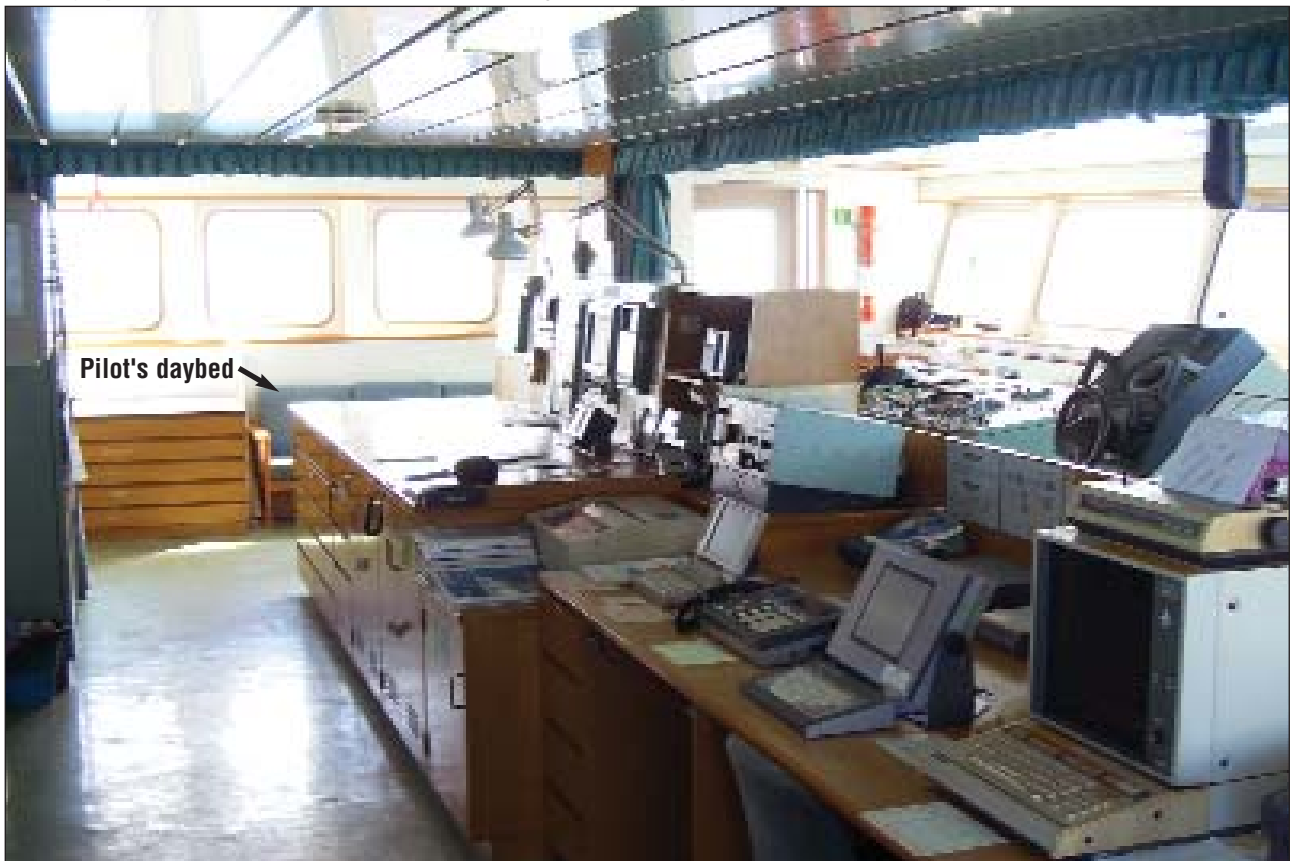
FIGURE 2:
Photograph across the chart table towards the daybed on the port side

Unlike the earlier periods when the pilot rested, he did not mark the position on the chart where he wanted the OOW to call him. The pilot alleges that he told the OOW to adjust the ship's course as necessary to bring it back to the course line. He then took off his shoes and reclined on the settee on the port side of the wheelhouse.

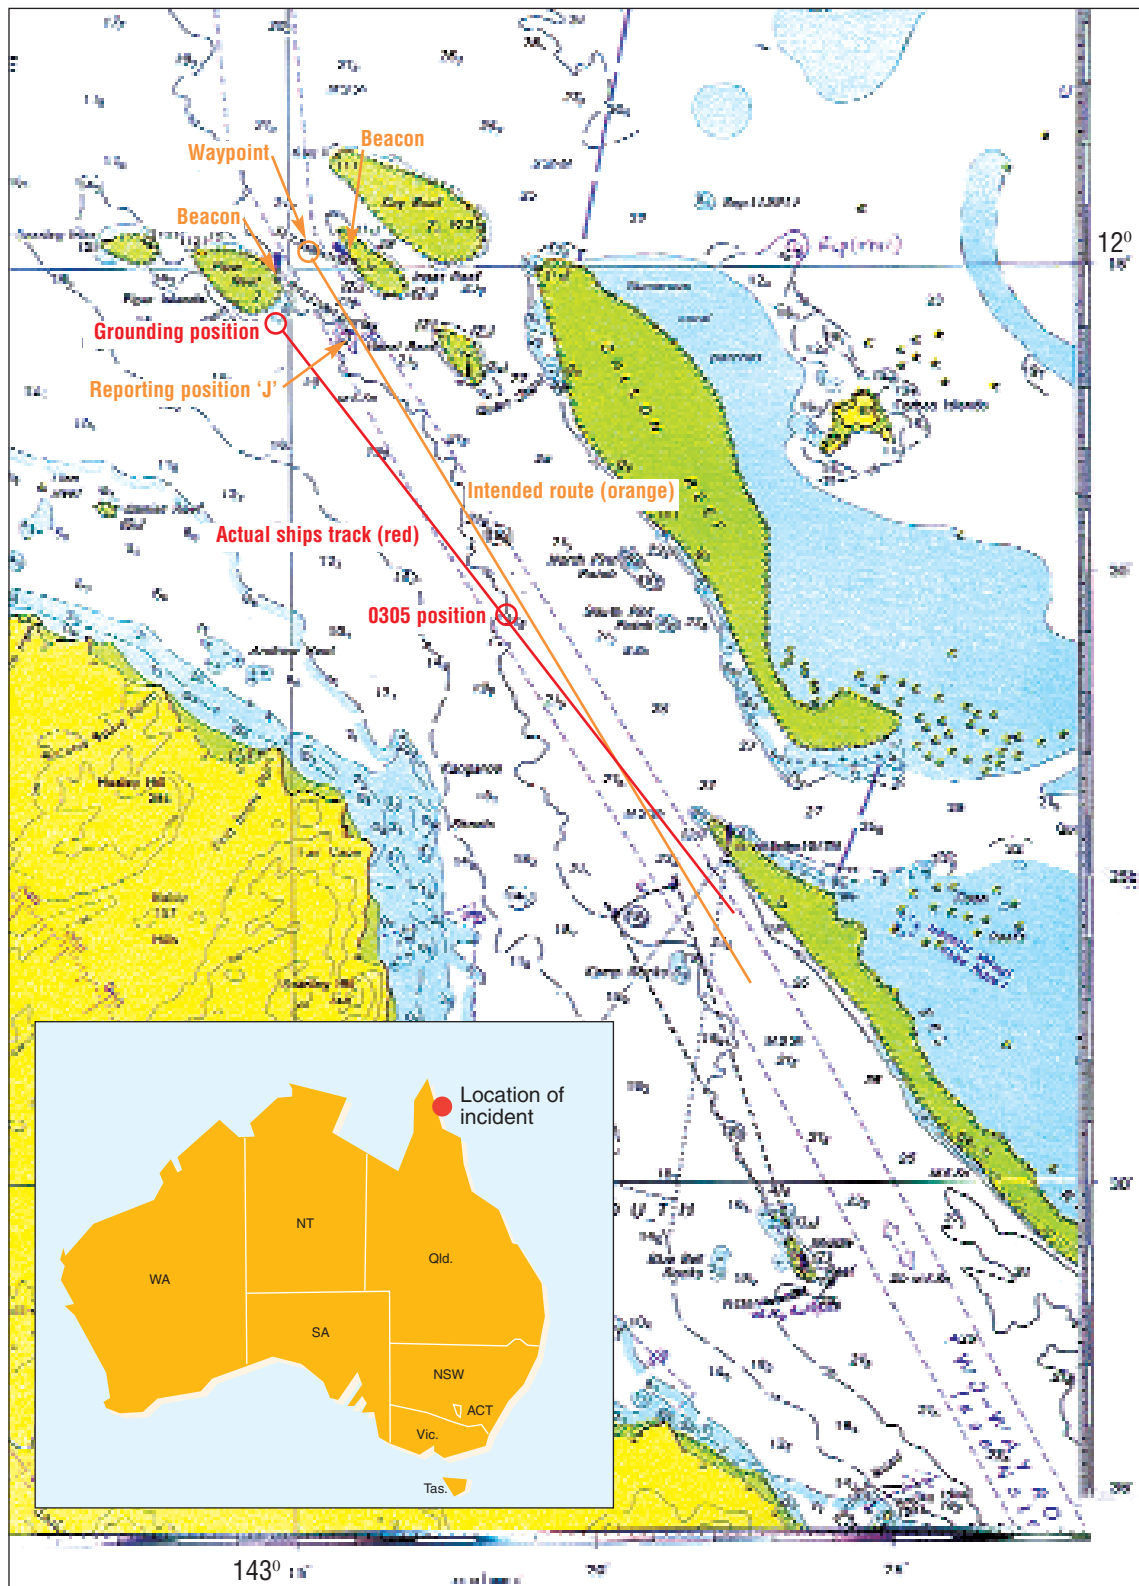
FIGURE 3:
Portion of chart Aus 835 showing grounding position

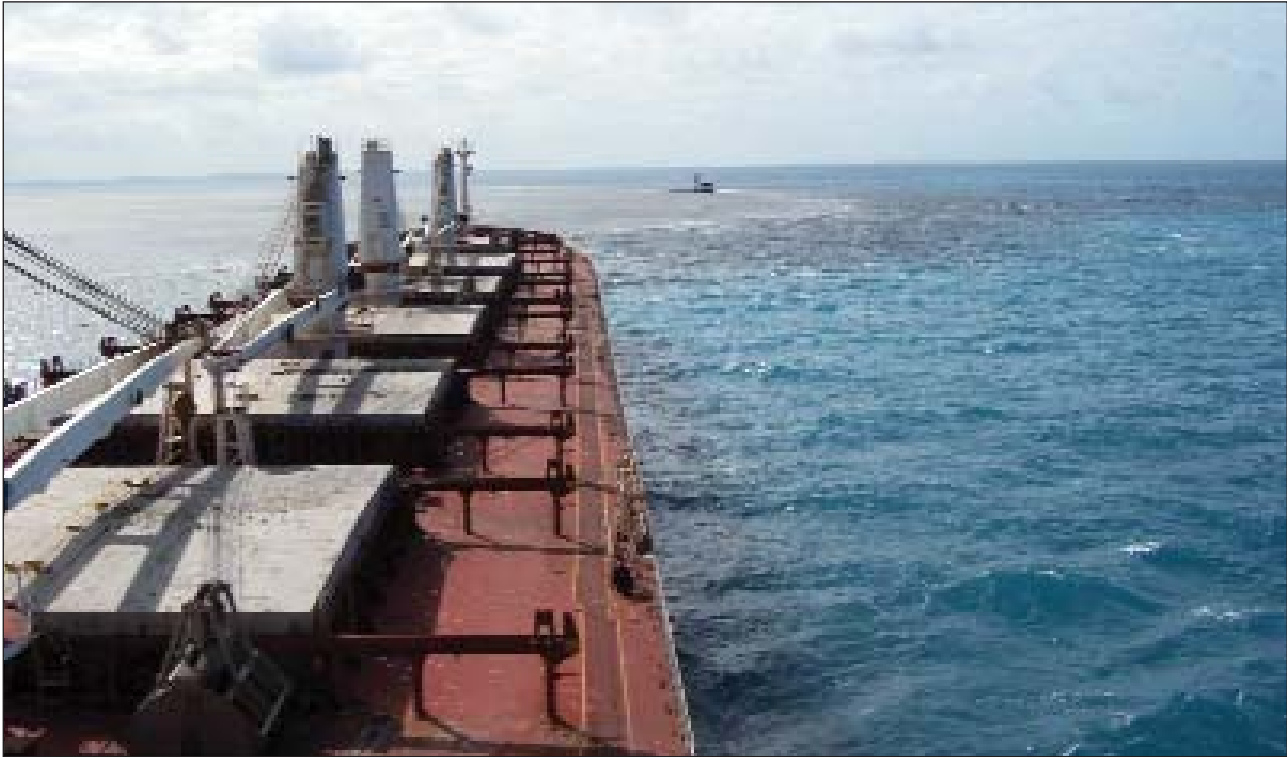
FIGURE 4:
Photograph taken from starboard bridgewing of *Doric Chariot* with Piper Reef light beacon in the distance

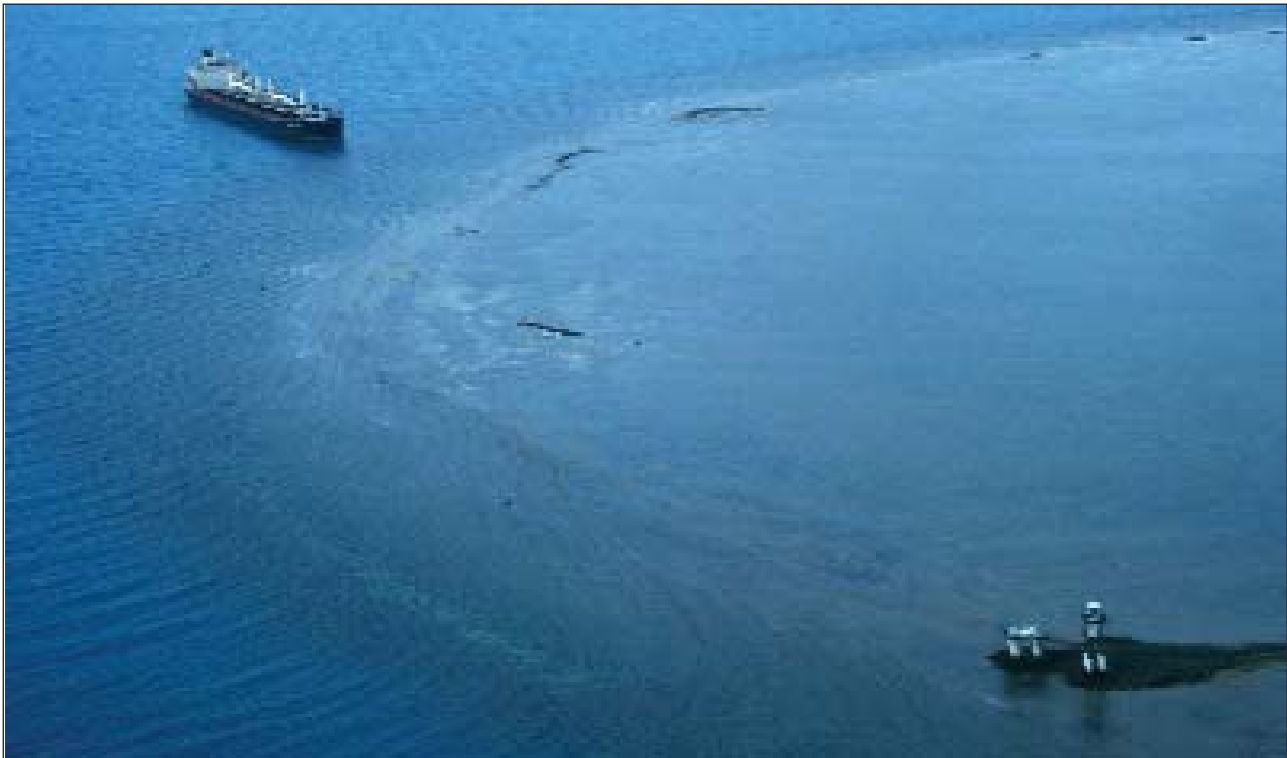
FIGURE 5:
Aerial photograph of *Doric Chariot* aground with Piper Reef beacon in the foreground

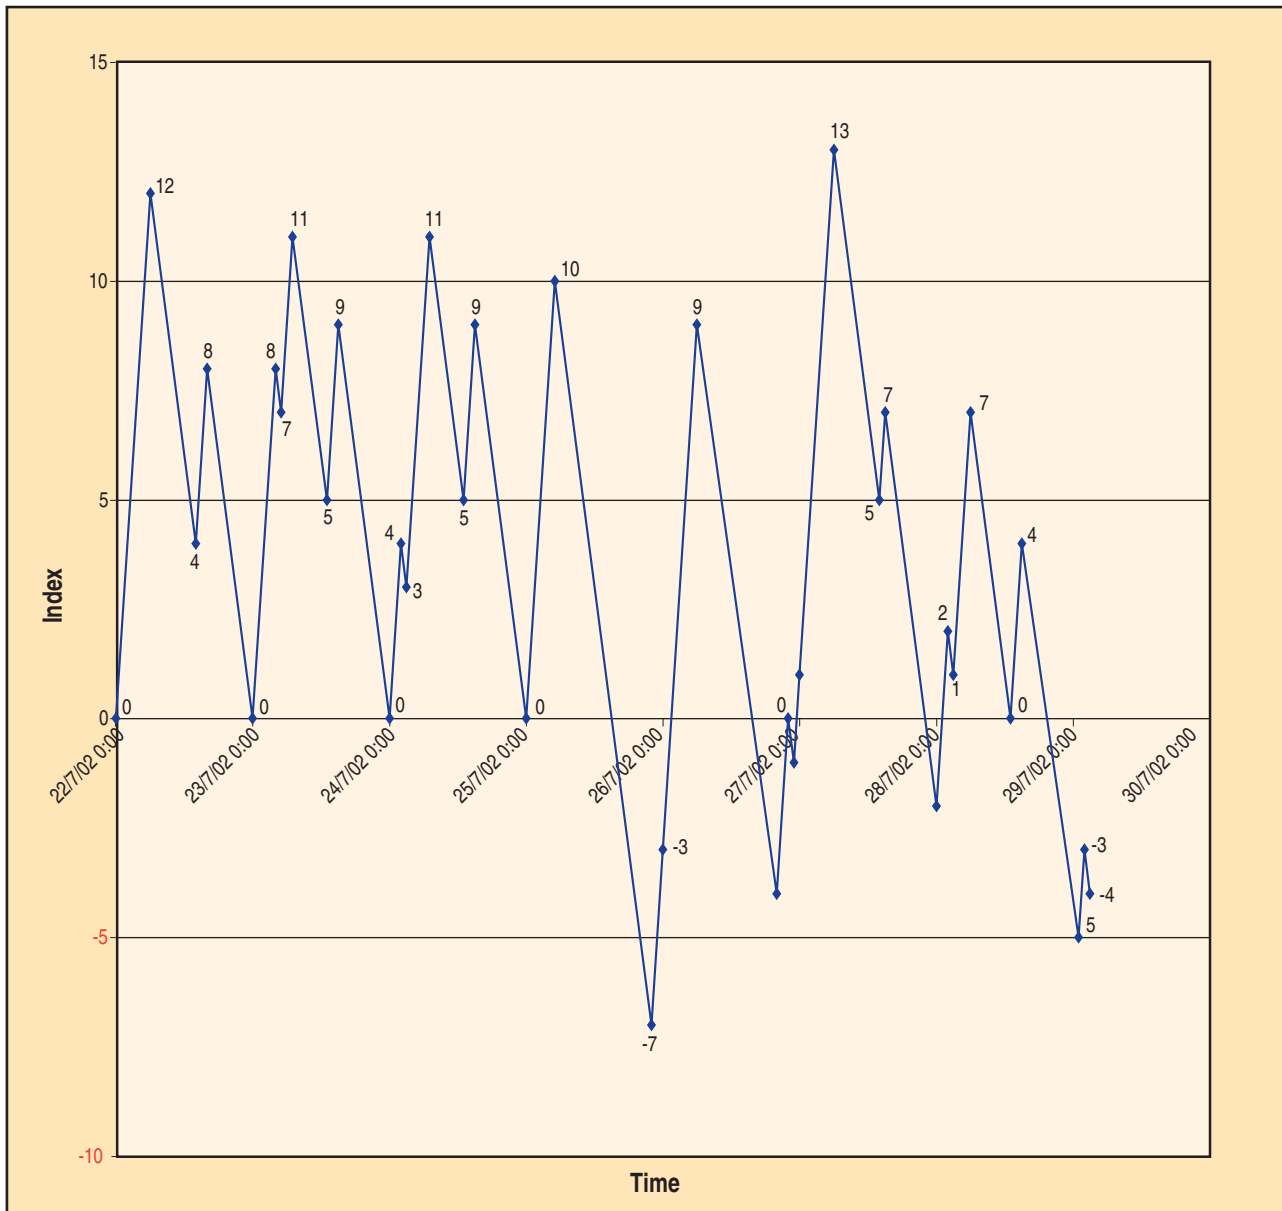
FIGURE 6:
Sleep credit/deficit analysis graph

effort or for circadian rhythms. A negative score only indicates that the work hours warrant further examination.

Given the negative score, the pilot’s routine was then subjected to further examination using the FAID fatigue computer program.

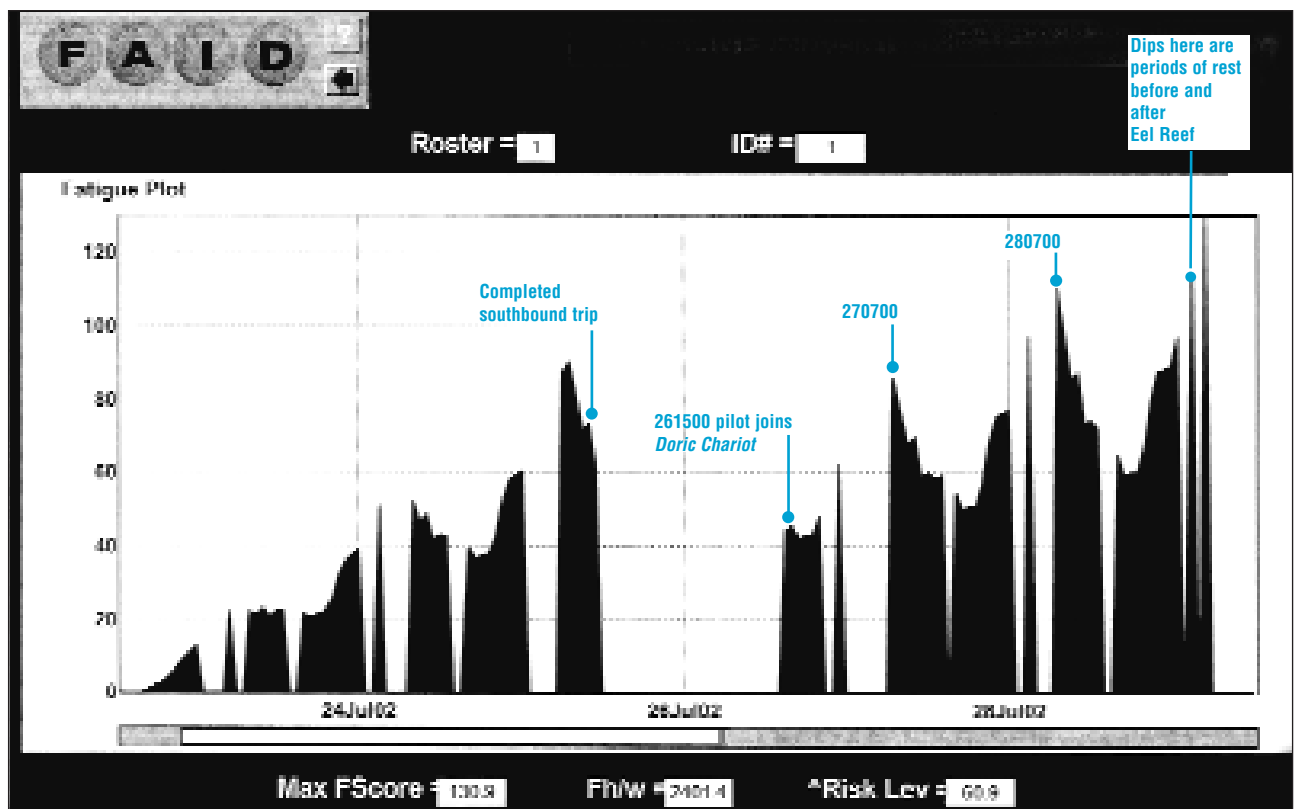
FIGURE 7:
The best case

To examine the pilot's fatigue using FAID a 'best' and 'worst' case scenario was adopted. The best case uses only the hours of actual work on the bridge as the input whereas the worst case uses all the waking hours as the input parameters. The 'true' score probably lies somewhere between these two extremes.

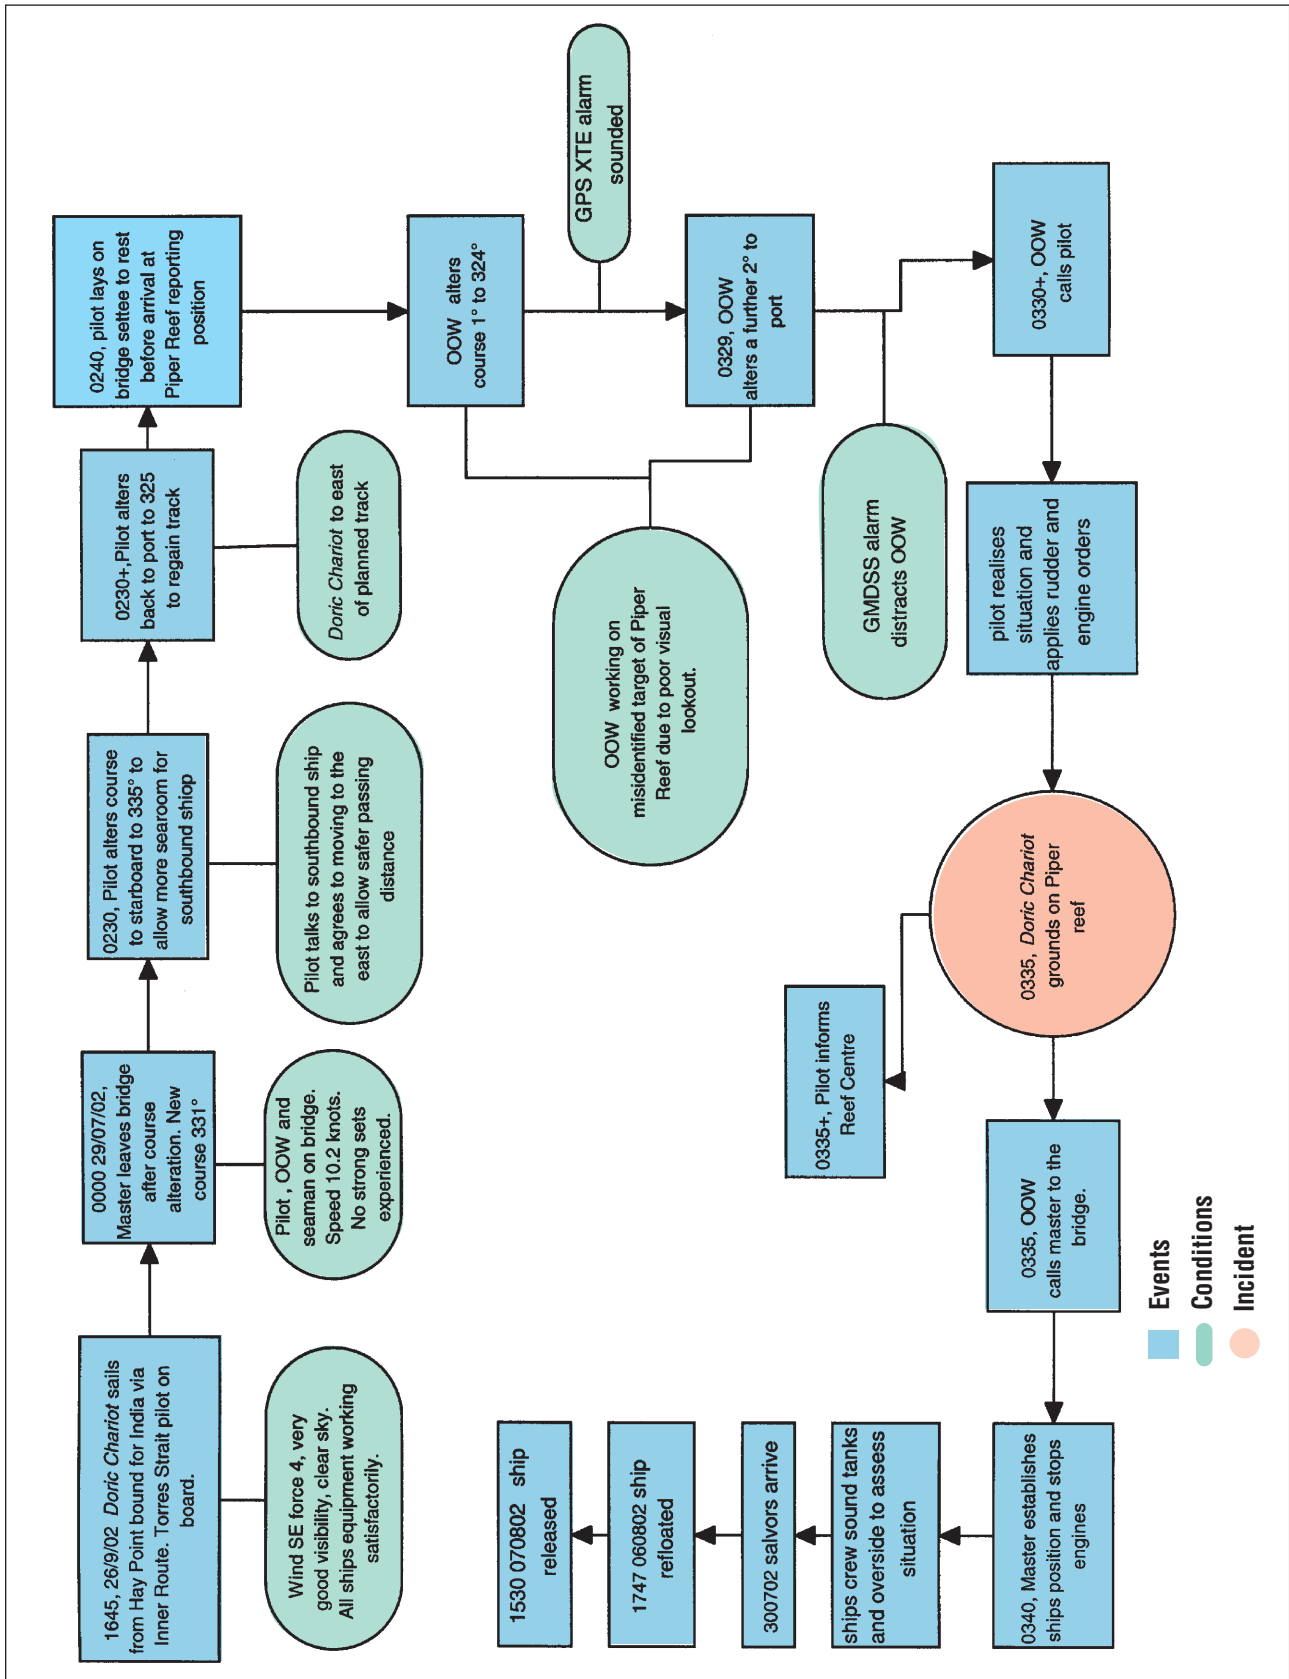
FIGURE 7:
Doric Chariot. Events and causal factors chart
