MARINE SAFETY INVESTIGATION
REPORT 184

Independent investigation into the grounding of the
Korean flag bulk carrier

Hanjin Dampier

at Dampier, Western Australia
25 August 2002

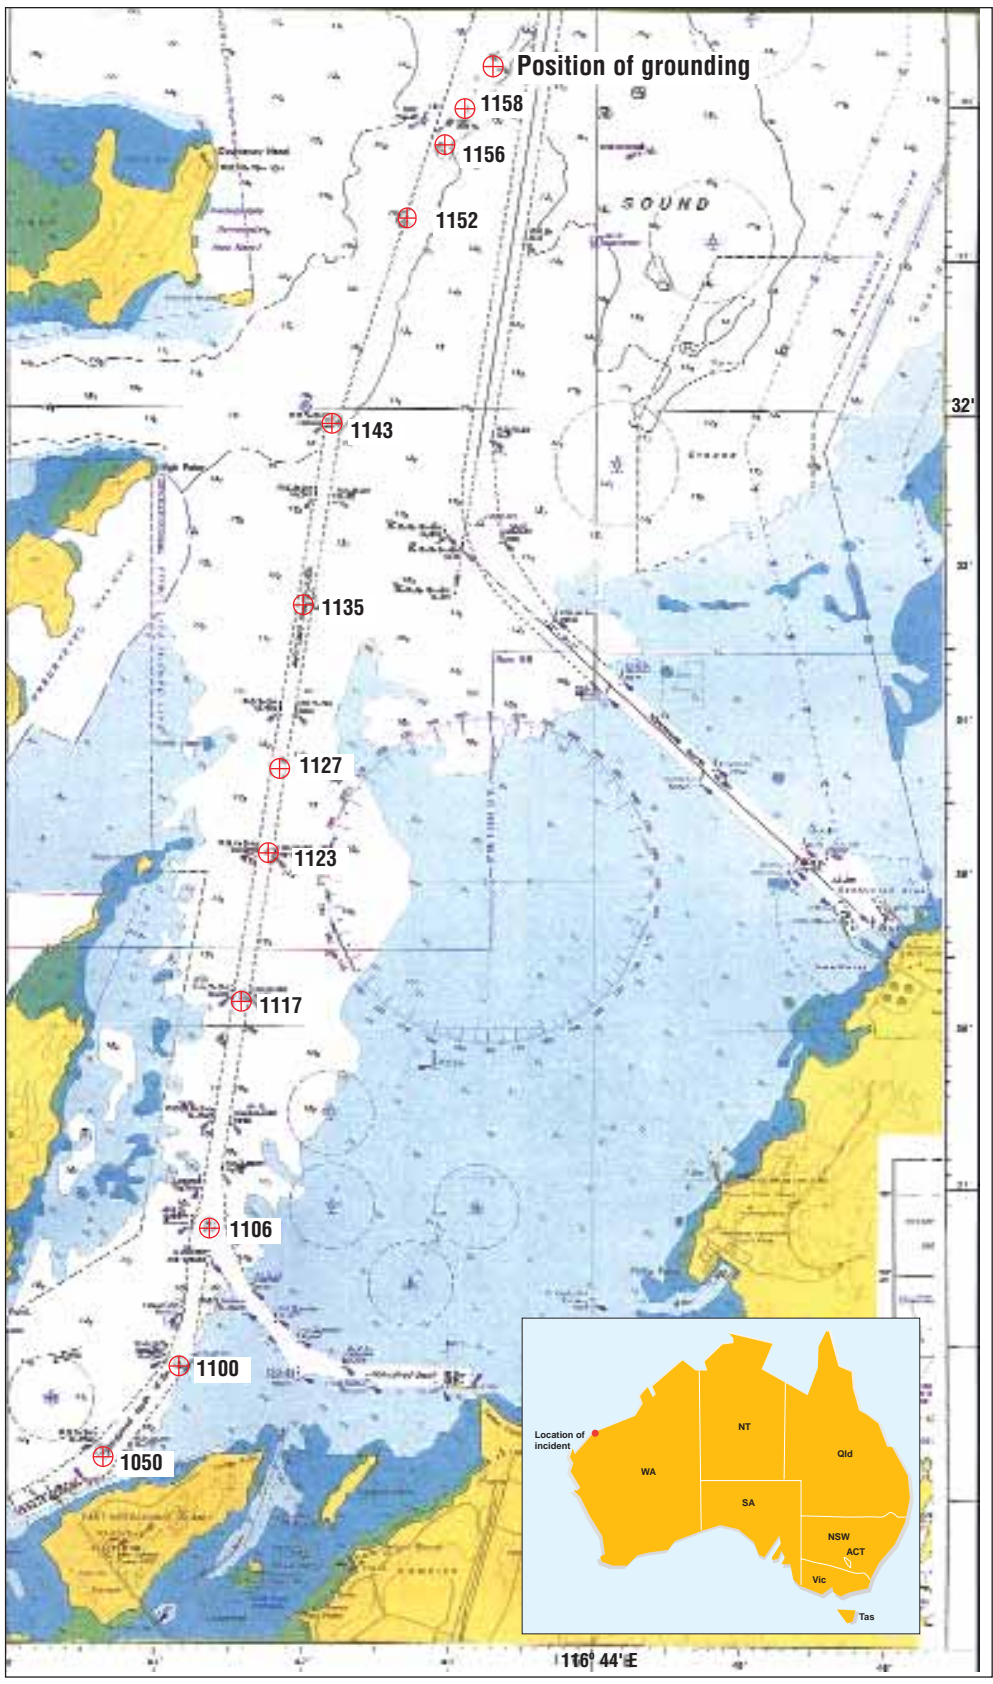
FIGURE 2:
Chart showing approximate track of *Hanjin Dampier*

At 1202, *Hanjin Dampier* touched bottom. By about 1203 the ship had come to a stop on a heading of 047°(T) in a position between the charted deep draught track and the Woodside Channel (20° 29.7'S, 116° 43.3'E).

At approximately 1155, *Hanjin Dampier* passed number four buoys. With 10° of starboard

rudder the ship was starting to turn to starboard towards the shallow water on the eastern side of the deep draught track. The pilot contacted the tugs at this time to request that a third tug attend the ship.

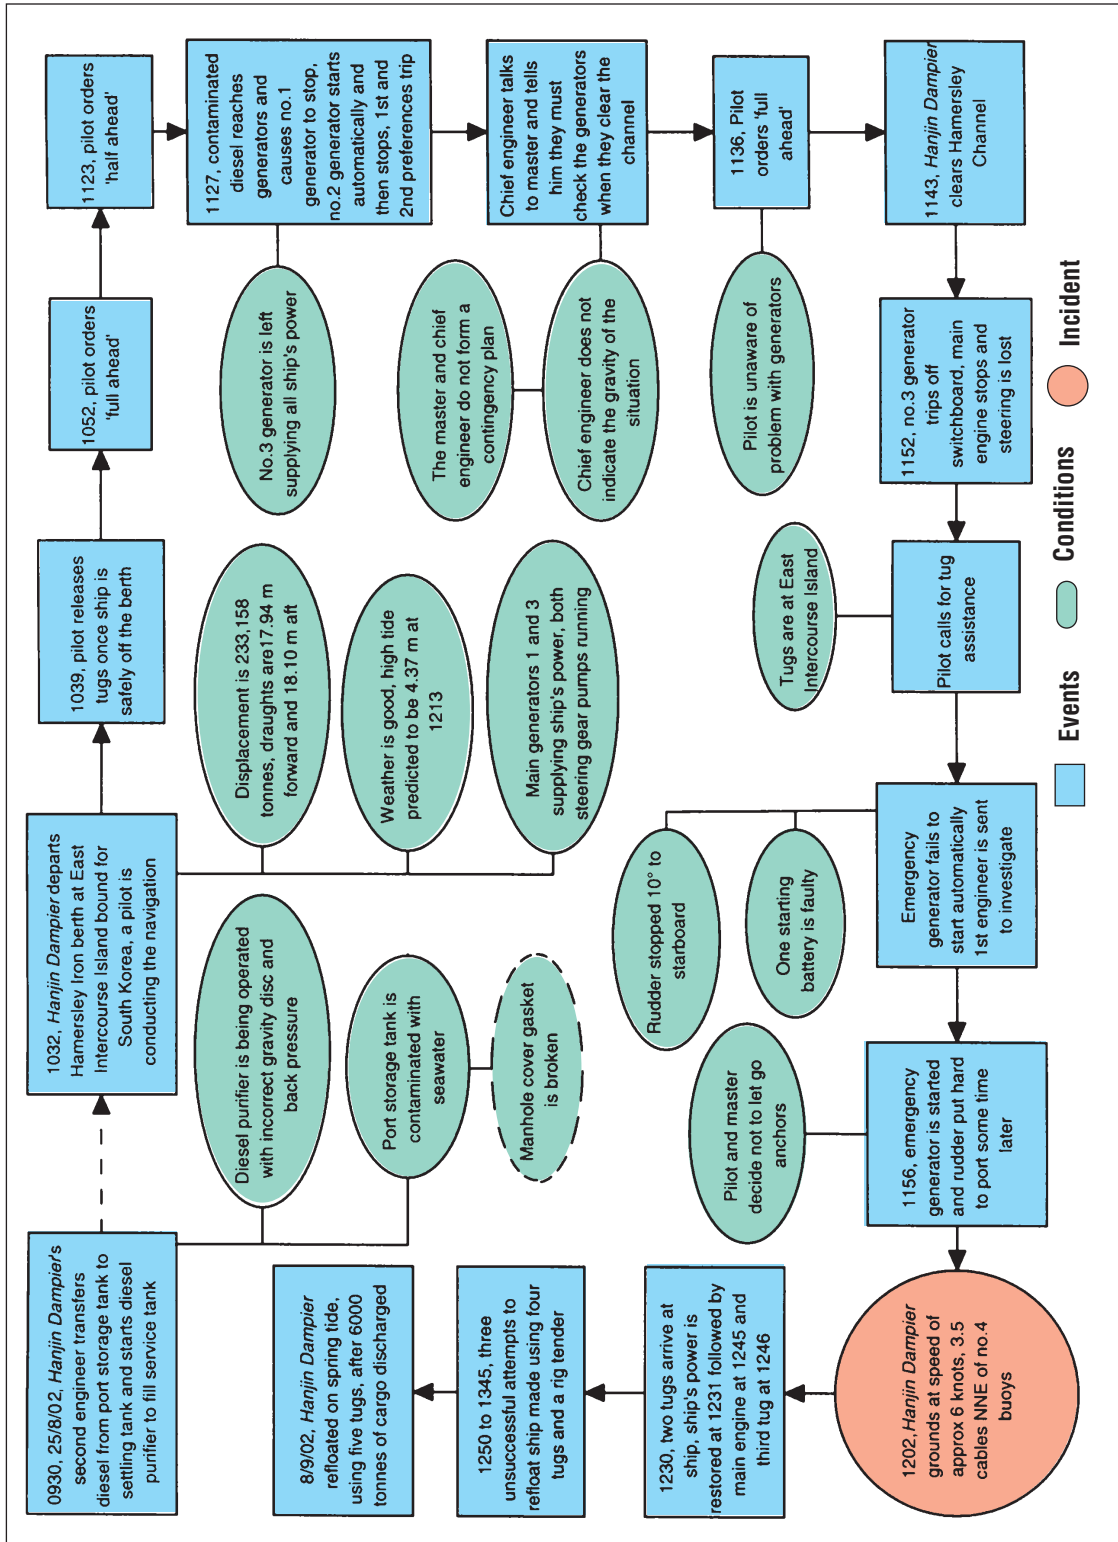
FIGURE 3:
Hanjin Dampier. Events and causal factors chart

On 25 August 2002, *Hanjin Dampier* grounded as a result of the total failure of the ship's electrical power supply and the lack of timely intervention by the crew, when the risk to the ship could have been mitigated. The initial shut down of number one main generator occurred at 1127; a minute later number two main generator also stopped to leave only number three generator supplying all of the ship's electrical power. At this point in the passage, there was time (although limited by the tidal window), to stop the ship, either in the channel or after it had cleared the channel, and investigate the generator shut downs.

- the contamination of the generator fuel supply which led to the blackout, loss of propulsive power and loss of steering
- the failure of the emergency generator to start automatically which meant that the ship was without steering for a critical period with the rudder stopped at 10° to starboard
- the failure of the crew to correctly assess the situation and take appropriate action during the 25 minute period between the first generator shut down and the blackout at 1152.

3. The diesel purifier was being operated in a manner which allowed the water contamination to be carried over into the diesel service tank.
4. The emergency generator failed to start automatically due to a fault in one of its starting batteries.
