Loss of the NSW registered vessel *Tamara* – 1 September 2002

ATSB
Australian Transport Safety Bureau

Tamara: Lost at sea

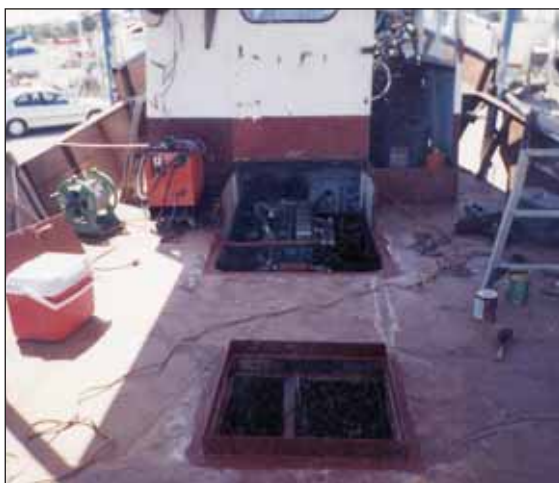
FIGURE 2:
Modification work proceeding on *Tamara's* hatches

There were no drawings of the vessel available and no drawings were made of the modifications. The evidence (from statements and photographs) is that the original hatch coamings for the engine room, ice room and steering compartment on the work deck were reduced from approximately 300 mm to 75 mm in height. The bulwarks around the work deck were raised by approximately 500 mm and the freeing ports for the work deck area were modified. The skipper stated that they 'had been welded up partially'. The watertight bulkheads between the accommodation, engine room, ice room and steering compartment had also been penetrated. Each of these modifications compromised the seaworthiness of the vessel.

The higher bulwarks, lower freeing capacity and reduced hatch coaming height resulted in *Tamara* being very susceptible to flooding. The higher bulwarks would have 'trapped' a much greater volume of water on the work deck with relatively slow run-away through the partially welded-up freeing ports. The reduction in coaming height meant that water on the work deck higher than 75 mm would now run into any space where the hatch was not absolutely secure. The penetration of the watertight bulkheads beneath the work deck meant that there was no reserve buoyancy in the event of one compartment becoming flooded, with the water free to flow through the length of the vessel. In combination, these modifications virtually guaranteed *Tamara* would founder if a large enough wave or series of waves were taken over the stern. Given its relatively low freeboard, it is not surprising that *Tamara* sank so quickly when the wave washed over the stern on the afternoon of 1 September 2002.

State and Northern Territory marine authorities should review their practices relating to the scrutiny of commercial vessels changing registration status.
