ATSB TRANSPORT SAFETY INVESTIGATION REPORT
Marine Occurrence Investigation
No. 186 and 191
FINAL

**Independent investigation into the
equipment failure on board the
Australian registered bulk cargo carrier
*Goliath***

in Bass Strait on 22 September 2002 and
off Jervis Bay, New South Wales, 12 February 2003

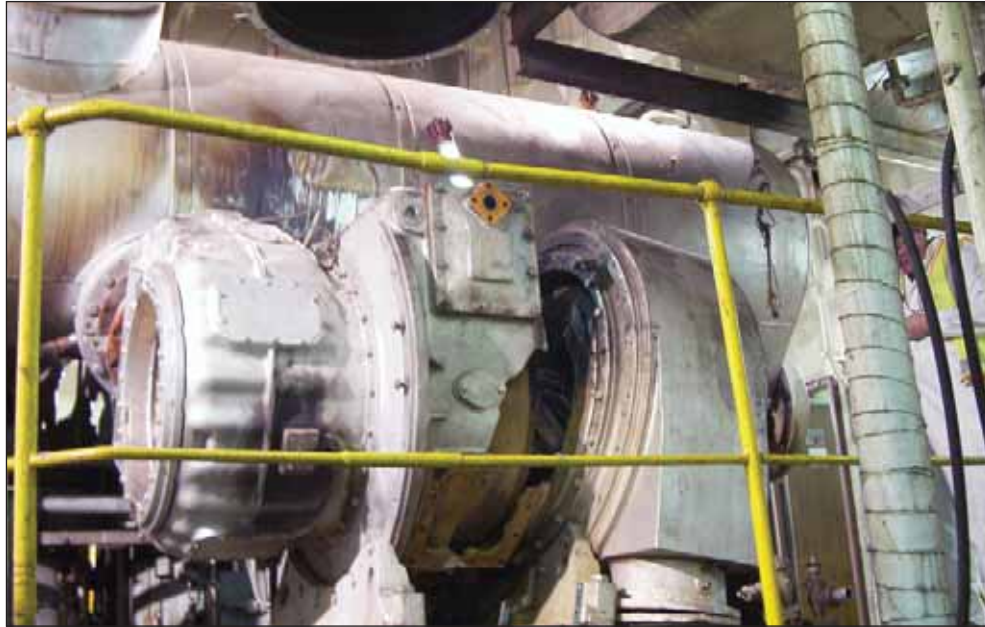
Figure 4: Failed turbocharger 22 September 2002

After the main engine had stopped the chief engineer made a closer inspection of the damaged turbocharger (Figure 4). He found that the gas outlet casing had been shattered and the rotor was lying in the bottom of the casing without its compressor disc. He then rang the master to inform him that the turbocharger had failed completely and that there was no way the turbocharger could be repaired and so the main engine could not be run.

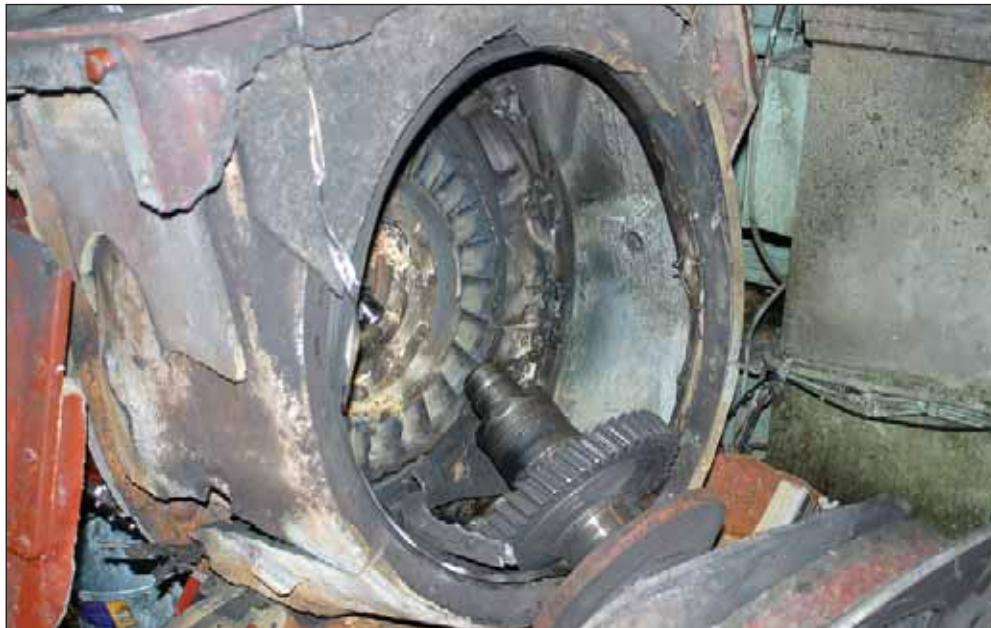
Figure 5: Failed turbocharger 12 February 2003

After the second and third engineers had risen from the control room floor, they found the engine room full of smoke with cooling water and debris lying all around the main engine top plates. The turbocharger outlet casing had ruptured and the air casing was lying approximately two metres from the turbocharger (Figure 5). The fire alarm was sounding. The second engineer went to the engine side and brought the main engine fuel rack control to zero to stop the main engine.

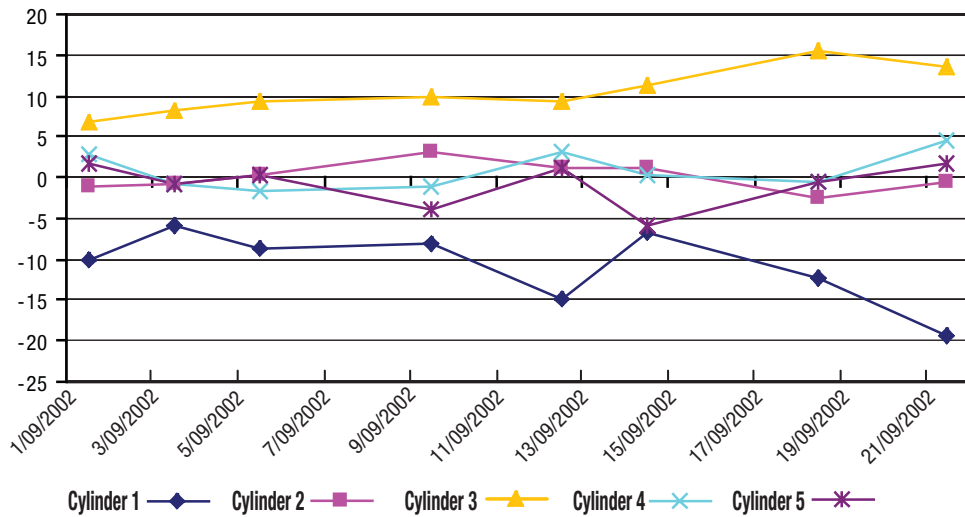
Figure 6: Cylinder exhaust temperature deviations from 1 to 21 September 2002 before first failure

While the engine performance data prior to each failure does not reveal a definitive cause for the turbocharger failures they do reveal some information of relevance. It is significant that both turbocharger explosions occurred when the vessel was on longer voyages (i.e. not between Melbourne and Devonport) and the main engine was running in the higher range of normal load settings. In each case one cylinder had an exhaust temperature which was significantly higher than the average, although still within normal limits, and had an increasing trend in the days leading up to each turbocharger failure. The absence of any particularly abnormal data or any alarm prior to each failure is also significant as it indicates that the mechanism which caused the turbocharger overspeeds occurred over a very short time period.

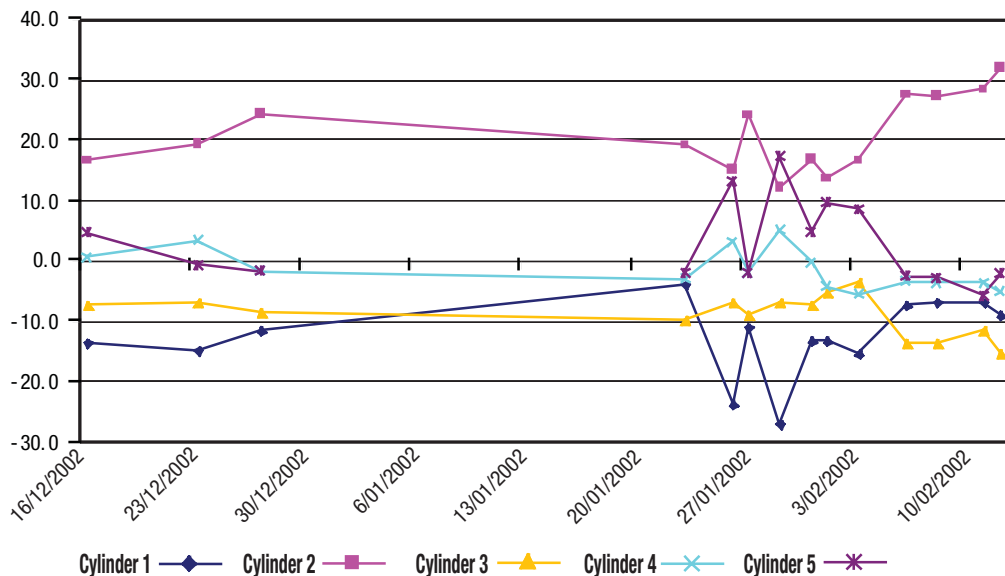
Figure 7: Cylinder exhaust temperature deviations from 16 December 2002 to 10 February 2003 before second failure

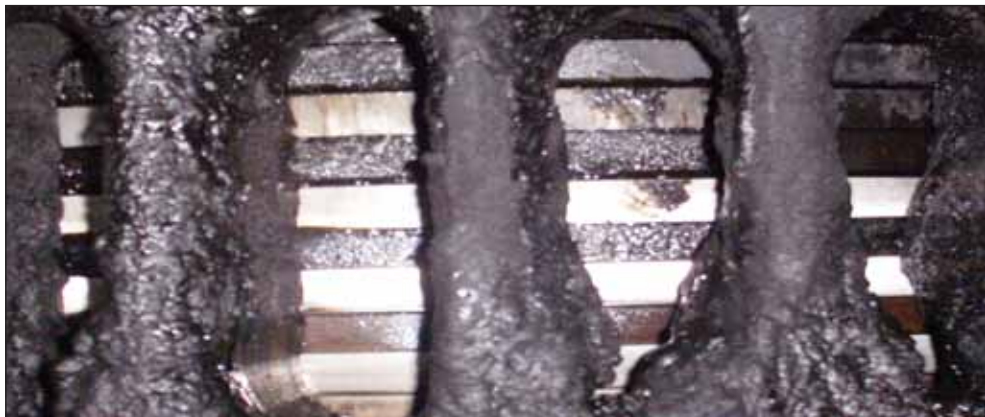
Given the discovery of the leaking piston crown O-ring some three months after the second turbocharger failure, it is probable that the excessive fouling in the scavenge space of this cylinder at the time of the second incident was caused by leaking piston cooling oil.

Figure 8: Number one cylinder liner scavenge ports (scavenge manifold side)

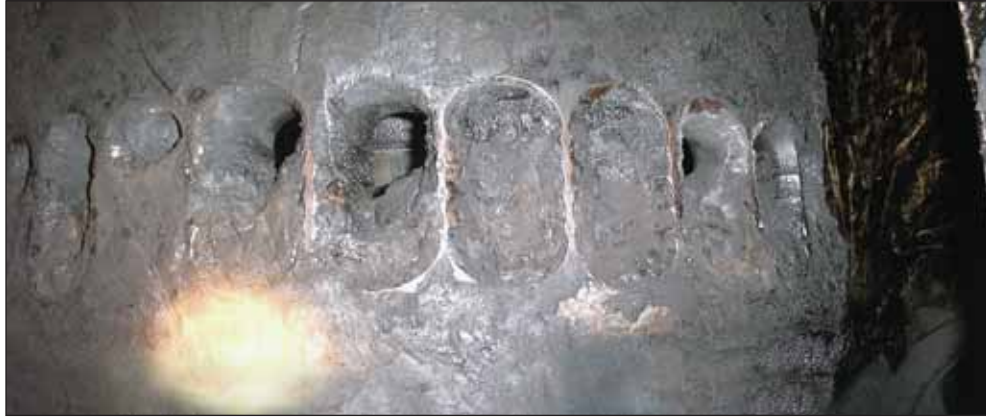
Figure 9: Number two cylinder liner scavenge ports (scavenge manifold side)

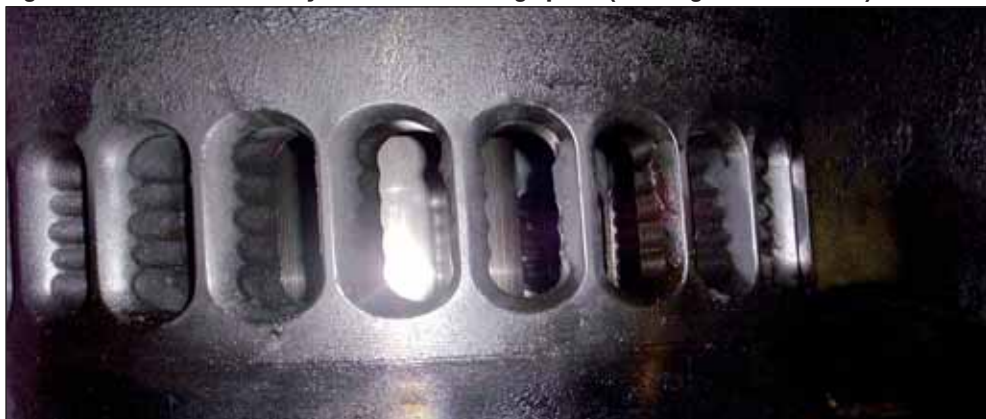
Figure 10: Number three cylinder liner scavenge ports (scavenge manifold side)

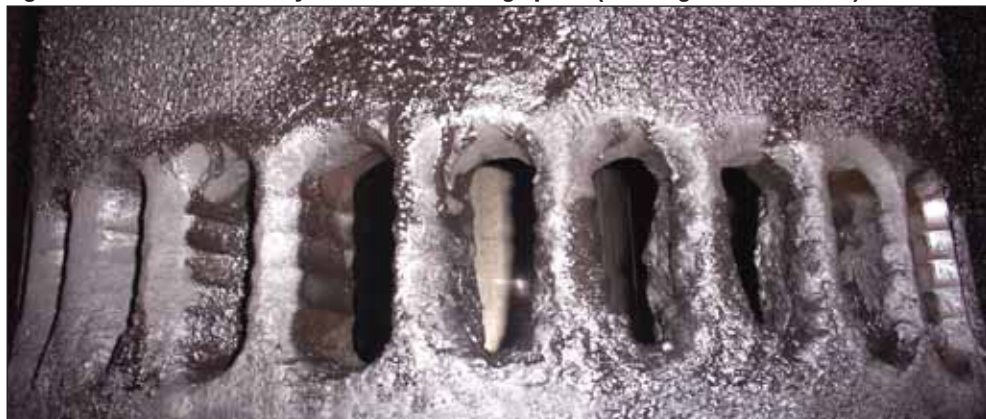
Figure 11: Number four cylinder liner scavenge ports (scavenge manifold side)

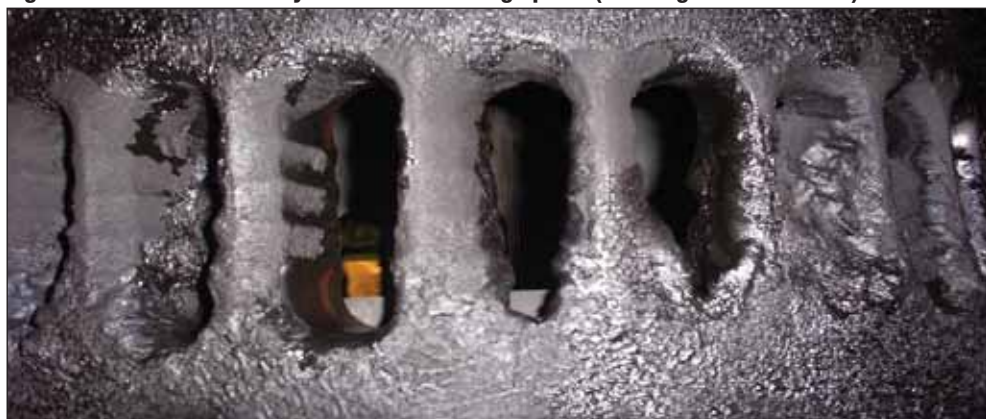
Figure 12: Number five cylinder liner scavenge ports (scavenge manifold side)

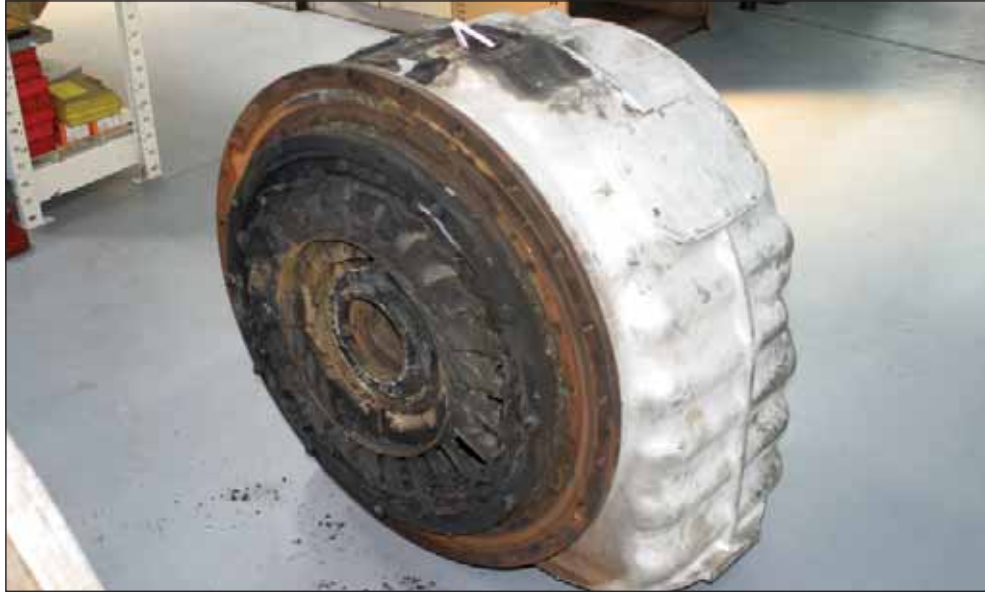
The turbine section of the turbocharger comprised two adjoining cast-iron housings. The engine exhaust gases were ducted into a housing located at the end of the assembly (fig. 2) and through a full circumference nozzle assembly into the rotor case. The gas inlet casing and nozzle ring, while having sustained significant impact damage (fig. 3), had not liberated any components or cracked/fractured in a manner that may have been a precursor to the failure. The remnants of the turbine rotor shroud assembly that surrounded the rotor within the gas outlet casing (fig. 4) had sustained multiple and extensive impacts from liberated turbine blade fragments.

Figure 2: Exhaust inlet casing and turbine nozzle ring

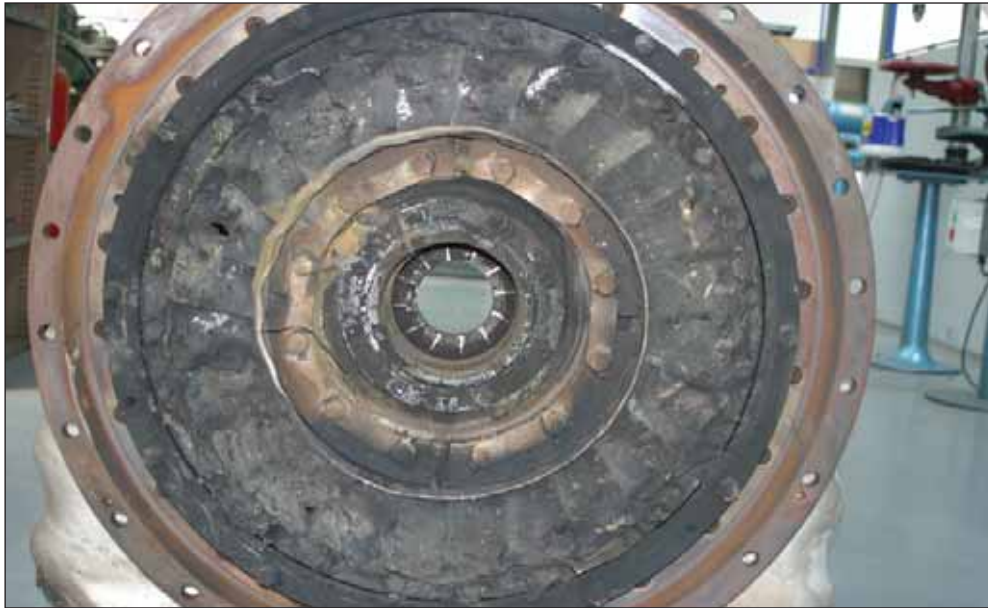
Figure 3: Heavy impact damage to the otherwise intact turbine nozzle ring

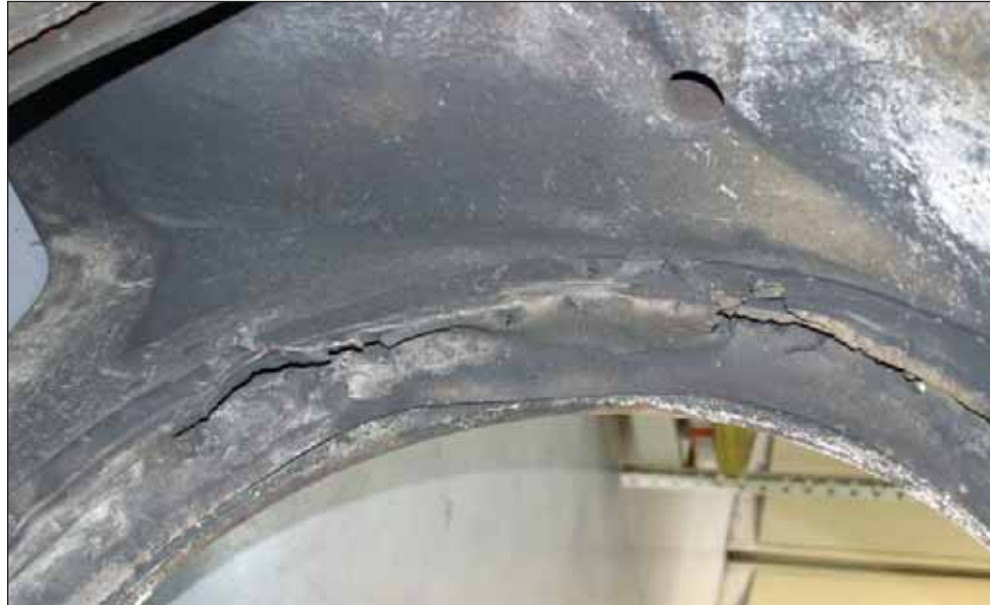
Figure 4: Remanents of the turbine shroud assembly

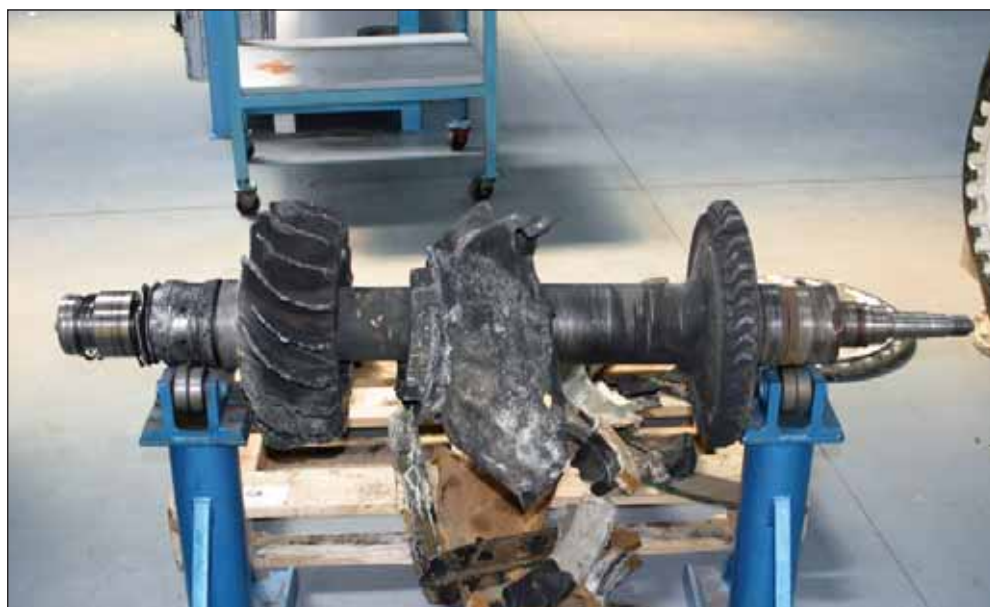
Figure 5: Turbocharger shaft with (left to right) inducer, missing impeller disc, partition and turbine disc

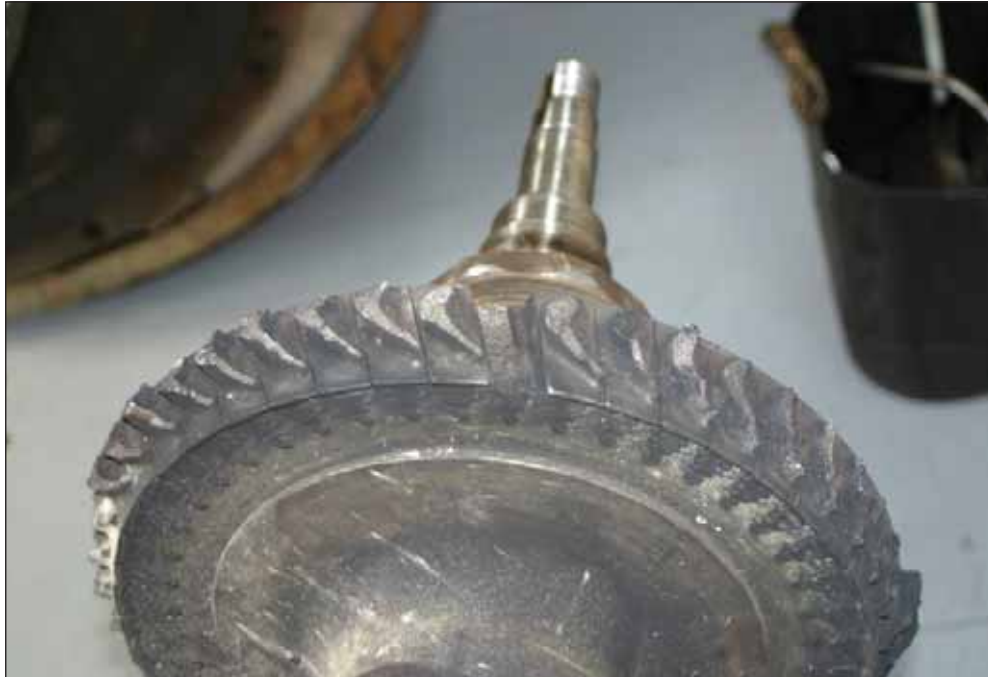
The turbine rotor comprised an integral shaft-disk (fig. 5), with a set of 45 blade elements installed within conventional fir-tree slots. All bar one of the turbine blades had fractured transversely from the base of the airfoil section (fig. 6), with that single blade fracturing from the top of the root 'fir-tree' (fig. 7). An inspection of the fracture morphology showed a similar semi-crystalline appearance across all blades, including the blade that fractured from the fir-tree root. Most of the blade set showed transverse rubbing contact against the nozzle-facing platform edges (fig. 7) around the full rotor circumference. A selection of five turbine blades was subsequently removed from the rotor disk for laboratory examination. Those included the fir-tree root failed blade and two additional blades from either side.

Figure 6: 'Cobbed' turbine rotor with all blades fractured

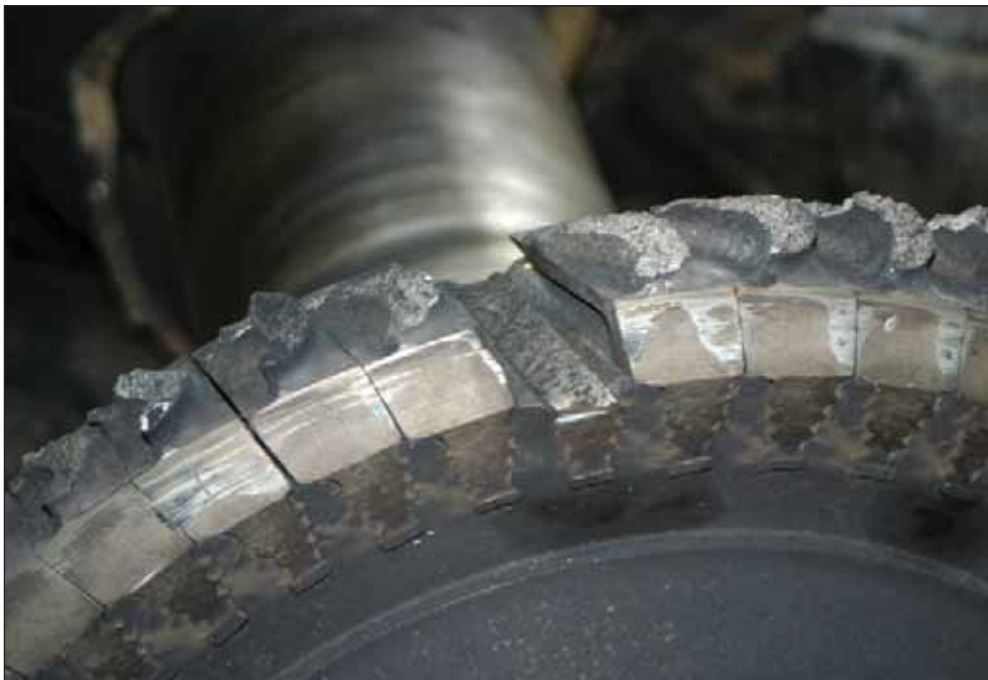
Figure 7: Left shingle turbine blade fractured at the top of the fir-tree root

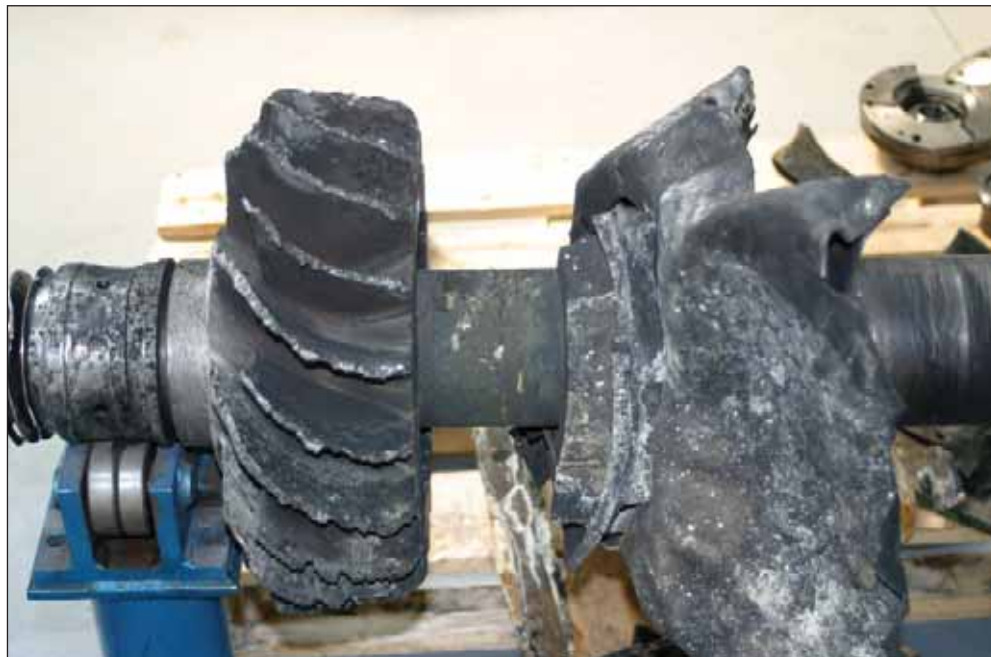
The compressor rotor was made up of a forward inducer coupled to the main centrifugal impeller. While the inducer section had remained on the turbocharger shaft and was essentially intact (fig. 8), the impeller had been liberated and was recovered in multiple fragments. The impeller had fractured radially into at least four comparably sized segments (fig. 9), with several smaller pieces also recovered. A section comprising approximately one-quarter of the disk was not recovered. The surfaces of the shaft from where the impeller disk was located were studied and showed no evidence marks or scoring that may have suggested the insecurity or rotation of the impeller on the shaft. The matching impeller face did not display scoring or damage of the type shown by the mating inducer face (fig. 10). All of the rotor fragments were subsequently retrieved and examined in the ATSB's Canberra laboratories.

Figure 8: Compressor end of the turbocharger shaft. Missing the impeller disc

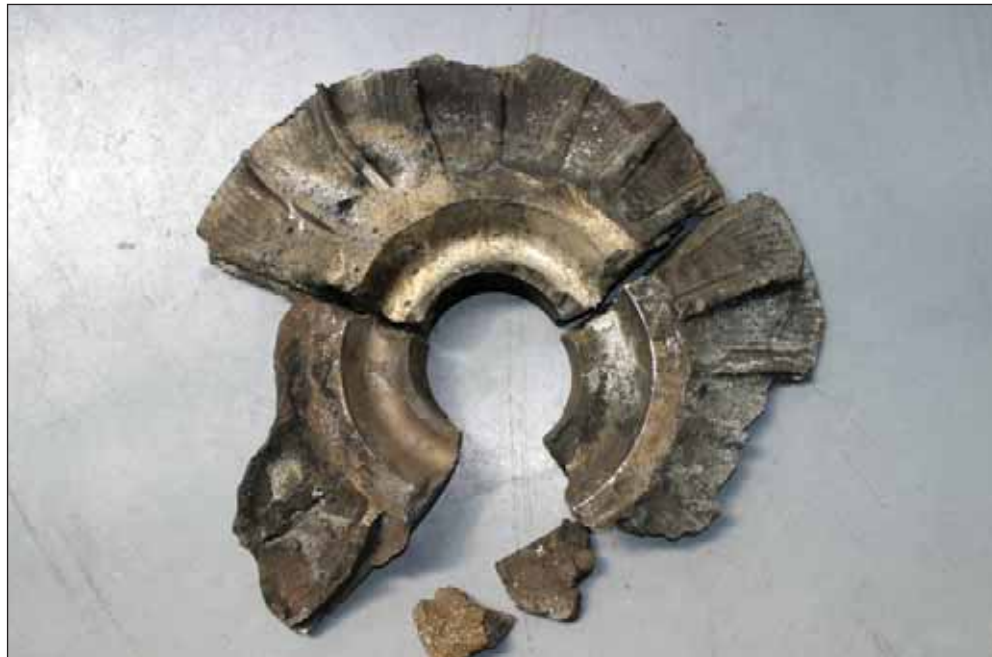
Figure 9: Recovered segments and fragments of the impeller disc

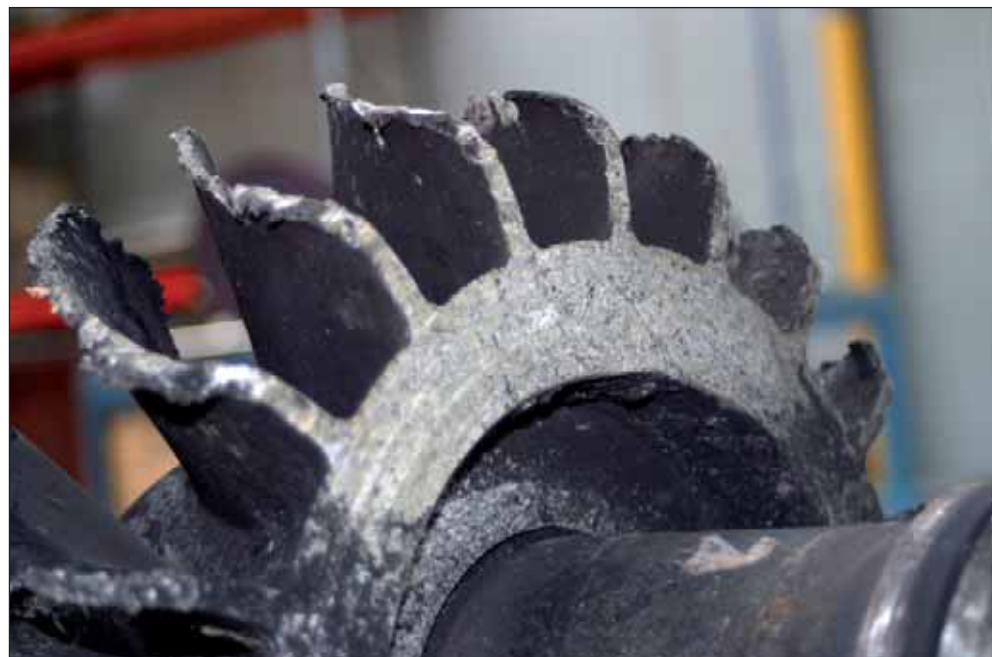
Figure 10: Rear face of the inducer element showing circumferential scoring consistent with continued rotation after the failure of the impeller disc

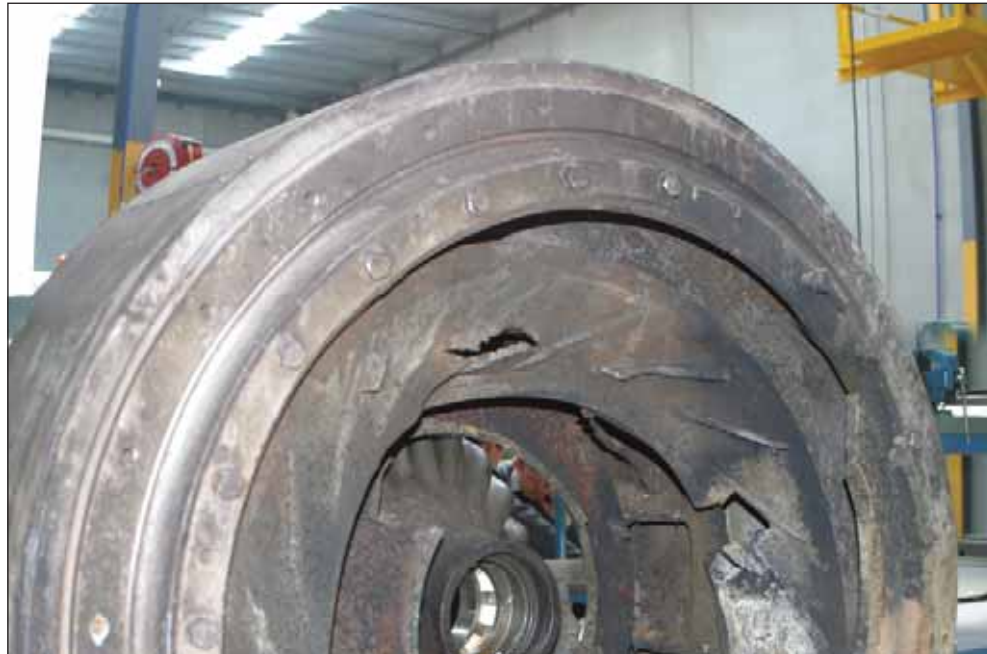
Figure 11: Looking into the remnants of the compressor housing

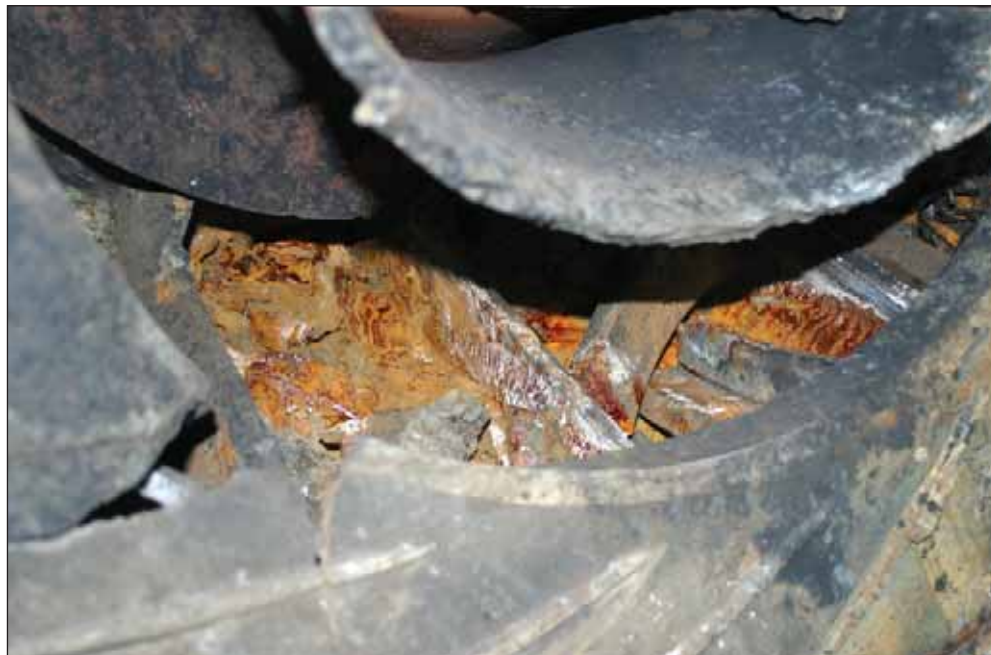
recovered from that area. Corrosion and other evidence of water ingress (fig. 12) was noted within the discharge casing, indicating the cooling water galleries around the turbine casing had been compromised. The entire housing body had fractured circumferentially around the flange adjoining the centre housing.

Figure 12: Debris and corrosion within the lower compressor housing body, indicating break-up of the cooling channels and the ingress of water

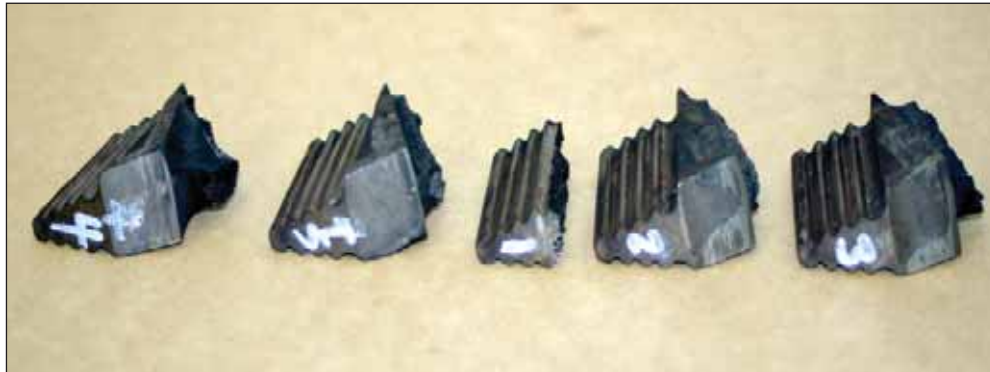
Figure 13: Selection of turbine blades taken from around the blade that failed at the fir-tree root

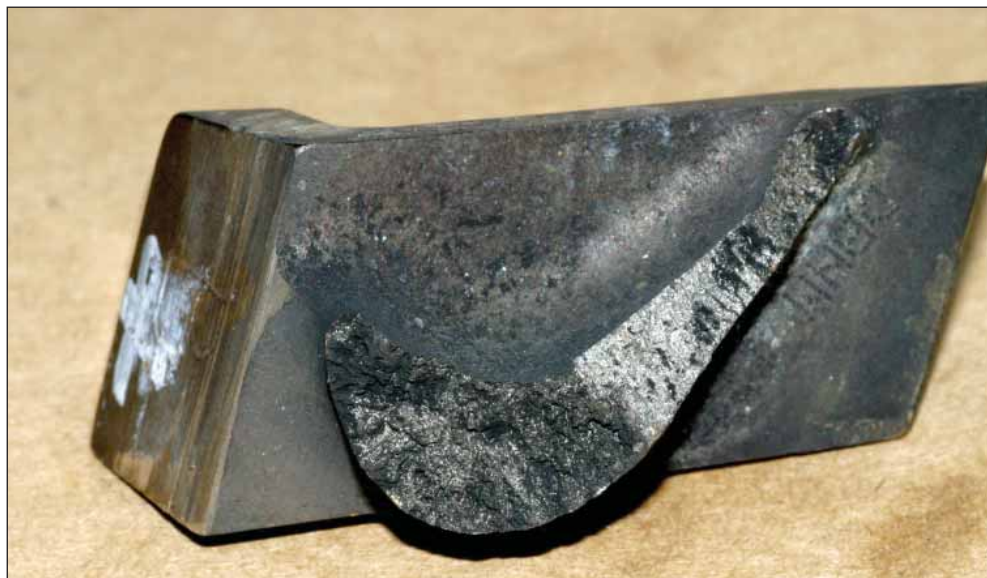
Figure 14: Carbonaceous, sooty deposit over a turbine blade fracture surface

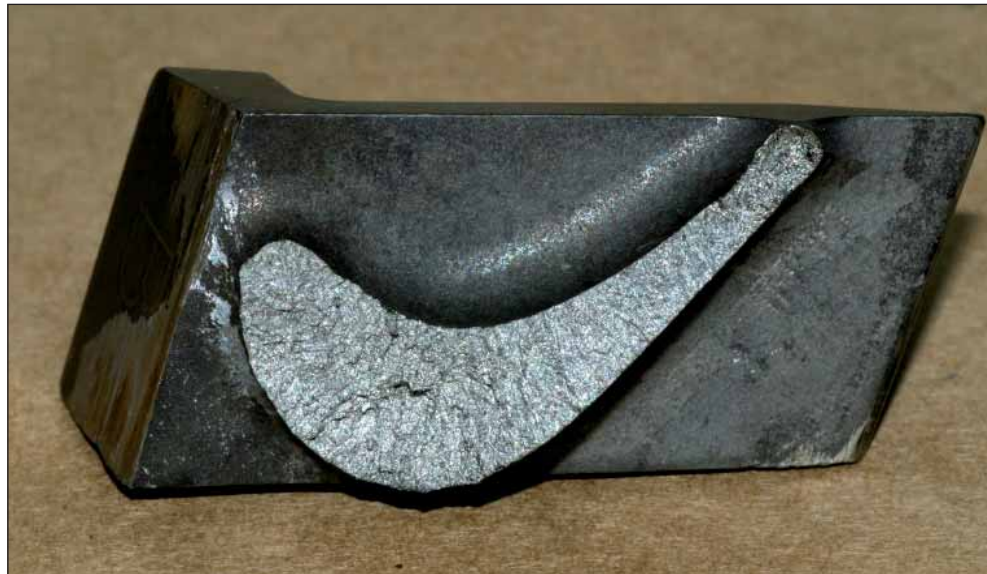
Figure 15: Same blade as fig. 14, cleaned and showing a uniform fracture typical of gross bending overloads

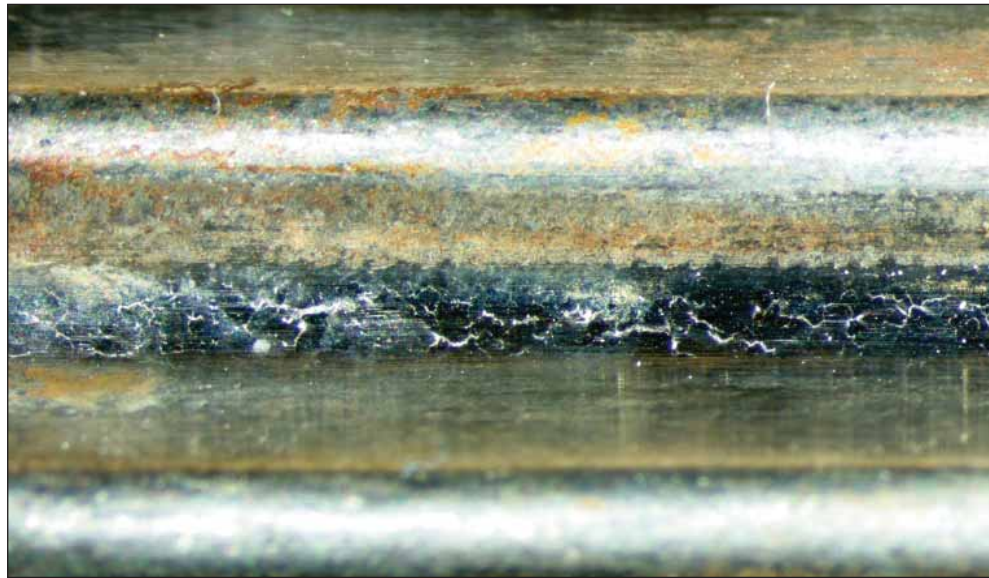
Figure 16: An example of cracks and fissures within the fir-tree root of the turbine blades – typical of bending overload forces

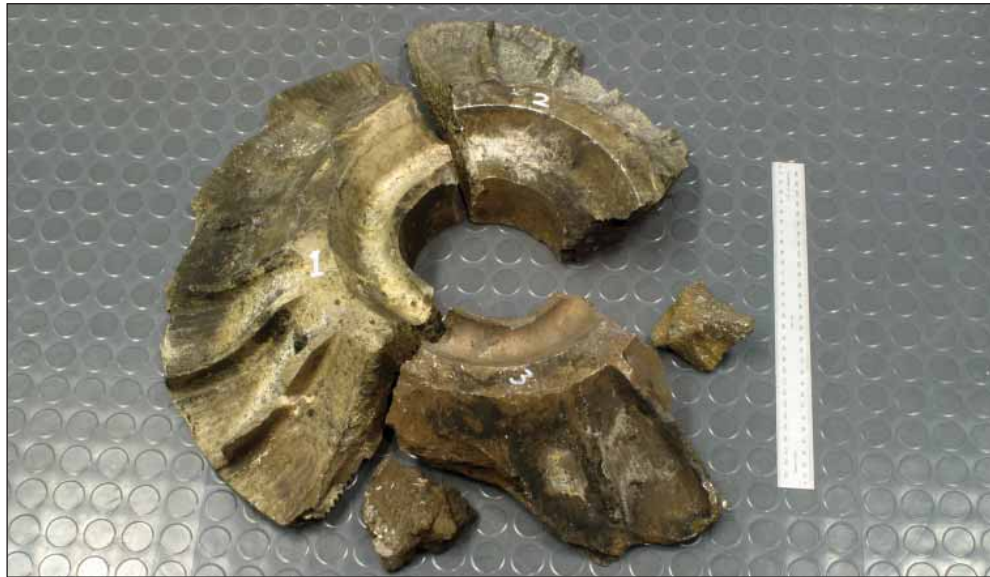
A total of five fragments of the ruptured impeller disk were examined (fig. 17). A large segment of the disk, representing approximately one-quarter of the impeller circumference was not recovered. All of the fragments had sustained extensive post-failure mechanical impact and abrasion damage over both forward and aft faces. The fracture and other surfaces had also been extensively stained with dark carbonaceous combustion products and a yellow-green product.

Figure 17: Segments and smaller fragments of the compressor impeller disc. Note the predominant radial orientation of the primary fractures

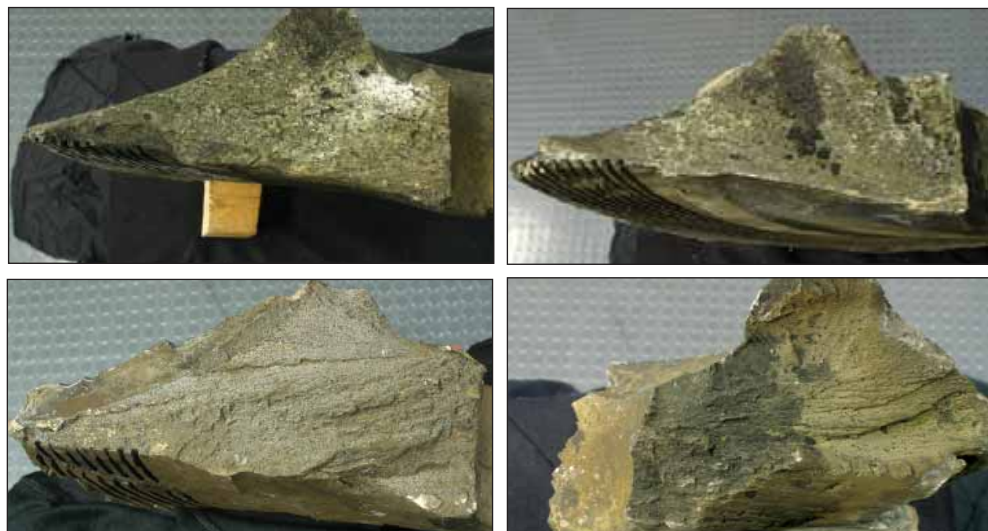
The primary disk fractures were predominantly radial in orientation. Although partially obscured by the staining, it was apparent that the dominant morphology was one of rapid brittle overload, with the riverline / chevron markings suggesting the commencement of fracture at the disk bore. Close visual and stereomicroscopic scrutiny of the fractures did not reveal any unusual fracture morphologies, nor did it find any evidence of the presence of pre-existing cracking or other defects along the planes of failure. Figures 18 to 21 present the primary fracture surfaces of the disk and show the direction of fracture where this was determinable.

Figures 18 & 19 (top), 20 & 21 (bottom): Primary fracture surfaces of the impeller disk fragments. All show features typical of gross overload

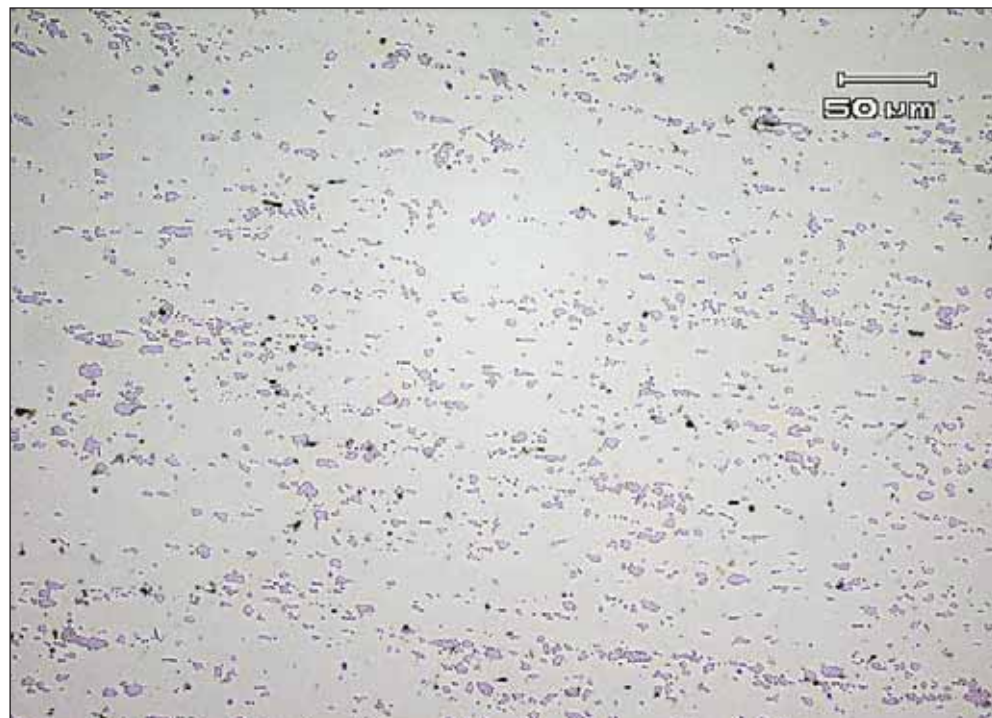
When examined in the unetched (as-polished) condition, the structure was typically comprised of an irregular distribution of rounded blue-grey particles within an amorphous matrix (fig. 22). A reference^[3] for the AA2618 alloy indicated these particles to be an insoluble FeNiAl₉ phase. Etching the specimen in a 0.5% HF solution revealed a fine distribution of CuMgAl₂ precipitate throughout the matrix (fig. 23). Microstructural anomalies or other potentially detrimental features were not observed within any of the areas examined.

Figure 22: Unetched and etched microstructural views of the impeller disk alloy. The coarse grey particles in figure 22 are the FeNiAl₉ phase

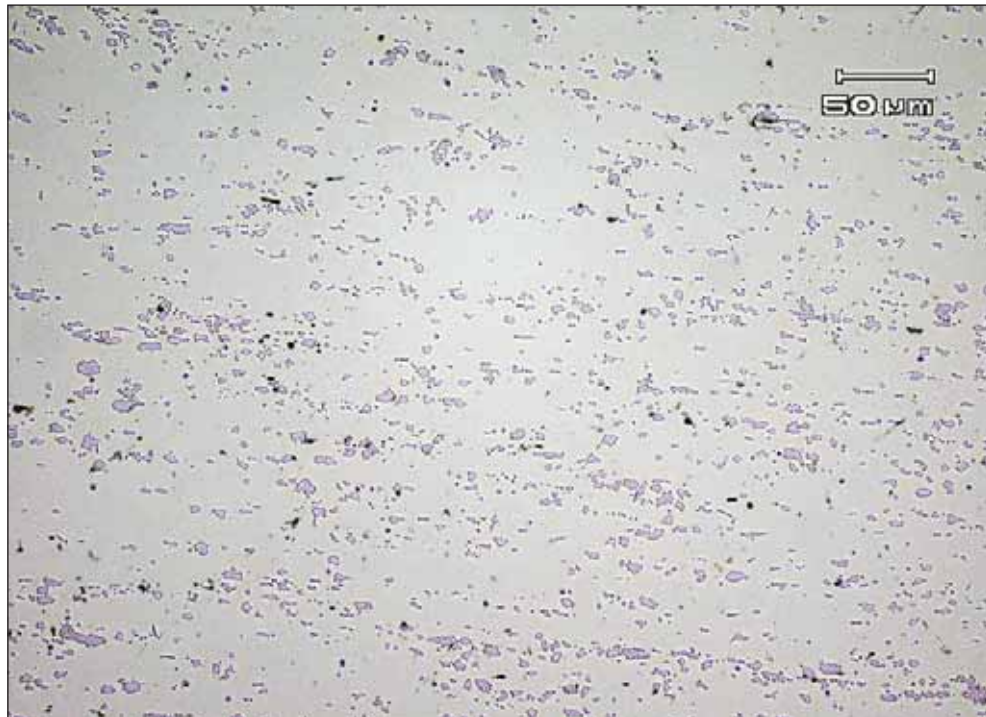
Figure 23: General mottled fine phase of the CuMgAl₂ age-hardening precipitate

The observed metallographic structures were consistent with the alloy being in the solution-treated and aged condition, which is generally the nominal state for engineering components produced from the 2618 alloy.

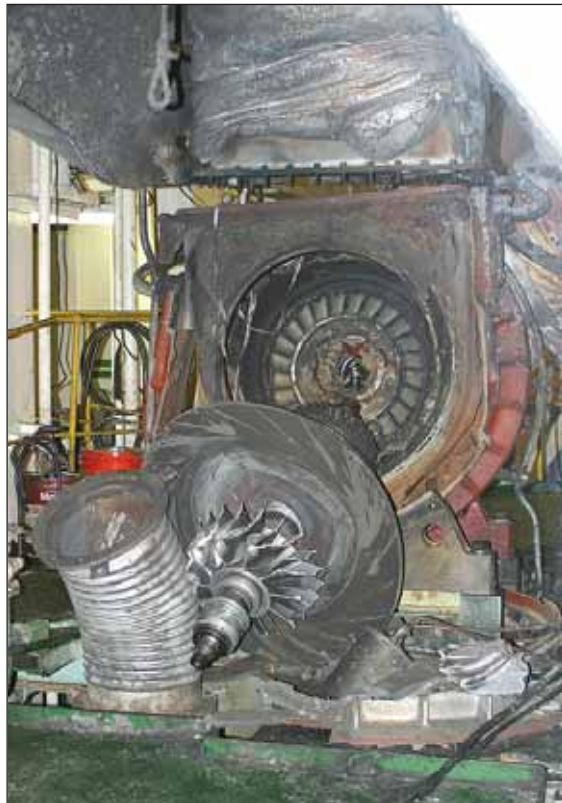
The wreckage of the second turbocharger unit was examined within the *Goliath*’s engine room, essentially where it came to rest following the failure. As had occurred previously, the casings of the turbocharger had sustained extensive damage and fracture and in this instance, the primary shaft had fractured at the turbine end bearings, allowing the entire shaft and rotors to displace axially out of position (figs 24 & 25).

Figure 24: View of the second failed turbocharger showing the ejected shaft and exposed exhaust outlet casing

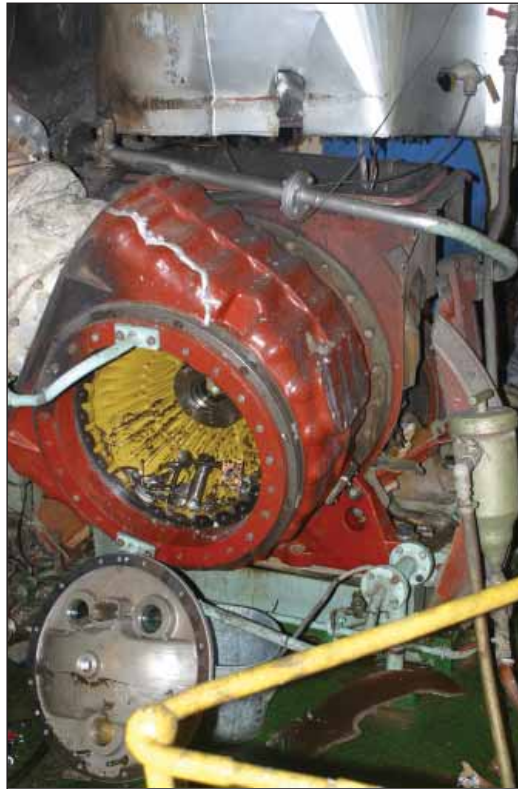
Figure 25: Opposite side of the second failed turbocharger, showing the exhaust inlet casing

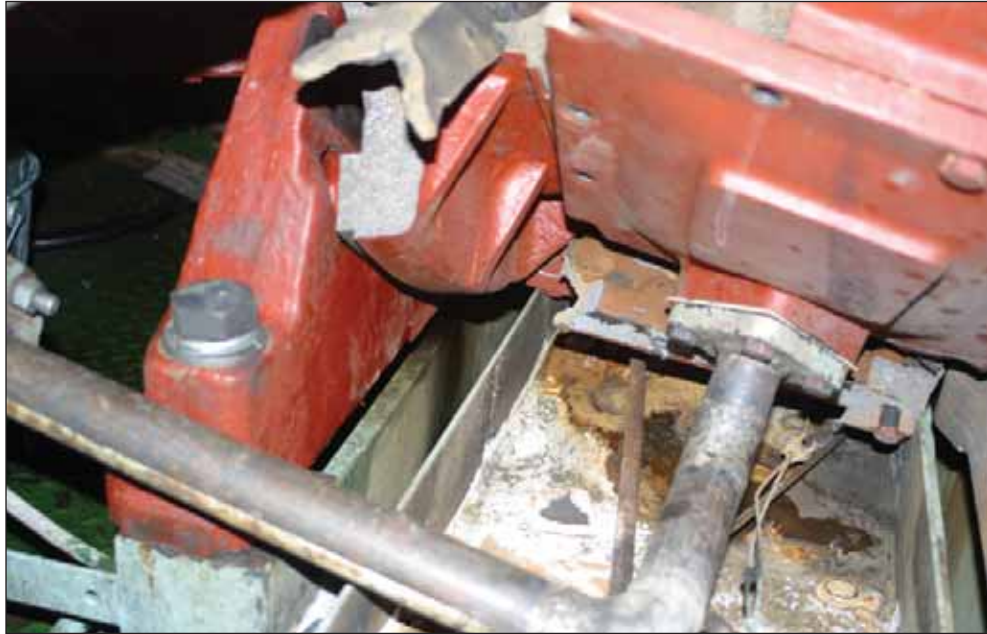
The turbine housing, shroud and nozzle guide vanes all showed extensive mechanical deformation consistent with multiple energetic impacts. The exhaust inlet casing had broken away from its mounts, as had the adjoining exhaust outlet casing (fig. 26), fracturing the housing cooling jackets and supply pipe-work. The outlet casing had dropped approximately 150 millimetres and broken away from the outlet manifold connection. The inlet manifold flexible coupling (bellows) had sustained considerable distortion but remained connected to the inlet casing. The guide vanes were all present and in place within the nozzle ring (fig. 27) and none of the associated components showed any evidence of having cracked, fractured or separated before the main turbocharger failure.

Figure 26: Failed housing mounts

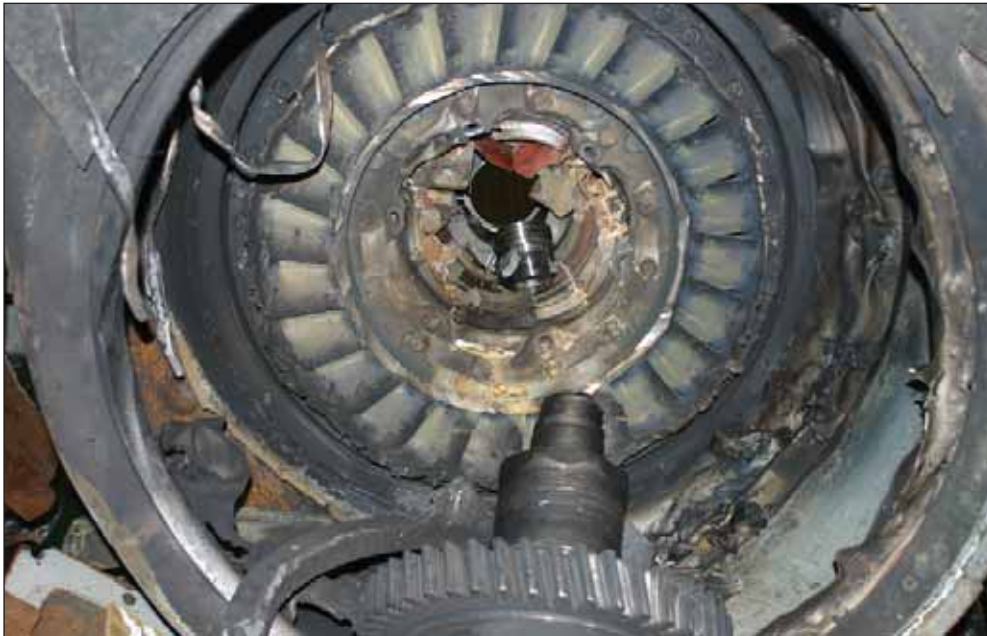
Figure 27: Intact nozzle ring and guide vanes

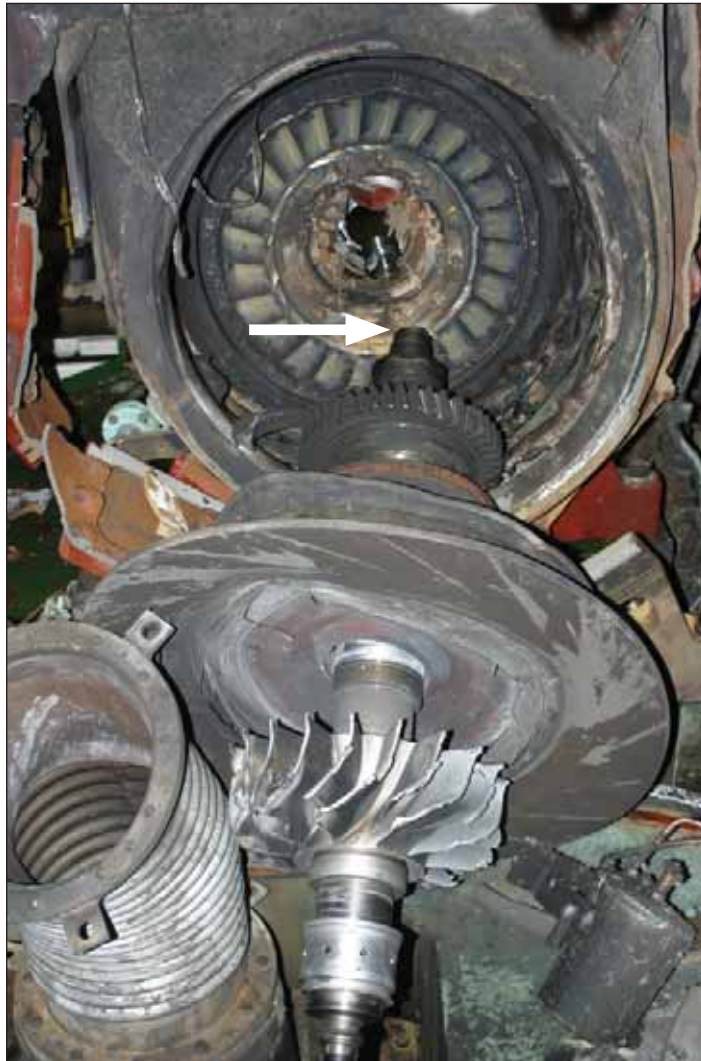
The turbocharger shaft had fractured approximately 150 millimetres from the turbine end and the entire assembly had moved axially toward the compressor. Fracture and complete separation of the compressor housing had allowed the shaft to fall almost completely out of the casing and onto the adjacent deck (fig. 28). Examination of the shaft fracture surfaces showed gross plastic deformation and ductile shear failure – features consistent with rapidly applied bending overloads. The inspection found no evidence of prior or progressive cracking or other defects.

Figure 28: Shaft and turbine wheel ejected from the casing due to the failure of the shaft at the bearing housing (arrowed)

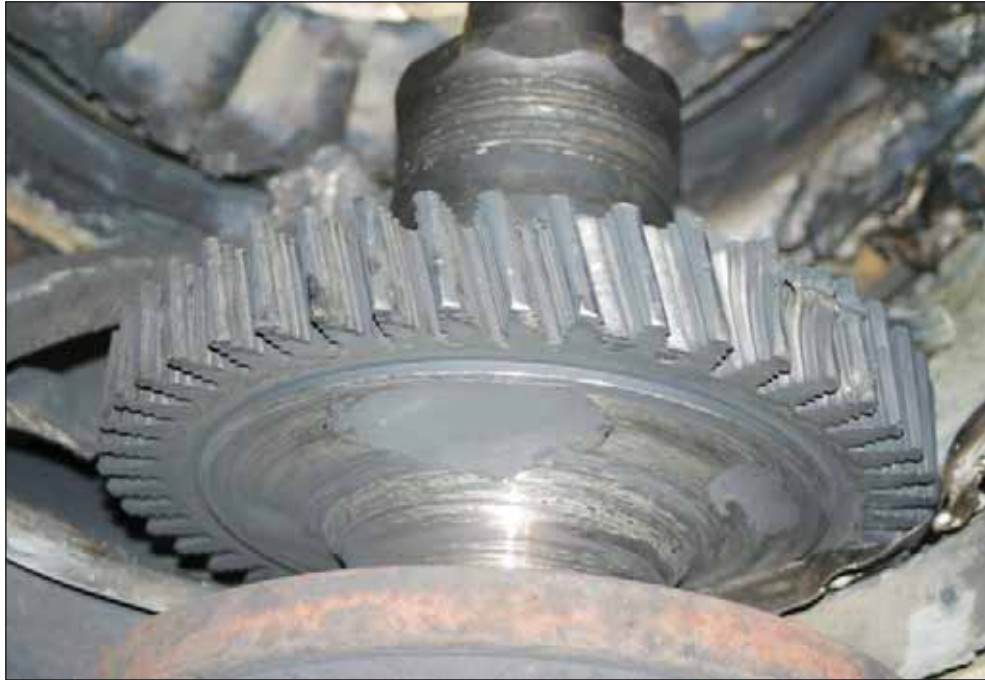
Figure 29: Completely de-bladed turbine disk
