ATSB TRANSPORT SAFETY INVESTIGATION REPORT
Marine Occurrence Investigation
No. 186 and 191
FINAL

**Independent investigation into the
equipment failure on board the
Australian registered bulk cargo carrier
*Goliath***

in Bass Strait on 22 September 2002 and
off Jervis Bay, New South Wales, 12 February 2003

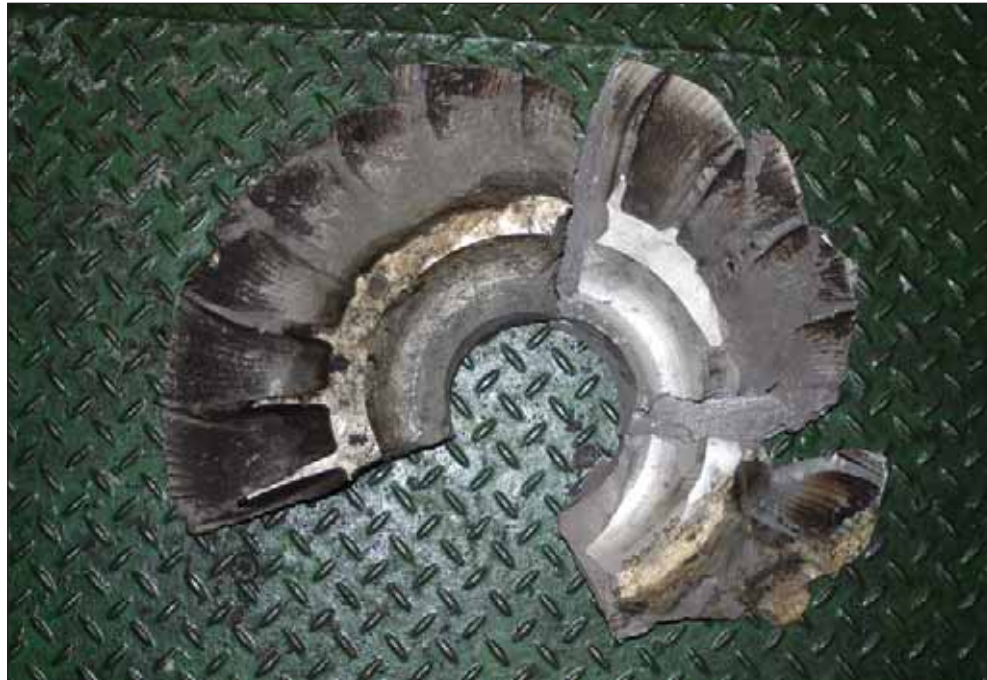
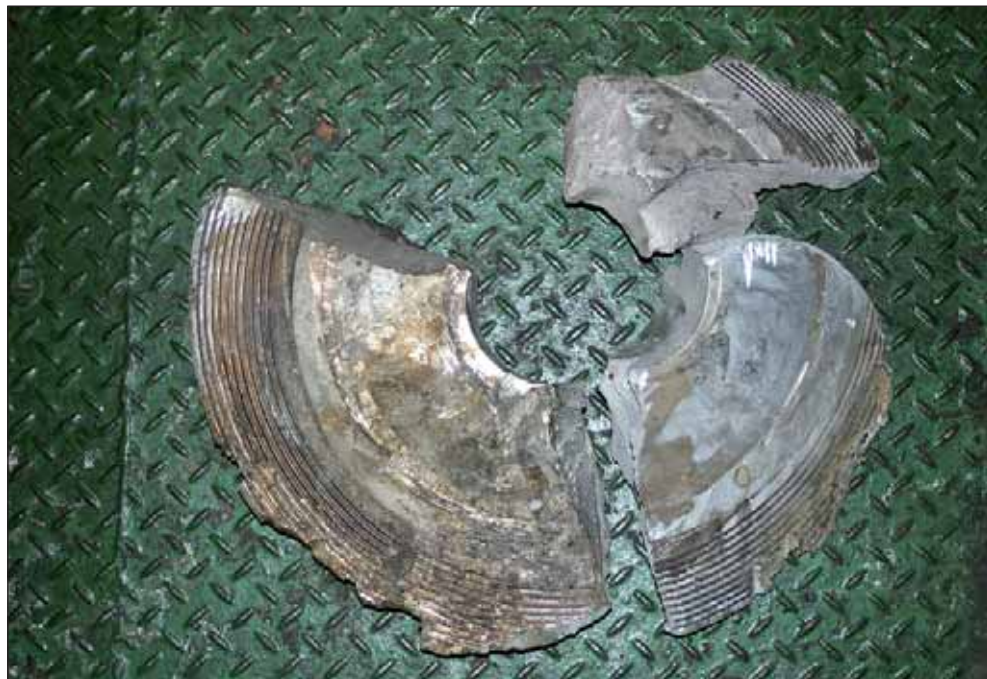
Figures 30 & 31: Segmented failure of the compressor disk, very similar to the first failure (fig.17)

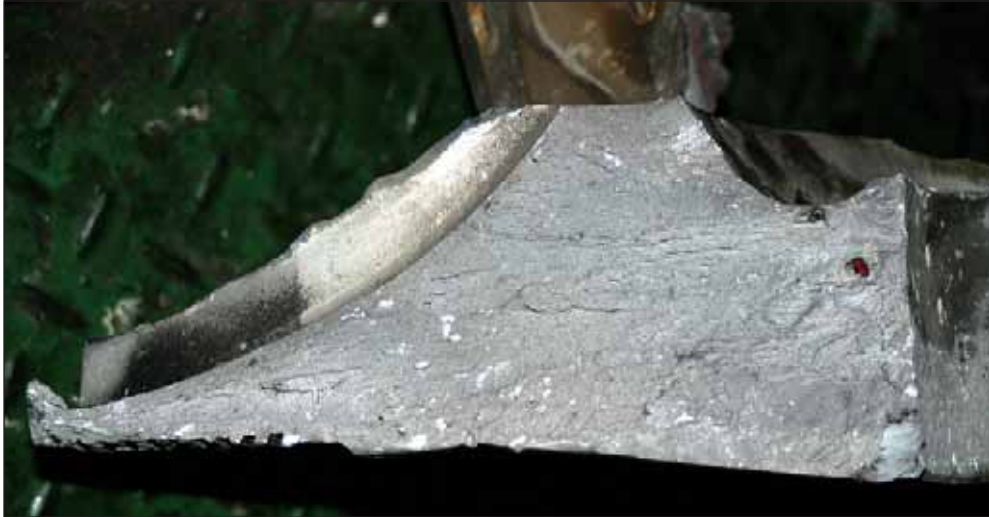
Figure 32: Typical brittle overload fracture exhibited by the impeller disk

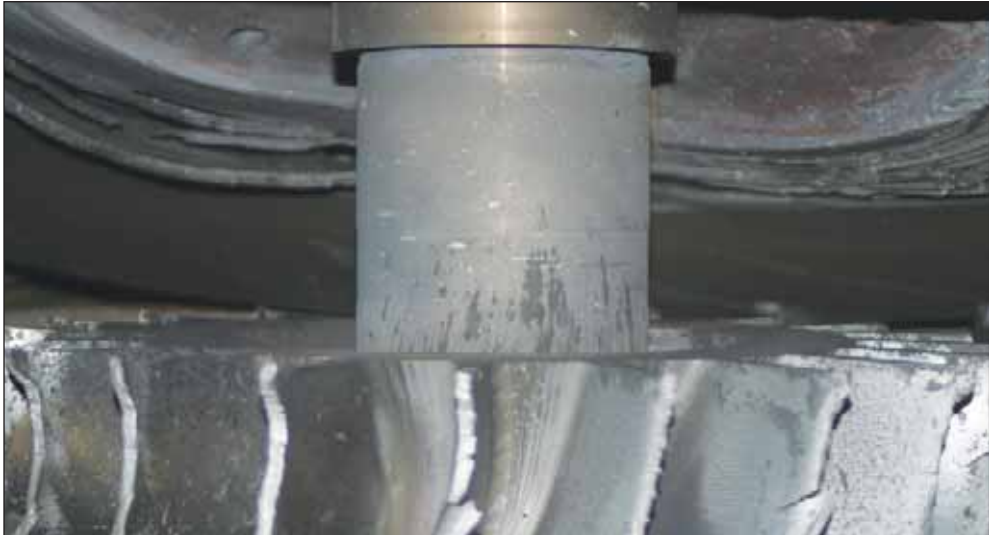
Figure 33: Shaft surface showing no evidence of impeller insecurity or rotation

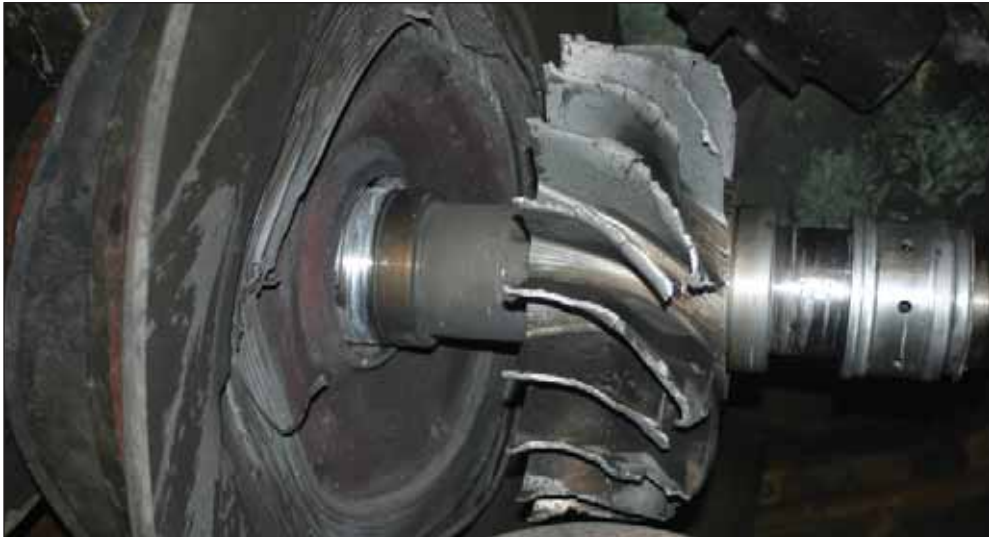
Figure 34: Inducer in place adjacent to the normal disk location

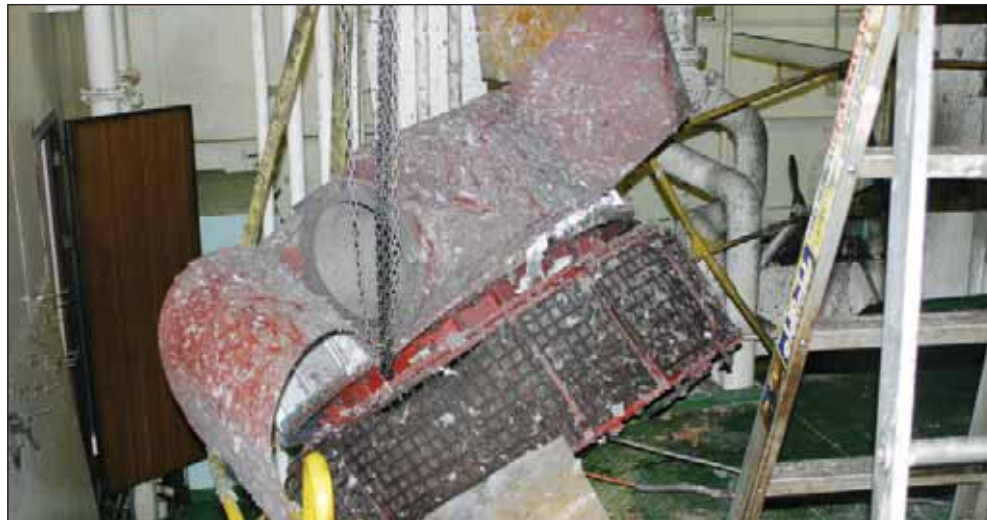
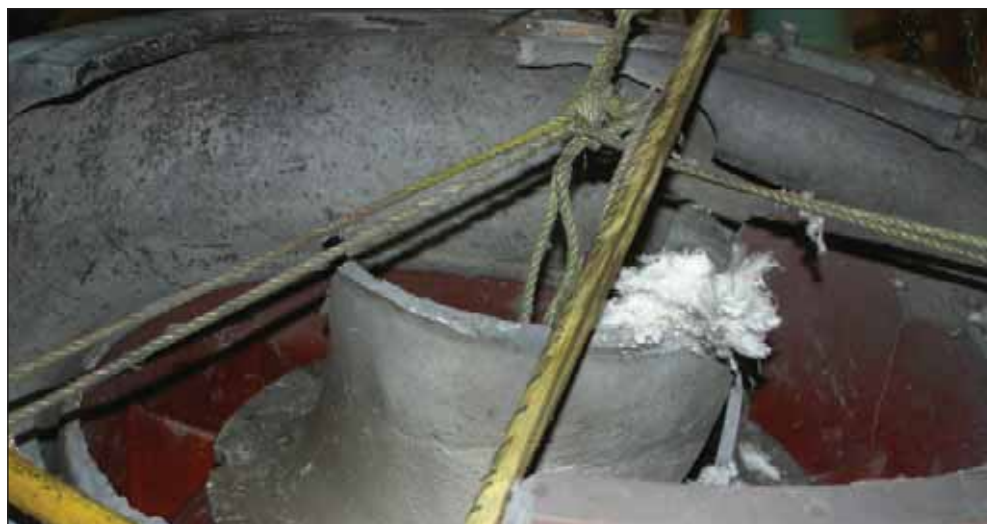
Figure 35 & 36: Compressor housing completely separated from the turbocharger body and exhibiting extensive internal damage
