MARINE SAFETY INVESTIGATION  
No. 196

# Lancelot

# Jenabar

14 nautical miles east of Diamond Head, New South Wales,  
21 August 2003

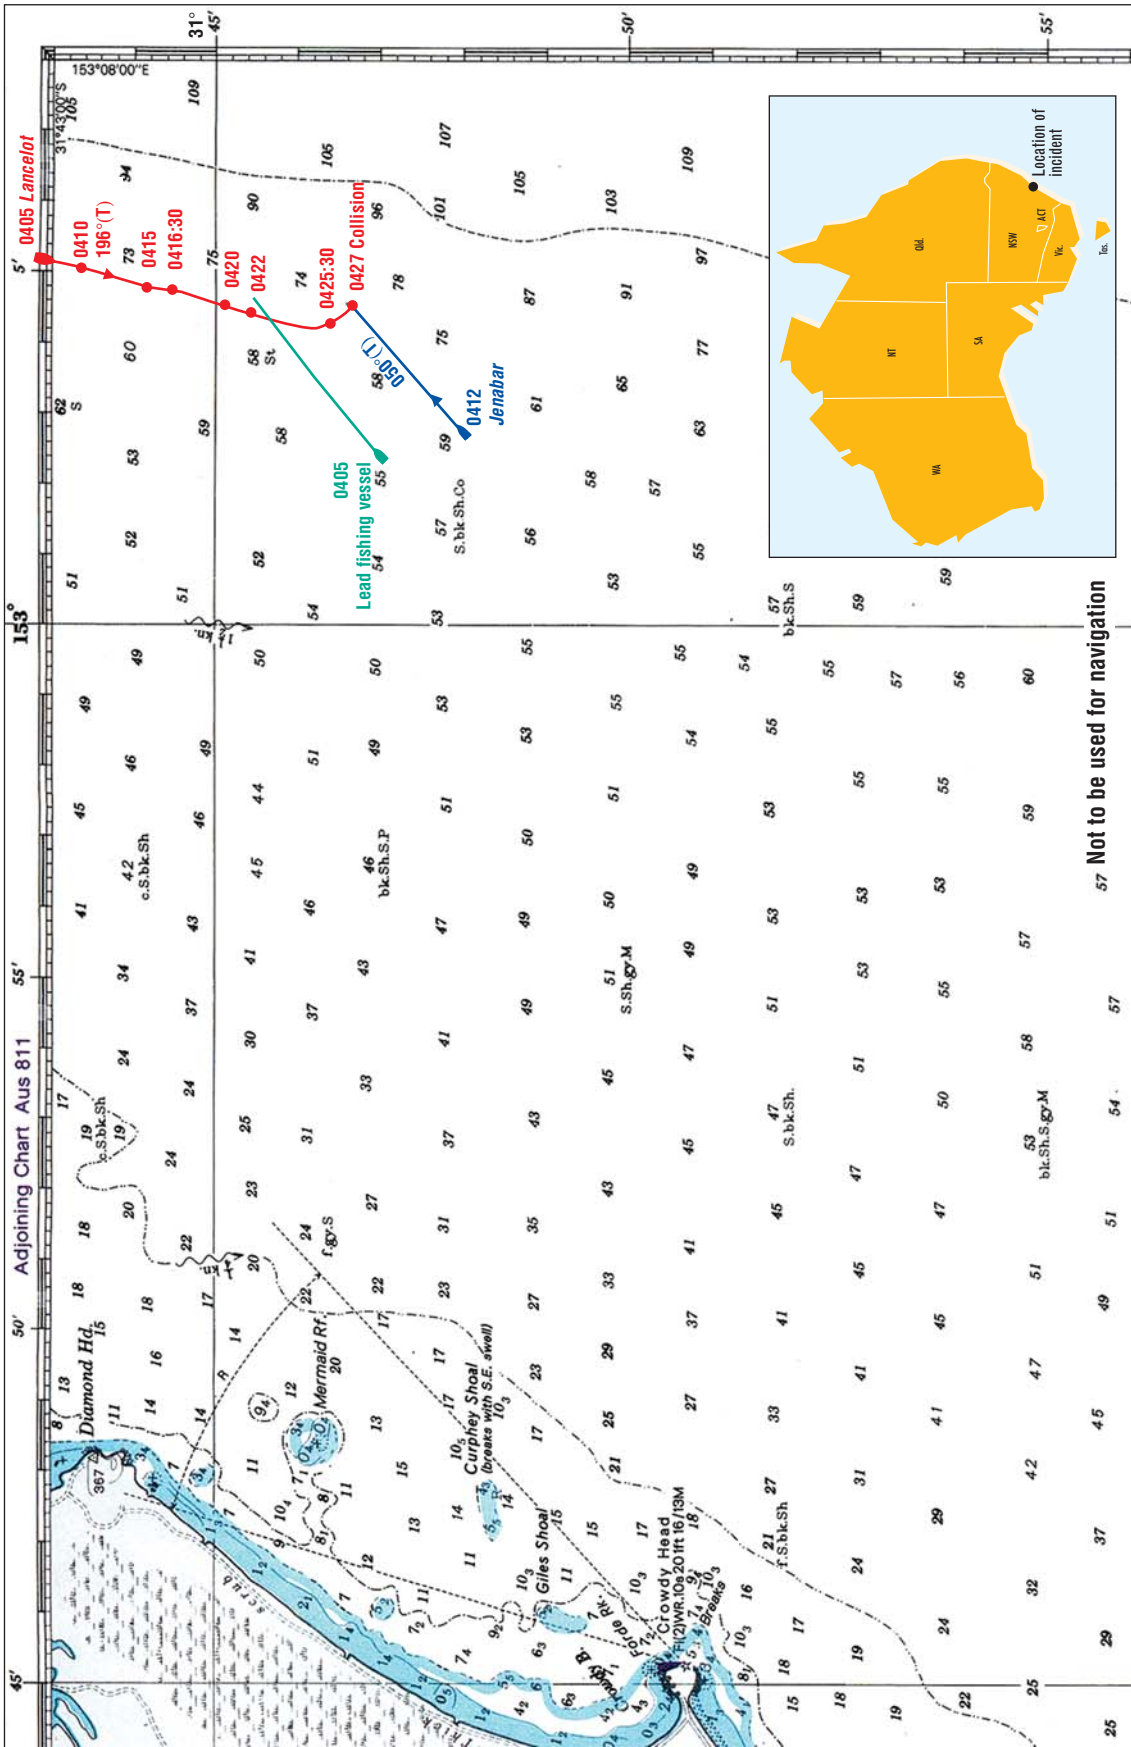
**FIGURE 2:**  
**Portion of chart Aus 810 showing tracks of ship and fishing vessels**

When the fishing vessel was about two cables off to starboard, he was able to see its port sidelight. By then, he had ordered the rudder 'hard to starboard', to reduce the angle of any impact and, if possible, to enable the other vessel to pass under the stern of the ship. However, at 0427, the fishing vessel collided with the starboard side of the ship, abreast of number six hatch. The position for the collision as logged by the ship was 31° 46.6' S, 153° 04.5' E (see fig 2).

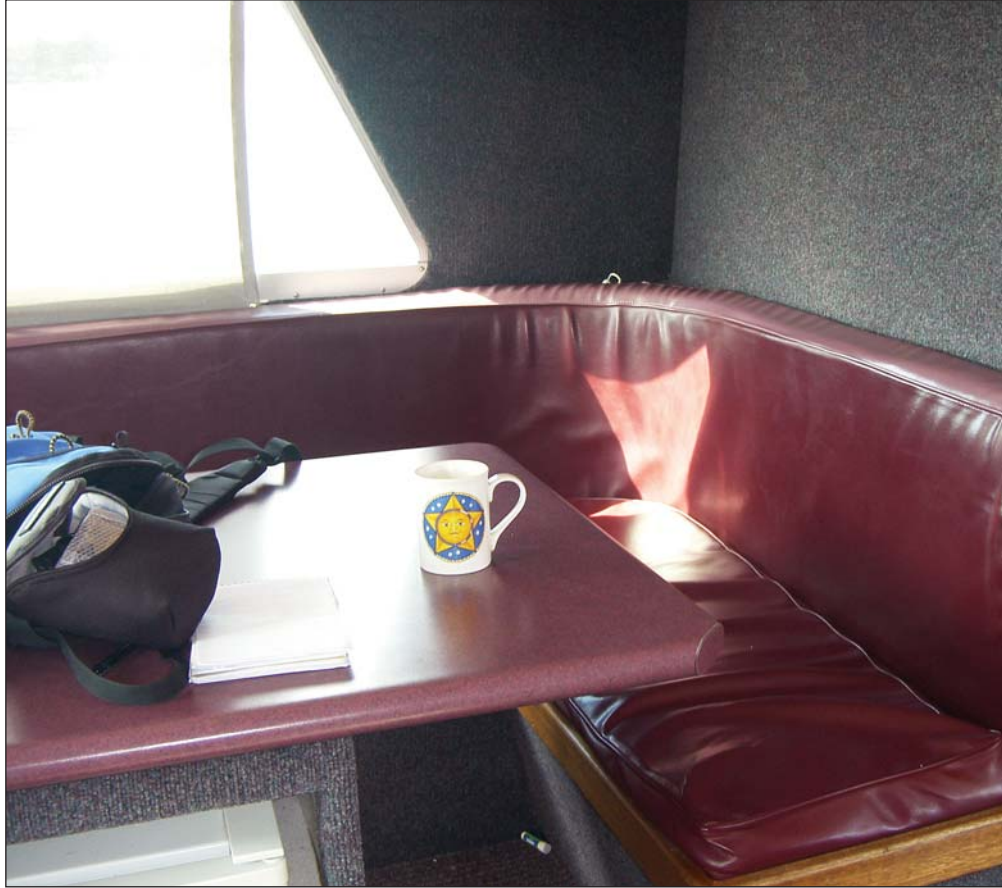
**FIGURE 4:**  
Table, aft of radar, at which deckhand was seated

The lookout being maintained by the deckhand was inadequate and ineffective.

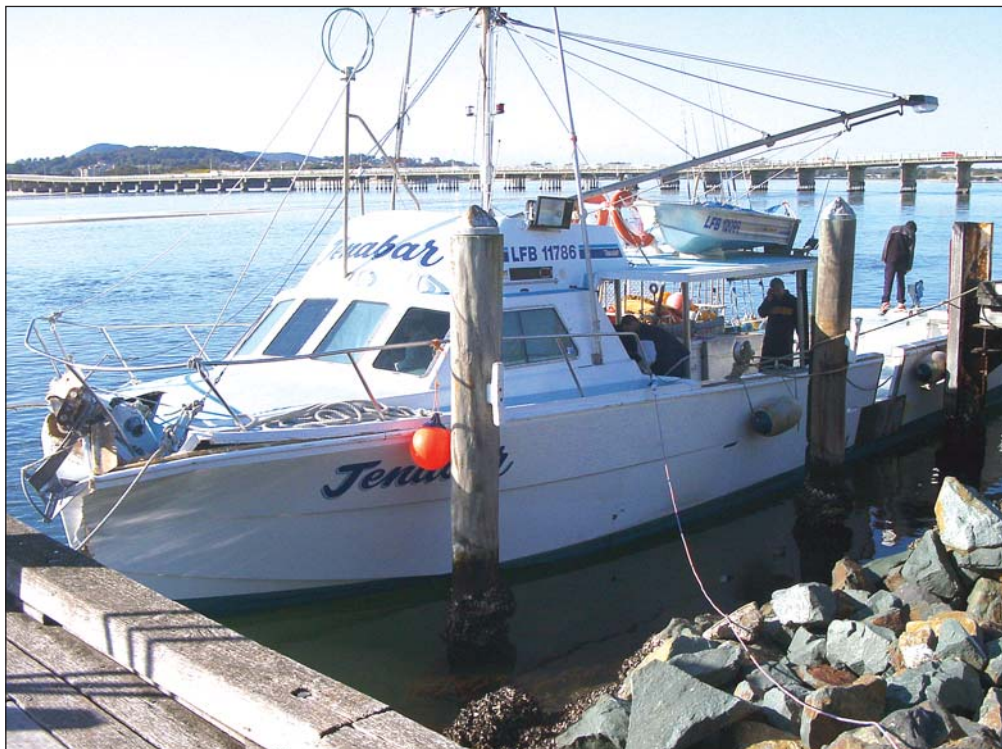
**FIGURE 5:**  
*Jenabar* at Forster

Although the fishing vessel's bow was badly damaged, the damage was above the waterline and there was no ingress of water (see fig. 5). The other fishing boats had come to *Jenabar's* assistance, but the skipper informed them that none was needed. After VHF contact was established with the ship, it was also advised that assistance was not required.

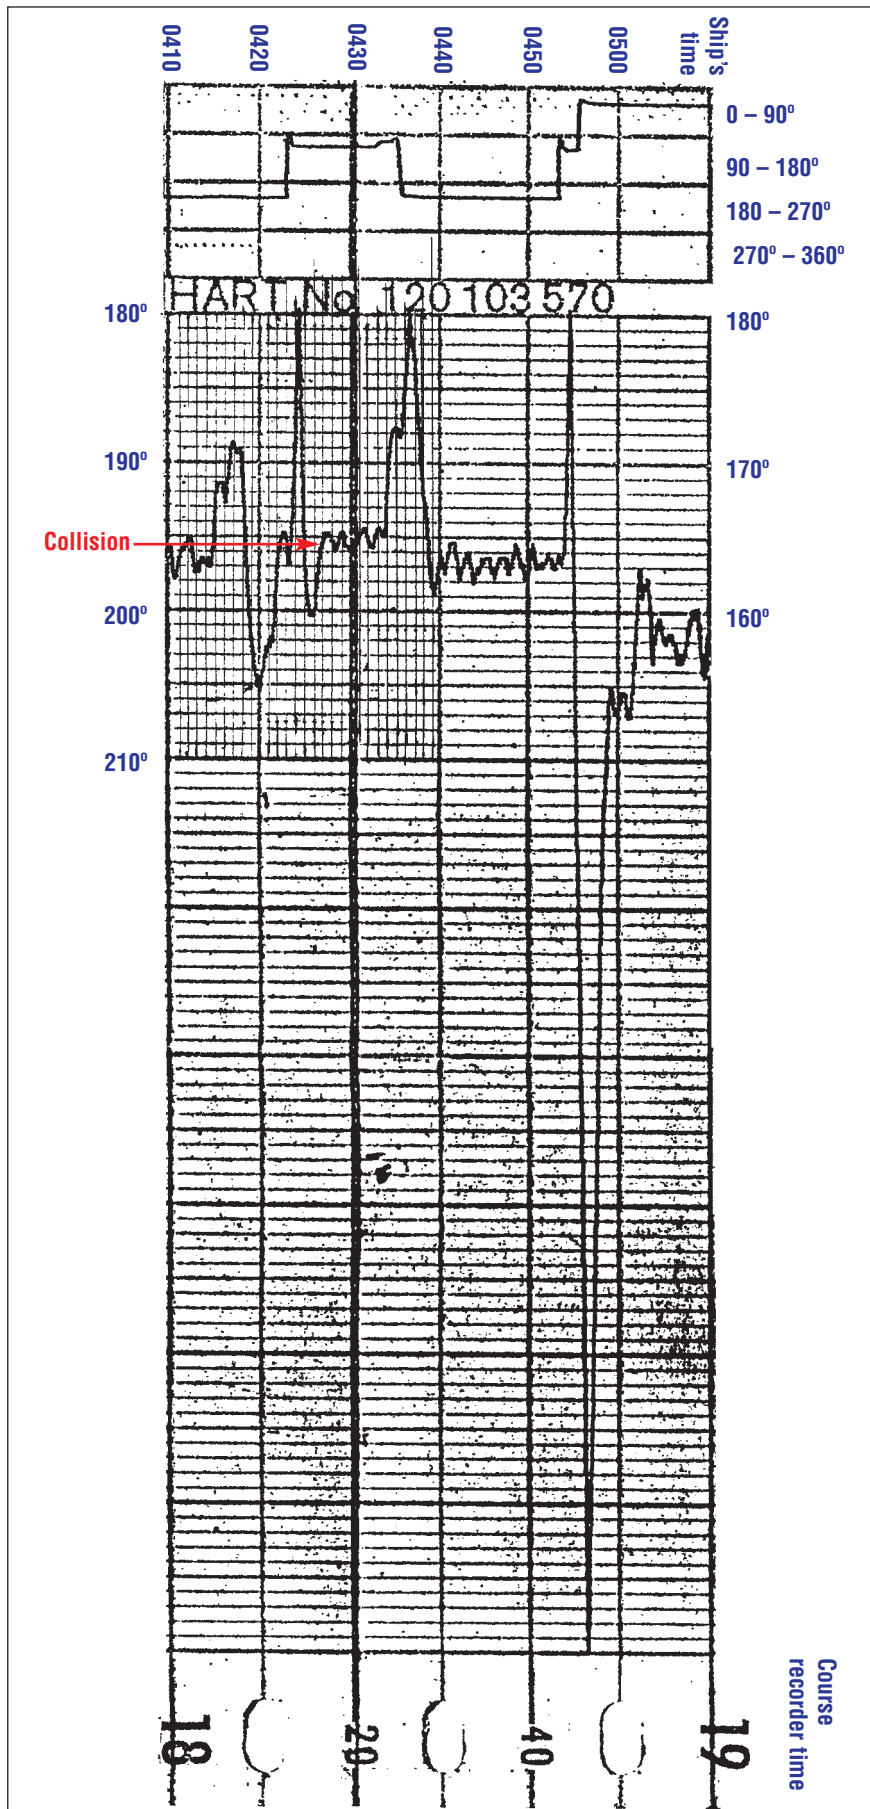
FIGURE 6:  
Portion of course recorder trace from *Lancelot*

The initial adjustment, at 0414½, over a period of almost four minutes, was to port, from 196° to 189°. The ship had hardly steadied on 189° when the mate ordered a 16° alteration to starboard to give way to the first of the fishing vessels. *Lancelot* reached a course of 205° at 0420, before counter helm was applied. At 0422, for about a minute, the ship returned to a course of 196°. At about 0423, port helm was applied to avoid *Jenabar* and the ship was turned rapidly to port to a heading of 160°, after which the course was altered to starboard, to 164½°.
