Australian Transport Safety Bureau

Crew member injury and fatality, Albany— 7 September 2003

Pacific Wisdom: Crew member injury and fatality

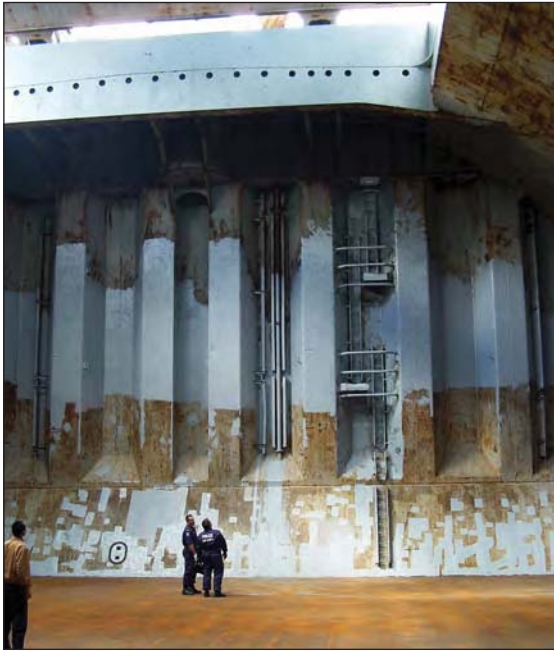
FIGURE 2:
No. 2 hold

The work, using the scaffold, was started at the forward end of this hold and continued from the starboard to the port side. At about 1600 the forward end was completed and the scaffold was moved to the after end of the hold to continue the work there. After this repositioning, two seamen immediately rescaled the tower to resume work on the underside of the deckhead. As soon as they had climbed onto the platform at the top of the tower, the entire tower fell towards the after bulkhead. The two men fell about 12 m to the tank top as the platform scraped down the bulkhead.

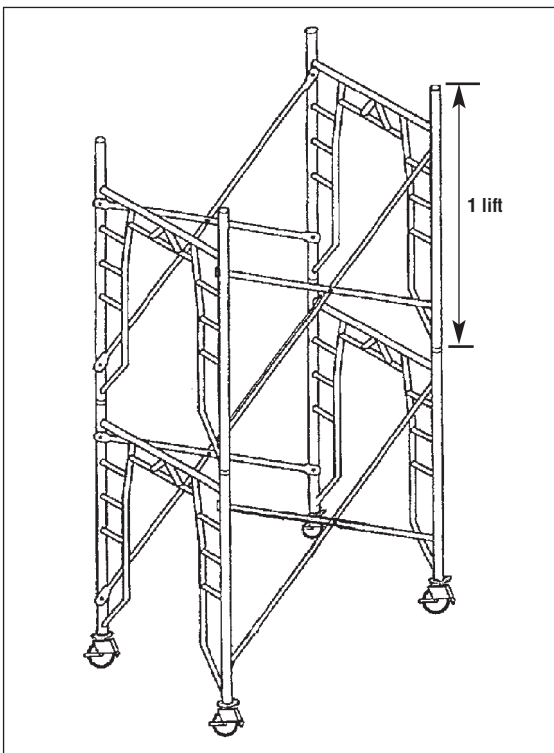
FIGURE 3:
Diagram of scaffolding arrangement (one 'lift' = 1.7 m)

On 7 September, in number two hold, seven 'lifts' were used to enable the crew to clean and paint the underside of the main deck and the hatch coaming. The scaffolding consisted of a set of seven prefabricated frames assembled and then secured in tiers or 'lifts' each of 1.7 m in height. The entire structure was 12.3 metres high when complete. The work platform on the top lift was made up of metal 'planks' fitted over the frame of the platform. This platform is also fitted with guard rails. It was of sound construction, in reasonable condition and correctly erected. At the base of the scaffold, rubber tracked castors fitted at each corner allowed the structure to be moved easily from position to position. These castors could be locked to prevent unintended movement. Each tier, or lift, was 1.26 m wide by 1.875 m long. With seven tiers fitted, the scaffolding had a height to base length ratio of about 5.2 to 1. Although not a requirement for this ship, a ratio of 3 to 1 for height/width is considered by the Australian authorities ashore to be the maximum for safe working.

For the structure to remain stable, the forces acting vertically downward through the resulting, very high centre of gravity had to act within (or very nearly within) the area enclosed by the castors at the base.

A single force or combination of dynamic and/or static forces (either a slight movement – roll – of the ship, or one or both men leaning over the platform guard rail, or a force applied as a restraining lashing was secured) acting downwards or outward through the very high centre of gravity would easily cause a rotational force and the scaffolding to fall.

1. The base of the scaffolding was too narrow for the assembled height making the scaffolding inherently unstable.
2. Guy ropes were not secured and the castors were not locked prior to the men going back up the tower.
3. The two men had not secured their safety harnesses to the ship's structure.
4. It is probable that some combination of ship movement in the seaway and the distribution of weights at the working platform level were factors in the fall of the scaffolding.
5. Both company ISM procedures and normal seaman-like practices were violated, some at least in an attempt to optimise the work in hand.

Responsible persons should ensure that the height to base ratio of a scaffold should not exceed 3 to 1 without guy ropes or preventers in place prior to use. Wheels must be locked before anyone is permitted aloft.

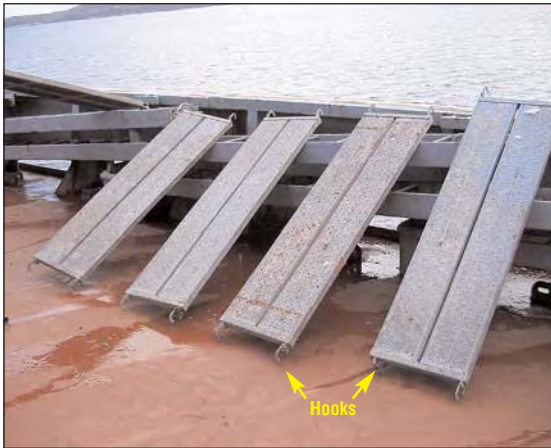
FIGURE 4:
Metal planks

Note the hooks that fit over the frame of the platform. This arrangement helps to make scaffolding more rigid.

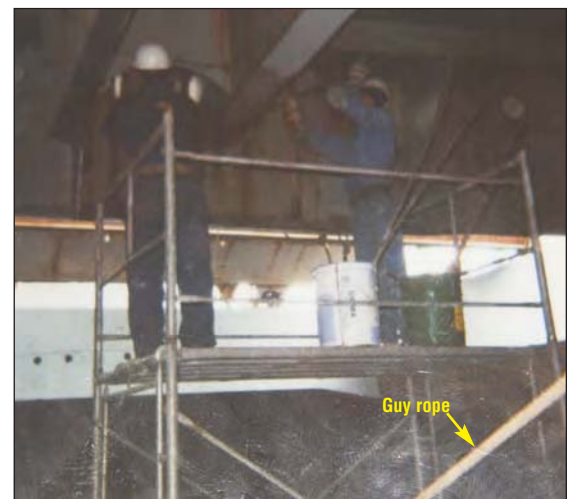
FIGURE 5:
Photo taken earlier that day showing two seamen working on the top platform

Although both men were reportedly wearing hard hats, safety belts and lanyards, these were not secured and both men fell to the tank top as the tower toppled.

Despite the procedures and safe guards, there is anecdotal evidence that proper, usual, safe working practices were not followed. It seems that when moving the scaffold across the forward end of the hold, the castors were released, the lashings loosened and the men stayed on the platform. The area of deck head that could be reached in safety from the platform was limited and would have needed a number of moves to clean the area and apply any paint that was necessary. Each time the scaffolding was moved the men working on it should have descended to the deck; but they almost certainly did not on every occasion. This form of 'optimising violation' may have, in part, been due to the fact that the ship had given 'notice of readiness' to load and the imperative was to ensure the ship was ready for the impending inspection prior to loading.
