Australian Transport Safety Bureau

Collision near Creech Reef in the Great Barrier Reef – 5 January 2004

Collision between *Bunga Orkid Tiga* and *Stella VII*

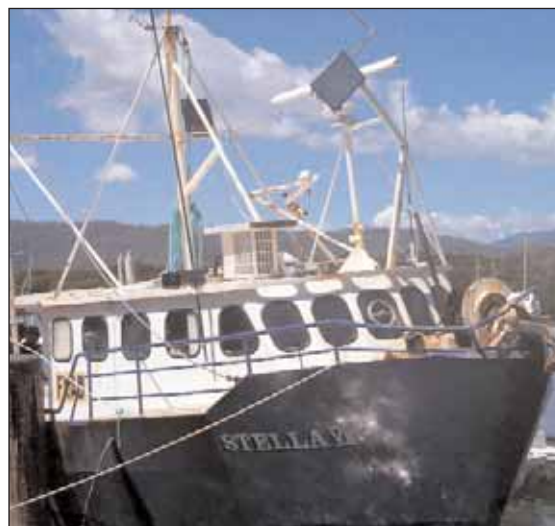
FIGURE 1:
Stella VII

The crew slept in two cabins below the forecastle and the skipper in the wheelhouse. On the forecastle deck a windlass, offset to the port side, obscures the line of sight from about three degrees on the port bow to about

40 degrees. *Stella VII* engages in line fishing, undertaken from five metre long dorys, six of which are towed astern. *Stella VII*, being equipped with freezers, acts as the mother ship.

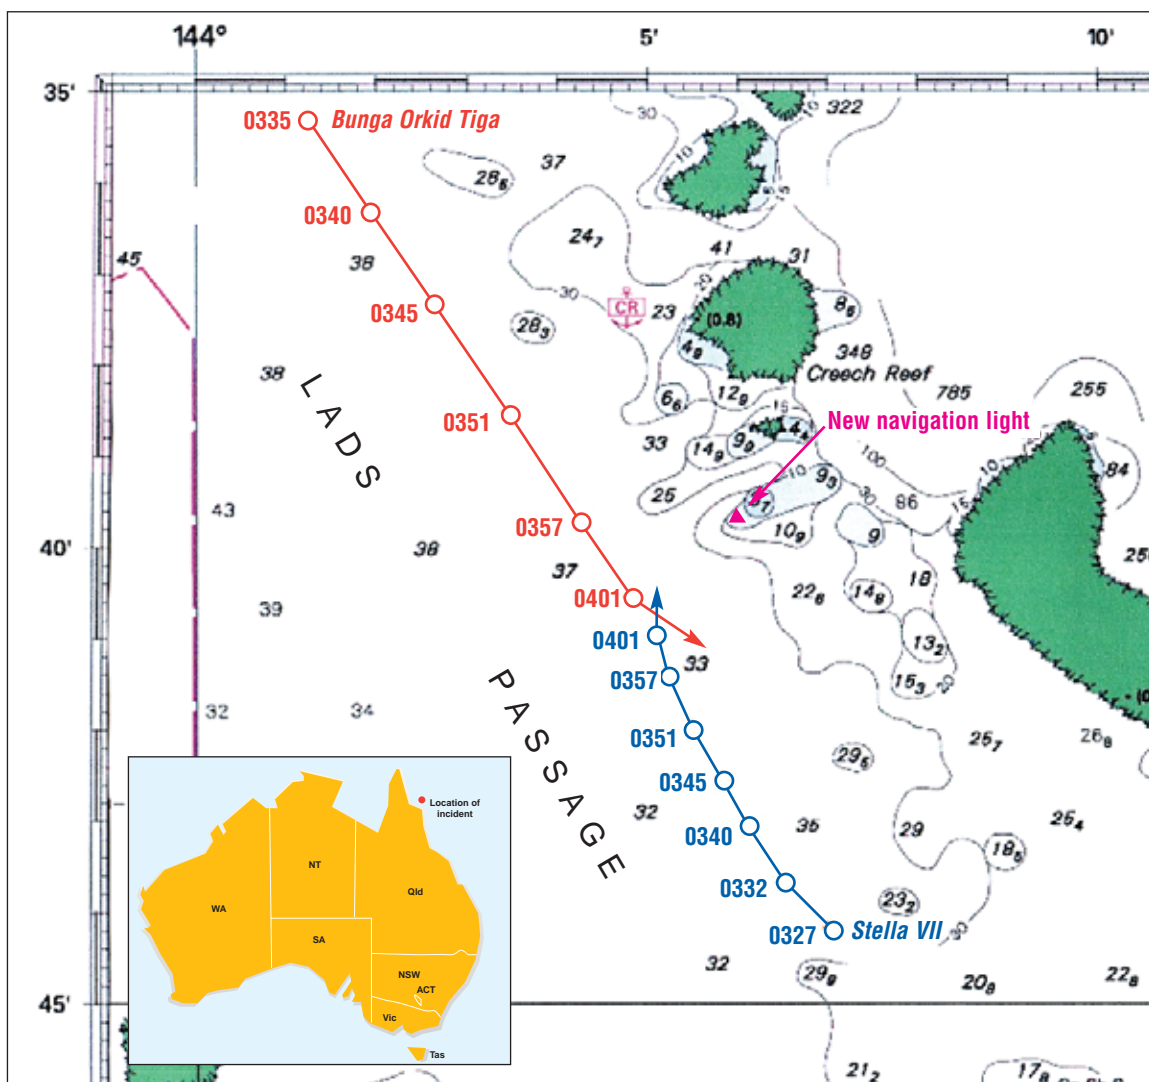
FIGURE 2:
Portion of chart Aus 833 showing position comparison for the two vessels

At 0327 on 5 January 2004 *Bunga Orkid Tiga* was in position 13° 33.71'S 144° 00.19'E, on a heading of 151°(T) and making good a course of 147° at a speed of 14.3 knots. *Stella VII* was in position 13° 44.21'S 144° 06.99'E, 12.3 miles to the south, two degrees on the ship's port bow, making good a course of 317°(T). The OOW's recollection that the light was one point on the bow was inaccurate.

The OOW maintained the ship's course of 151°(T) until about 0340 when *Stella VII* was about 7.8 miles ahead and had crossed the bow to be two degrees on the starboard bow. The OOW made a slight adjustment of course of about two or three degrees to port.

From that time *Stella VII* remained, for all intents and purposes, on a steady bearing between dead ahead and three degrees on the starboard bow. Rule 14 of the International Regulations for *Preventing Collisions at Sea, 1972* (Colregs) applied and each vessel should have altered course to starboard. Even if there was doubt through the inability of either vessel to make out the lights of the other, given the steady relative bearing close on the bow, the watchkeepers should have assumed that the risk did exist and should have acted accordingly.
